## Recall 15V-628: Passenger's Front Air bag

This Service Information bulletin supersedes SI B65 18 15 **dated October 2016**.

I01 (i3)			
Produced from March 21, 2014 to August 18, 2015

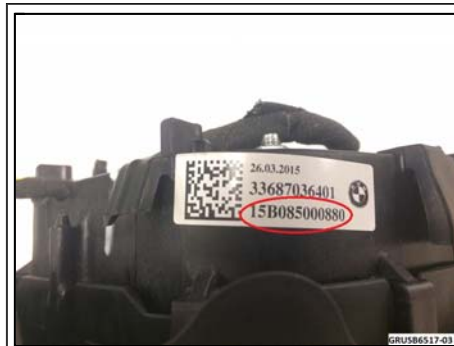
**UPDATE!** There are two different serial numbers that can be found. For this recall we only need the serial number on the label on the side of the air bag. This is the longest number usually on the bottom of the label. (The other number can be found on the actual gas generator below the barcode)

It is necessary to document which air bag goes into which vehicle. Therefore the technician is required to note on the repair order the serial number of the new air bag. The serial number should also be entered into the warranty claims comment section.

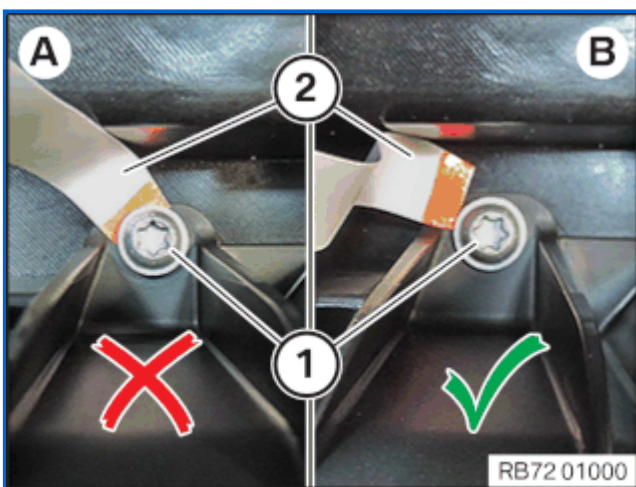
Although the screws were correctly tightened using the torque wrench, it is possible that the **screw head (1)** is **not seated without a gap**.

1. Tighten all screws on the airbag module to the **prescribed tightening torque without retorquing.**

2. Check that for **all screws** (1), the screw head (1) is seated without any gap, for example, by using a thin paper strip (2) as shown in the illustration:

- A. Paper strip (2) slides under the screw head (1). The screw (1) is not seated without a gap, screw connection is not correctly seated:

Loosen screw (1) and tighten it once again to the **same, prescribed tightening torque without retorquing.**

- B. Paper strip (2) does not slide under the screw head (1). The screw (1) is seated without a gap, screw connection is correctly seated.
