Technical Service Bulletin

GROUP	NUMBER
	CAMPAIGN	16-01-010
٥,	_	MODEL(S)
	MARCH 2016	Sonata (YF) Elantra (MD)

INSTALLATION OF URETHANE PROTECTOR OVER FRONT COIL SPRINGS (RECALL CAMPAIGN 133)

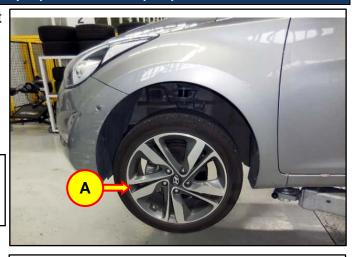
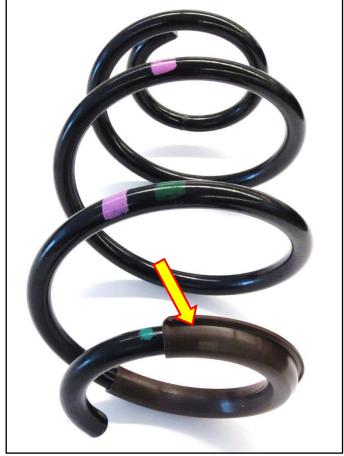
- 1b. Some Sonatas might have a brown urethane tube installed on the spring.
 - Carefully remove the tube without damaging the black coating.
 - Then perform the procedures in this TSB.

1a. Lift up the vehicle and then remove the front wheels & tires (A).

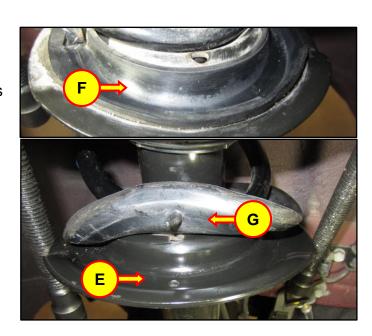
- 4a. Use an air nozzle to remove any debris from around the lower spring seat.
 - -Clean the lower portion of the spring where the urethane tube will be installed.
 - -Inspect the lower coils of the spring for damage or corrosion. Replace as necessary. If the spring is still under warranty, submit a separate claim using the same Repair Order. If the spring is out of warranty, submit a Prior Approval Request for goodwill consideration prior to performing the work.

- 4b. If a Sonata is in need of a replacement spring, P/N 54630-3Q010, the spring might have a brown urethane tube installed.
 - Carefully remove the brown urethane tube without damaging the black coating.
 - Install the yellow urethane tube, P/N 54631-3Q000QQH, onto the replacement spring as described in this TSB.
 - Remove the spring from the vehicle according to the applicable workshop manual.
 - Install the replacement spring into the vehicle according to the applicable workshop manual.
- Carefully pull the rubber spring pad (F) off the lower spring seat.
 - -Clean the top (F) and bottom (G) surfaces of the rubber spring pad.
 - -Clean the lower spring seat (E).
