HYUNDAI
Technical Service Bulletin

GROUP RECALL	NUMBER 25-01-008H
DATE FEBRUARY 2025	MODEL(S) SONATA (YF) ELANTRA (MD)

SUBJECT: FRONT COIL SPRING URETHANE TUBE INSTALLATION
 (RECALL 133)

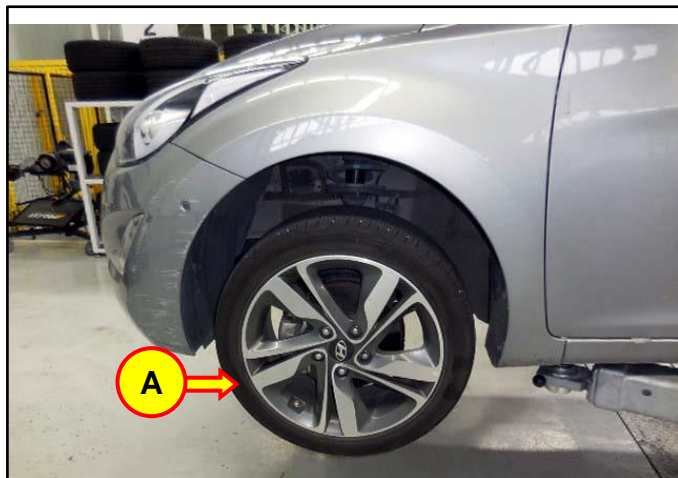
1. Lift the vehicle and remove the front wheels and tires (A).

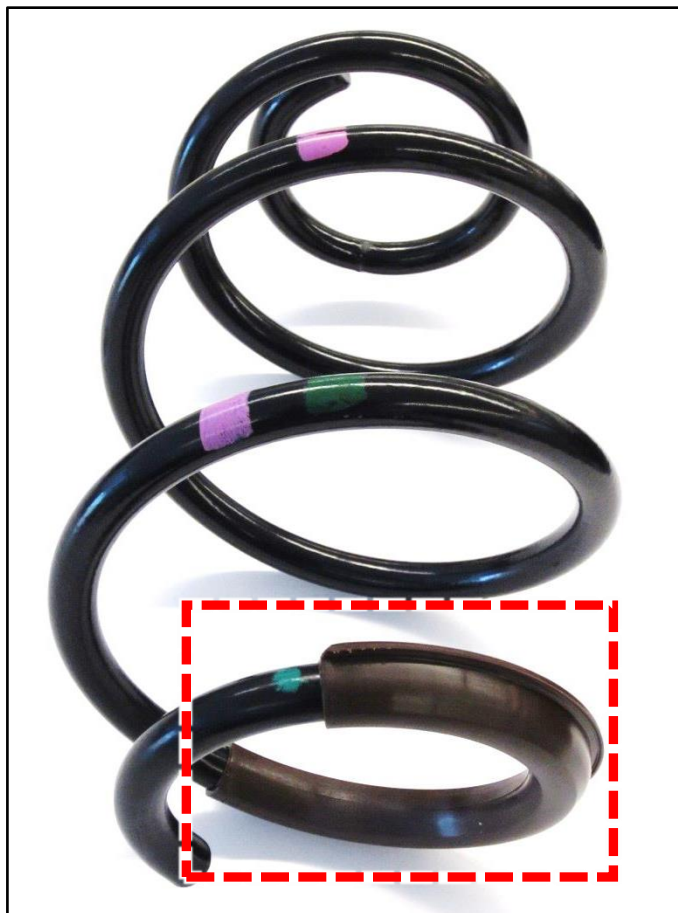
2. Carefully remove the tube without damaging the black coating.

Certain Sonata vehicles may have a brown urethane tube installed on the spring.

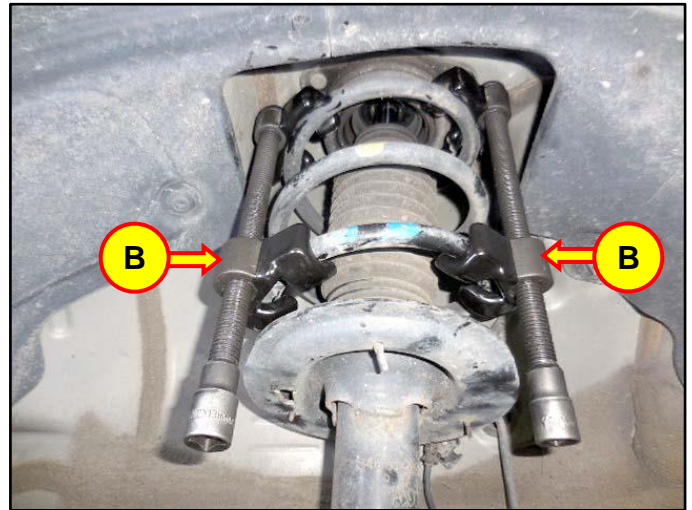
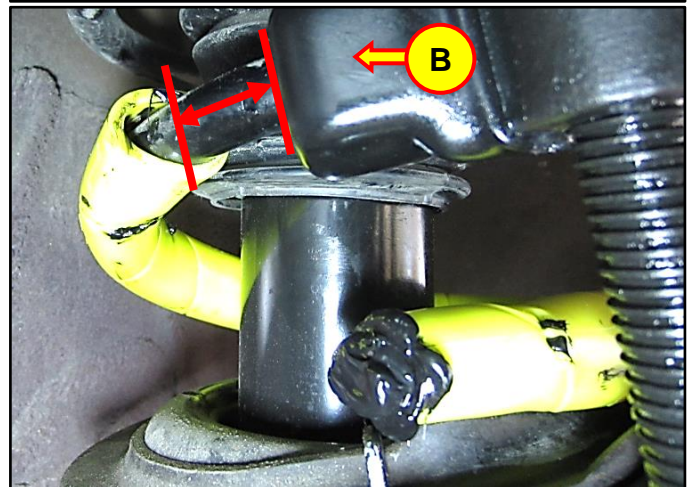
3. On one side of the vehicle, place the spring compression jigs (B) on opposites as show in the photo.

Compress the coil one side at a time, ensuring the gap does **NOT** exceed **25 mm (1 inch)** on either side.

Place the jig (B) on the spring toe allow enough clearance for the tube to fully slide on.

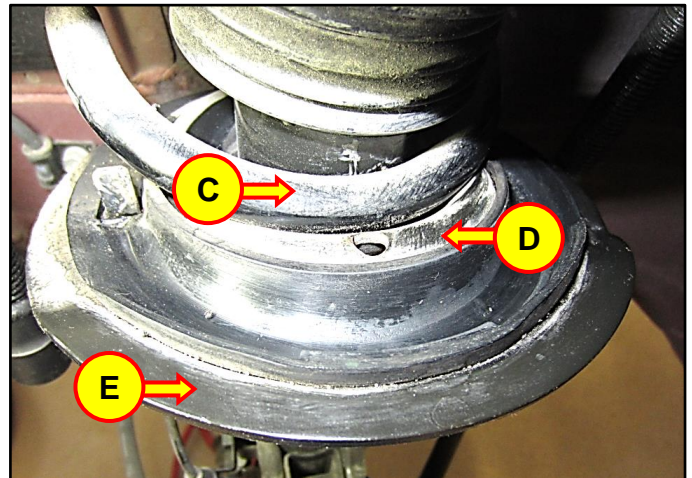
4. Move the bottom of the spring (C) over the inside hump (D) of the lower spring seat (E).

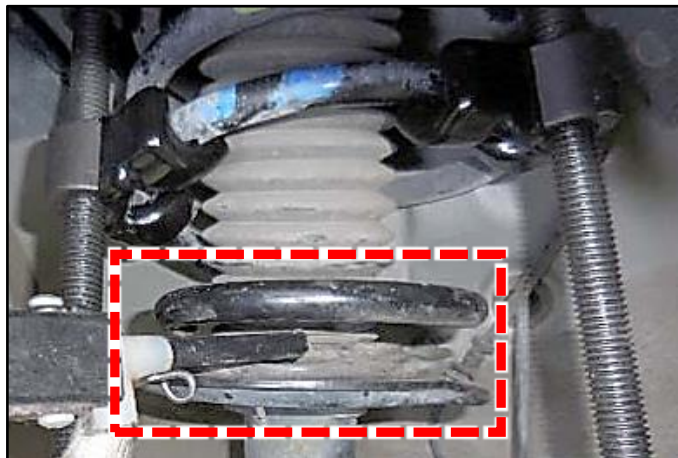
5. **Debris Removal:**

- Use an air nozzle to remove debris from the lower spring seat.

Clean & Inspect:

- Clean the lower part of the spring where the urethane tube will be installed.
- Inspect the lower coils for damage or corrosion.
 - If damaged or corroded, replace as needed.
 - If under warranty, submit a separate claim under the same repair order.
 - If the spring is out of warranty, submit a Prior Approval Request for goodwill consideration before proceeding.

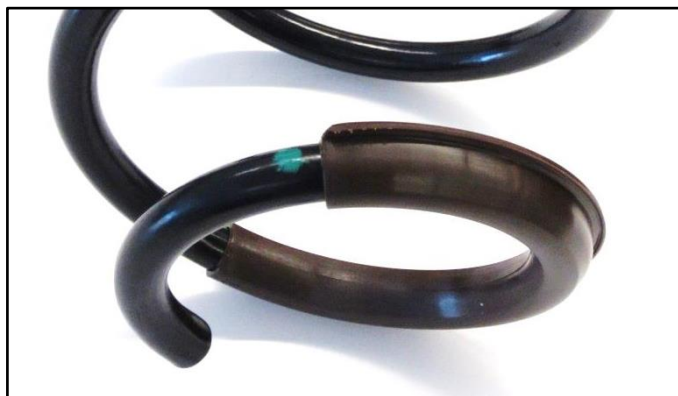
6. **Tube Replacement:****i Information**

If a replacement spring (**P/N 54630-3Q010**) is needed for a Sonata, it may have already had a brown urethane tube installed.

- Carefully remove the brown urethane tube without damaging the black coating.
- Install the urethane tube.
- Remove the spring per shop manual.
- Install the supplied spring into the vehicle per shop manual.

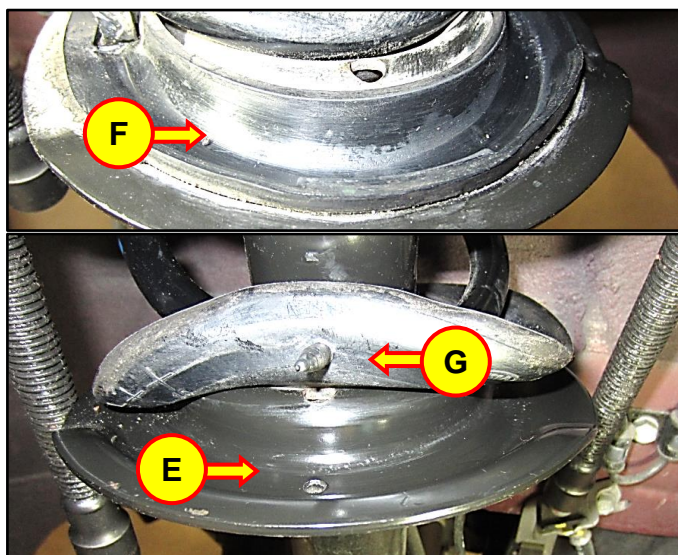
7. Remove the rubber spring pad (F) from the lower spring seat.

Clean the top (F) and bottom (G). surfaces of the pad and the lower spring seat.

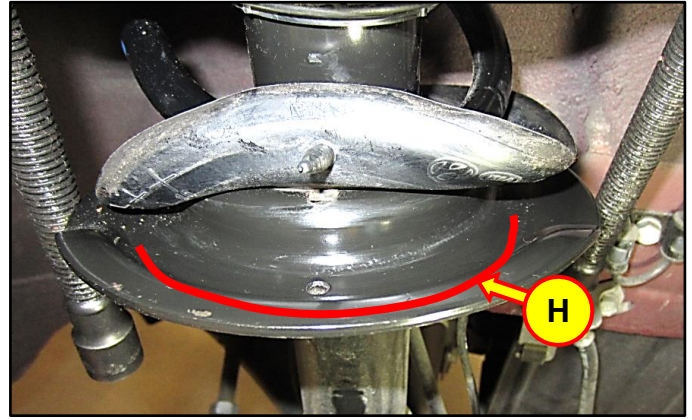
8. Apply a bead of sealant between the rubber pad and lower spring seat (H) as shown in the photo.

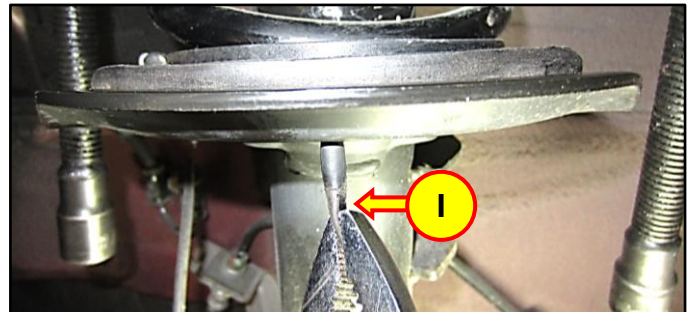
9. Reinstall the rubber spring pad by pulling the rubber pins (I) back through their respective holes in the lower spring seat.

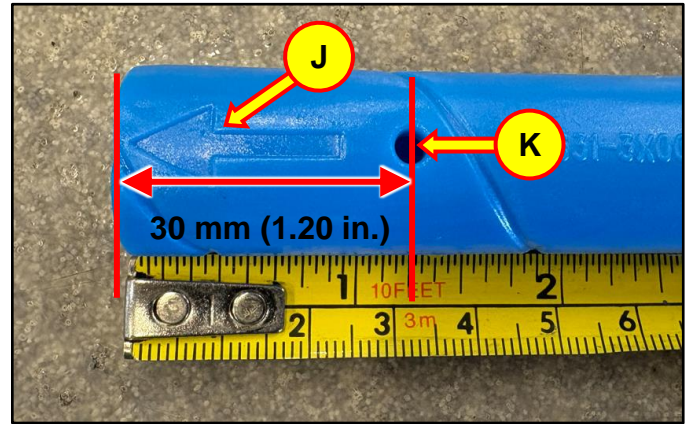
11. Locate the arrow on one end of the tube (J).

Fill the tube with sealant from the end marked with the arrow until the sealant reaches **30 mm (1.2 inches)** or the round openings (K).

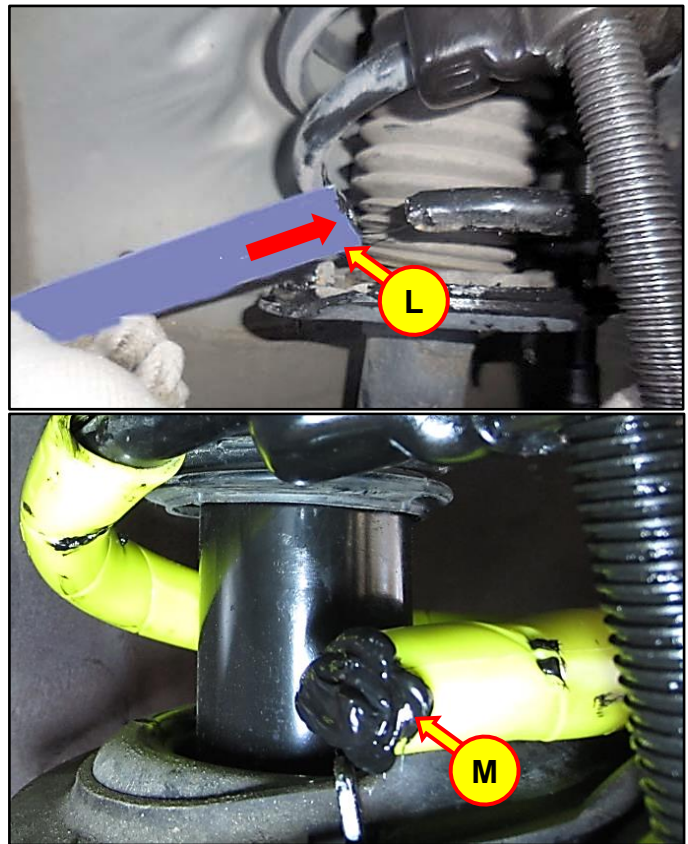
12. Start from the end marked with the arrow (L), slide the urethane tube over the end of the coil spring until tube (M) end aligns with the spring end.

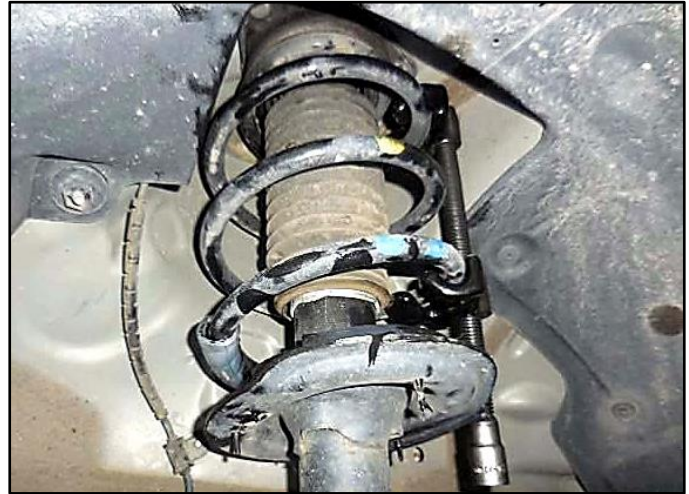
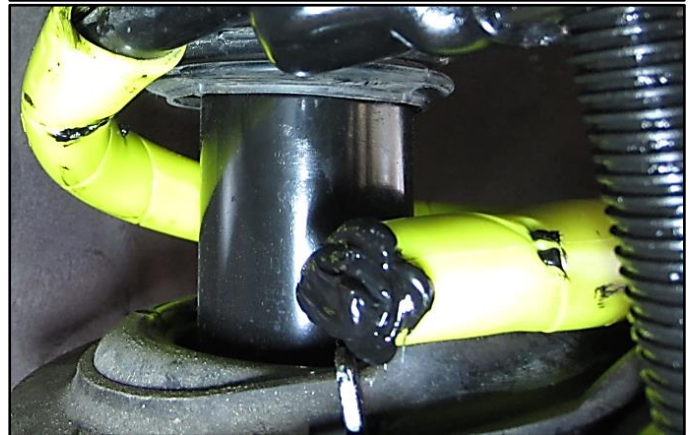
13. Spring Decompression:
- Carefully decompress the springs, ensuring the spring is properly engaged with the upper and lower spring seats on the strut.
 - The end of the spring should align with the lower spring seat guide (M).
 - Ensure the urethane tube stays in position during decompression.

Confirm the coil spring is properly engaged with the strut at the upper and lower spring seats. If misaligned, recompress and realign the spring.

Confirm the tube is **NOT** misaligned. If misaligned, then recompress and realign.
