# Recall Bulletin

**SUBJECT:** Seat Position Sensor Incorrectly Serviced

**MODELS:** 2014 Chevrolet Caprice PPV  
2014 Chevrolet SS

GM Recall #15567

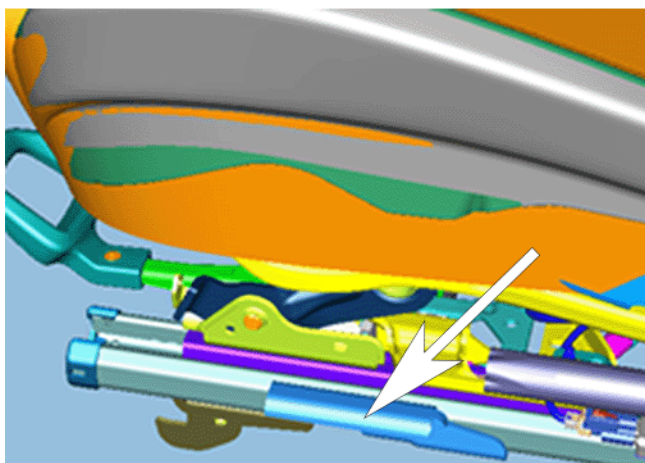
4295764

2. Inspect the inboard seat running rail to check if a seat position sensor bracket is fitted as shown above. If the seat position sensor bracket **is not fitted**, proceed to step #3. If the seat position sensor bracket **is fitted**, no further action is required.

3. Replace the seat cushion frame. Refer to *Driver or Passenger Seat Cushion Frame Replacement in SI*.
