This Service Information bulletin supersedes SI 32 02 15 **dated March 2016**.

SUBJECT**Recall 15V-660: Electro-Hydraulic Power Assist Steering (EHPAS) System****MODEL**

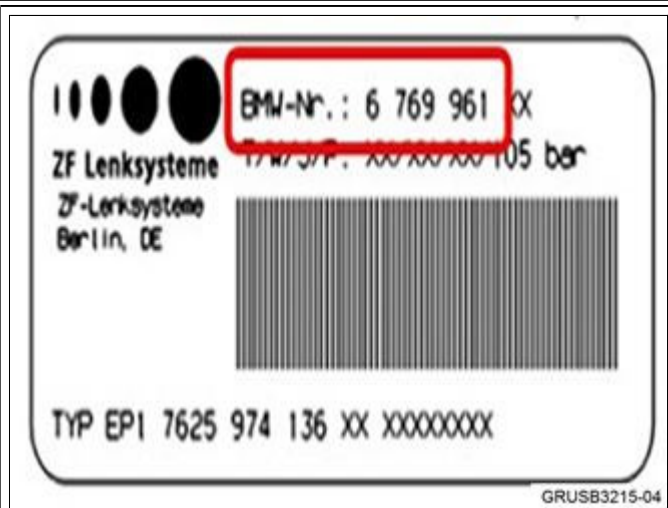
- Variant 1 with BMW part number located at the top

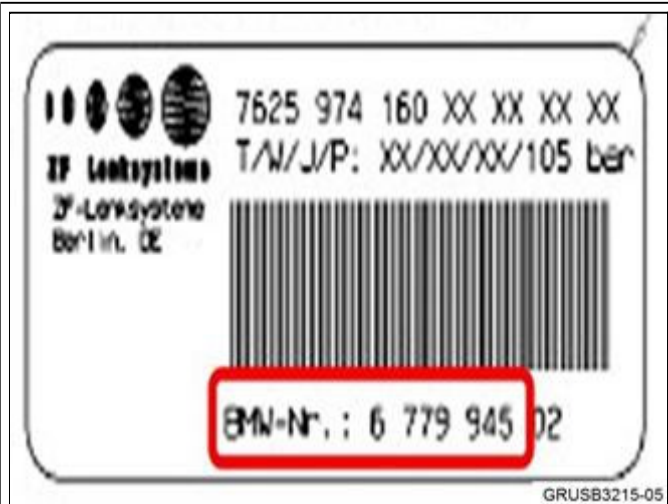
- Variant 2 with BMW part number located at the bottom

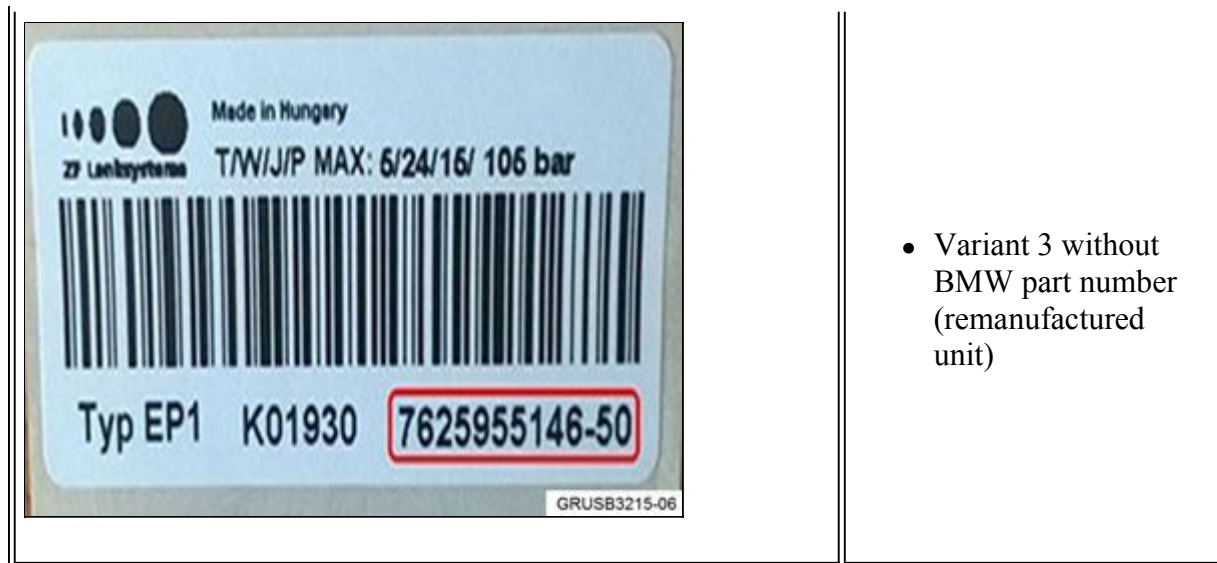
- Variant 3 without BMW part number (remanufactured unit)

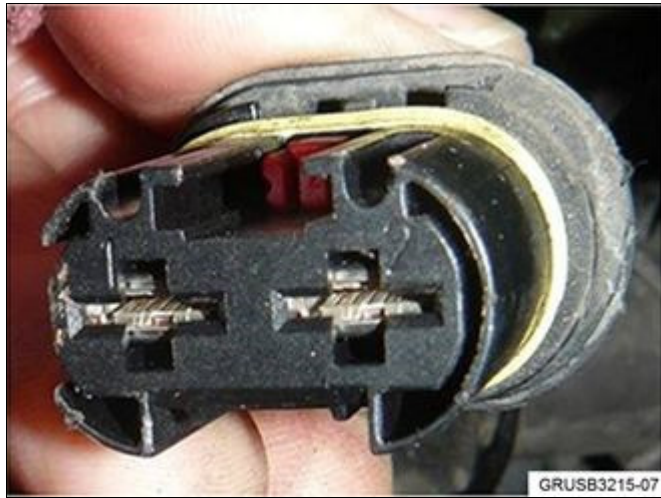
Connector without corrosion

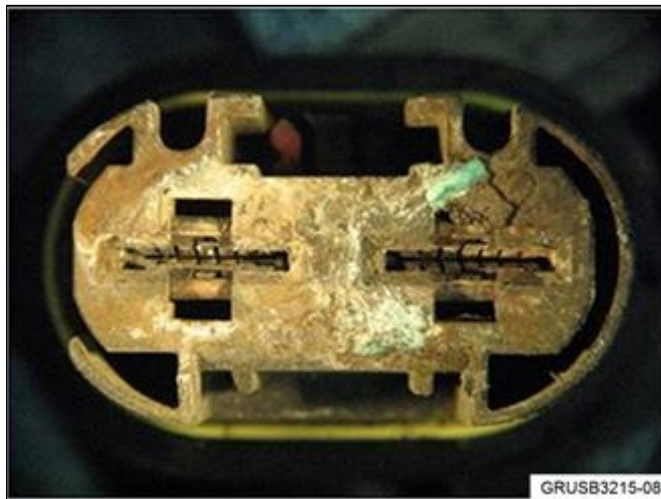
Connector with corrosion

YES - replace the additional wiring harness. Install the additional wiring harness in the same way as the existing wiring harness and connect to the power steering pump and fan.

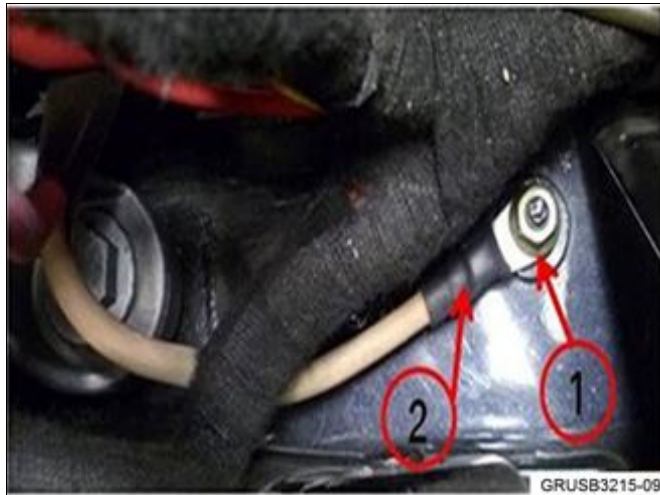
Ground connection (1) on the front

engine support with heat shrink tubing (2).

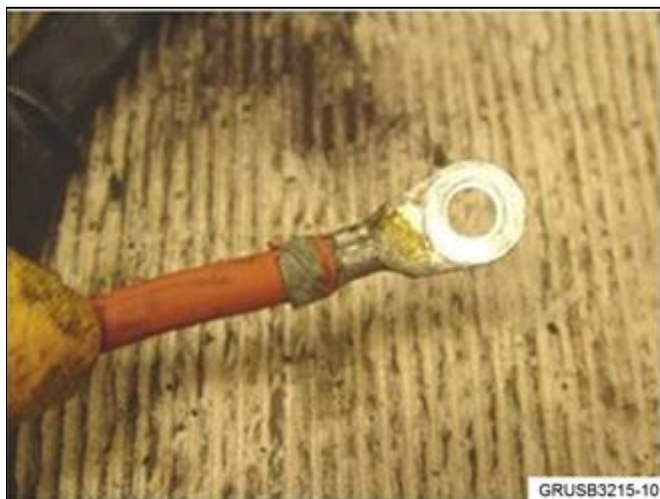
Ground connection without protective heat shrink tubing around cable eye crimp.

NO - Refer to REP 61 00 ...”Information on handling wiring harness and lines.
