This Service Information bulletin supersedes SI 32 02 15 **dated October 2015**.

SUBJECT**NEW** Recall 15V-660: Electro-Hydraulic Power Assist Steering (EHPAS) System**MODEL**

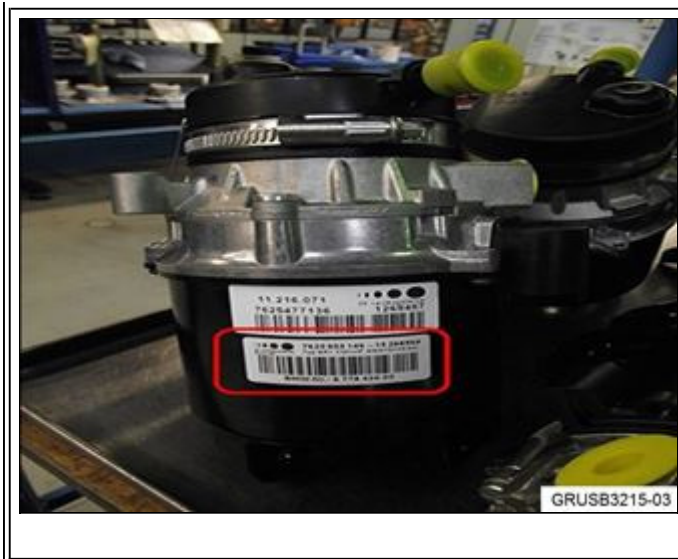
- Identify the part number on the label attached to the power steering pump

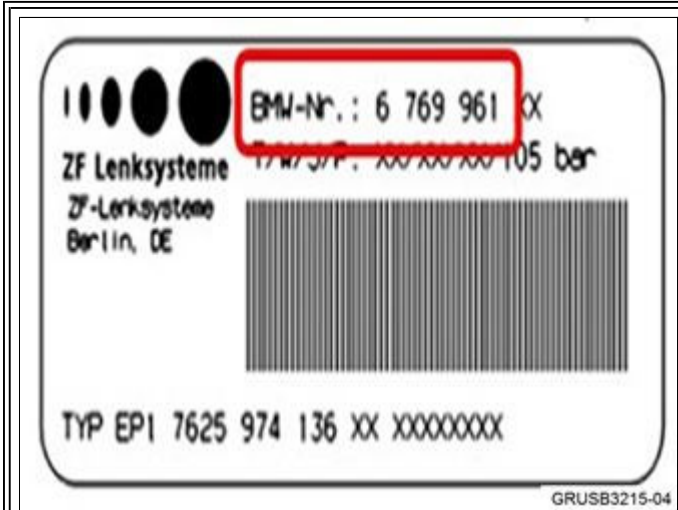
- Variant 1 with BMW part number located at the top

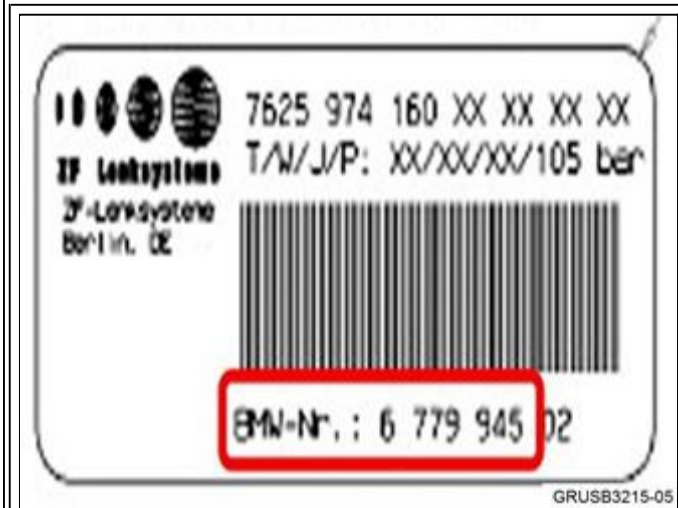
- Variant 2 with BMW part number located at the bottom

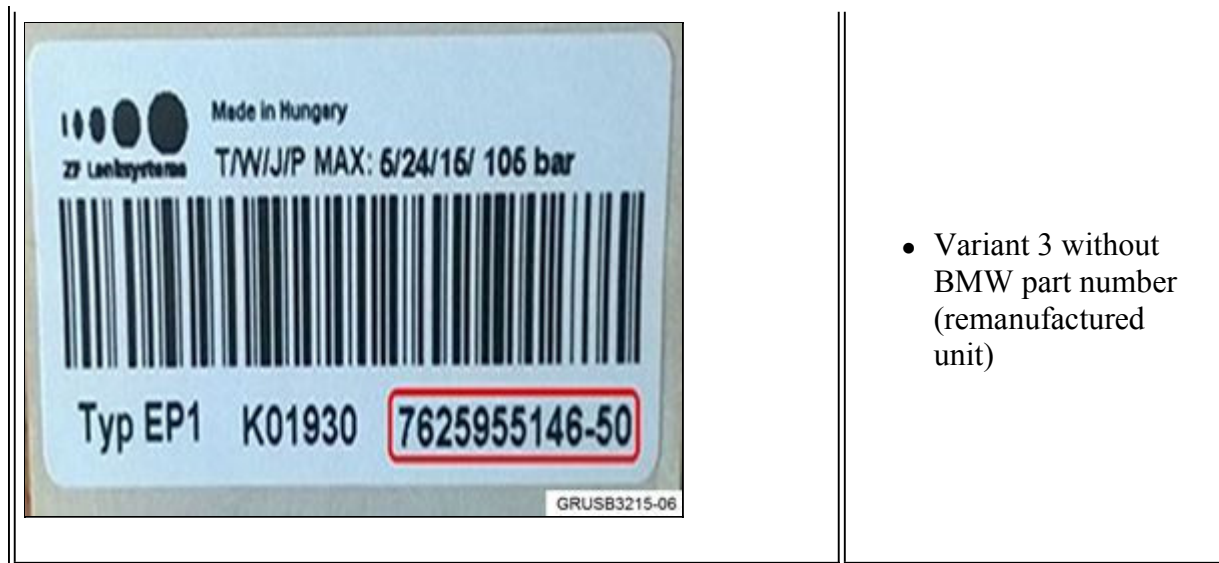
- Variant 3 without BMW part number (remanned unit)

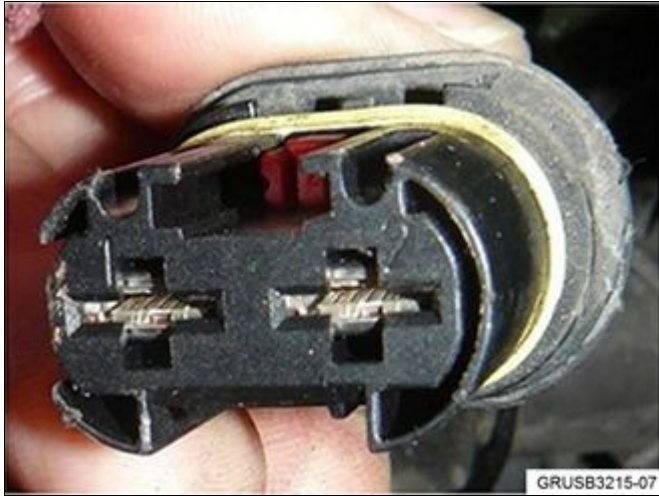
Connector without corrosion

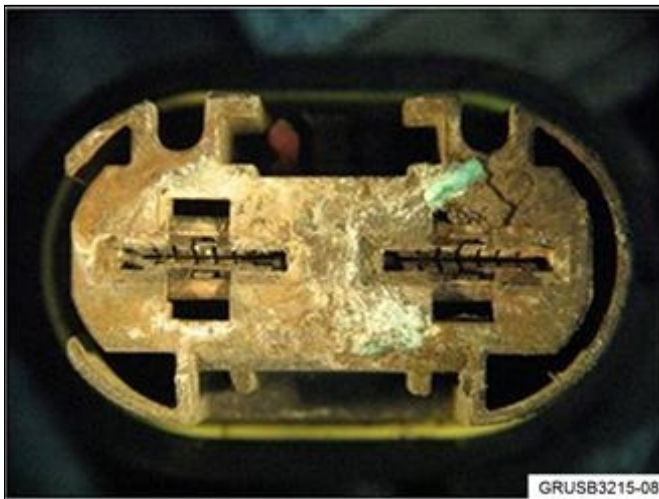
Connector with corrosion

YES - replace the additional wiring harness. Install the additional wiring harness in the same way as the existing wiring harness and connect to the power steering pump and fan.

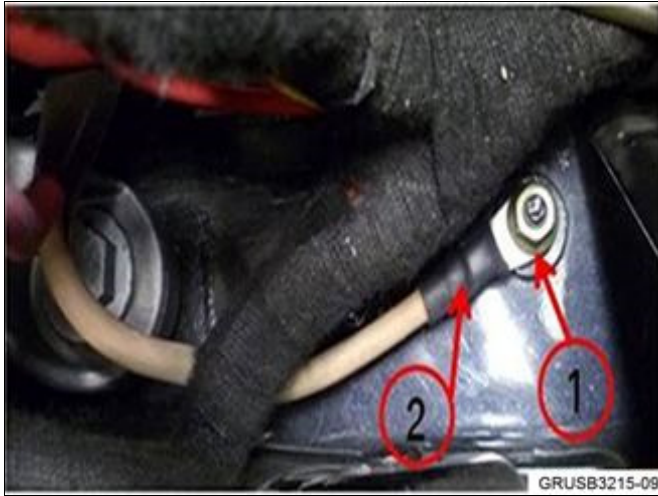
Ground connection (1) on the front

engine support with heat shrink tubing (2).

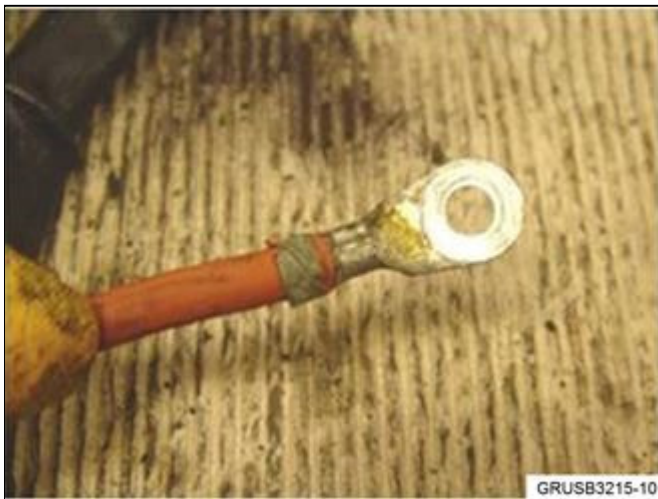
Ground connection without protective heat shrink tubing around cable eye crimp.

NO - Refer to REP 61 00 ...”Information on handling wiring harness and lines.
