Utilimaster Corporation

RECALL SERVICE BULLETIN

DOCUMENT P/N 03102245-X002EN Rev. A

SUBJECT: Utilimaster Corporation has determined a defect relating to rear brake lines on vehicles with Utilimaster bodies that may exist in certain vehicles.

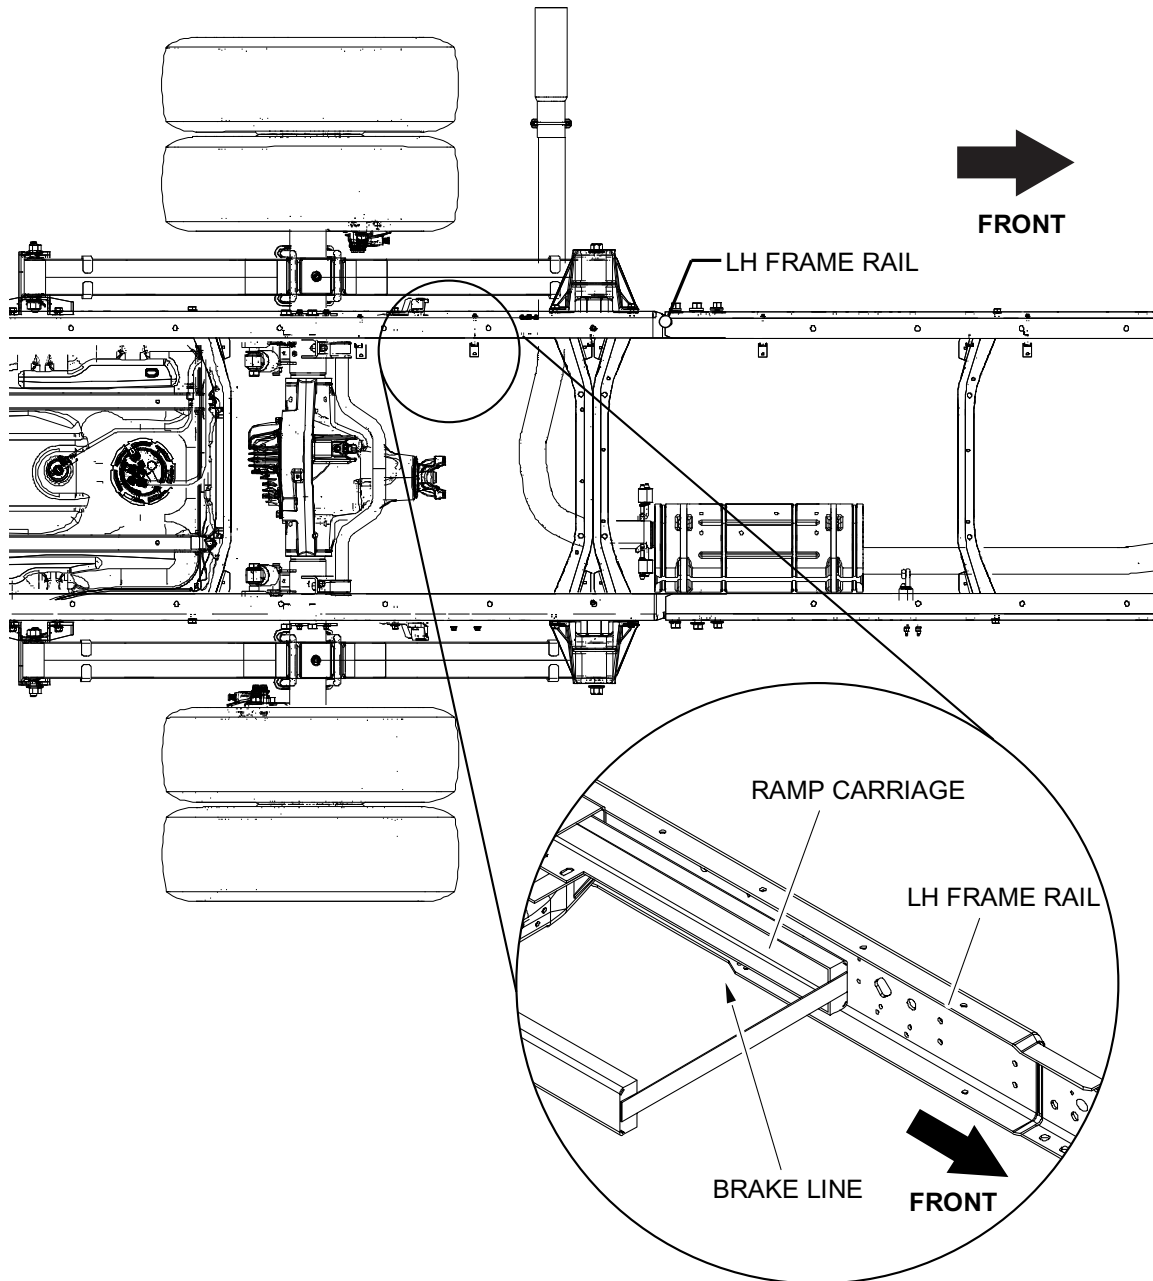
CONDITION: Left hand rear brake line may have inadequate clearance from ramp carriage.

Overview of brake line location at frame rail

CORRECTION: Adjust and secure brake line or replace if necessary.

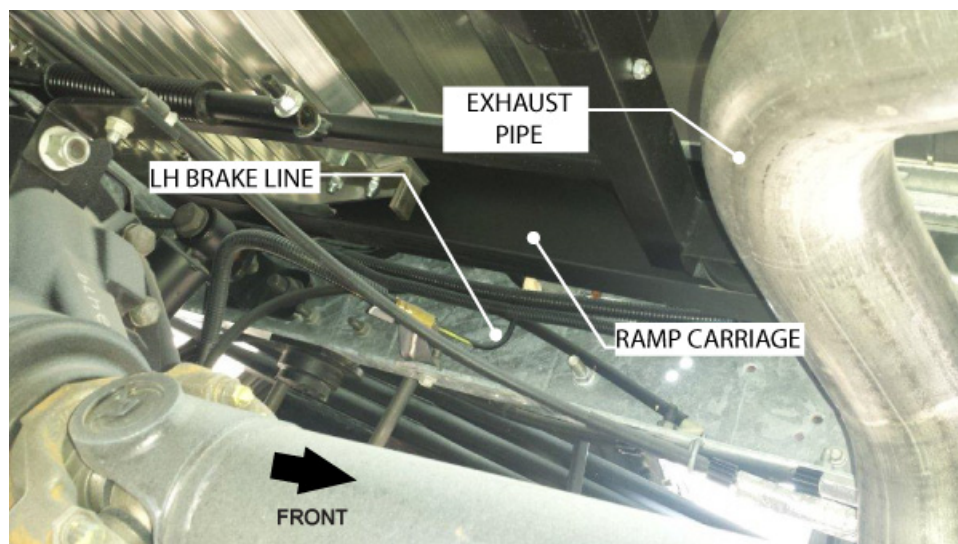
LH frame rail

1. Read and understand all the instructions before starting the repair.
2. Inspect the LH rear brake line clearance at the ramp carriage. If there is 1/2" clearance, no further action is needed.

3. If less than 1/2" clearance, proceed with repair.
4. If brake line shows sign of abrasion or leaks fluid, replace brake line using Ford P/N 6U9Z2265A. See chassis manufacturer's procedures for service.

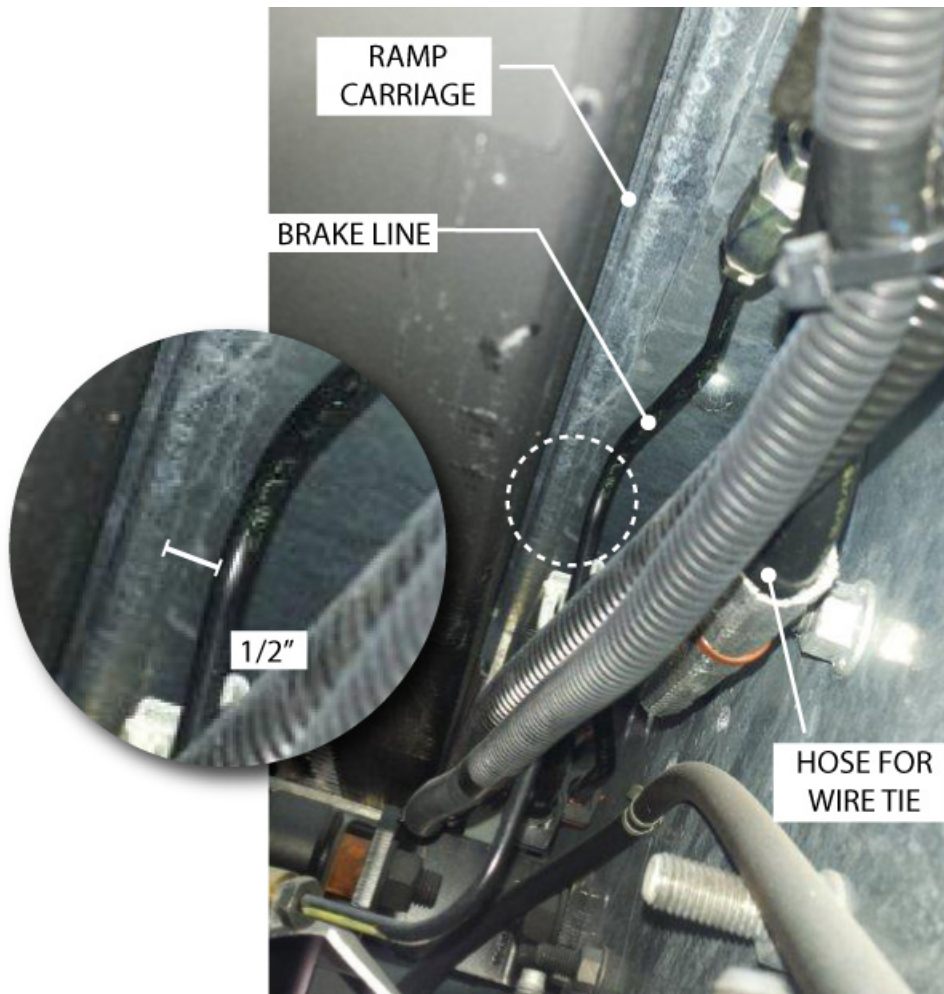
Brake line clearance

1. Reposition brake line until there is 1/2" clearance from ramp carriage. Use wire ties to secure brake line to hose at the frame rail hose.

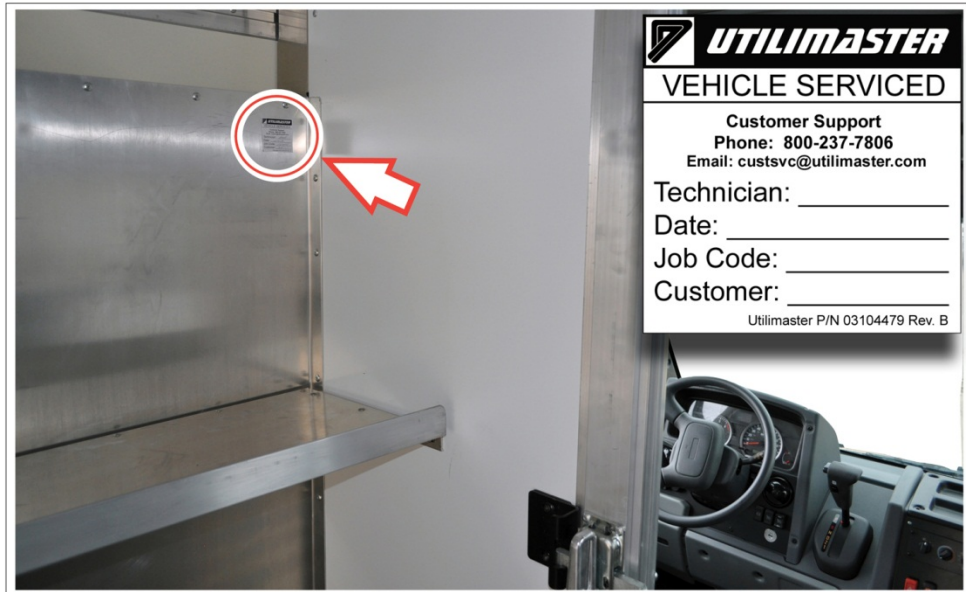
Service decal on driver's door pocket (cargo side)

3. Adhere the decal to the upper right-hand corner of the driver's door pocket panel next to the bulkhead wall. Do NOT cover any previously applied decals.
