Technical Service Bulletin

15-01-041

LFa SONATA

SUBJECT: LFA SONATA INSTRUMENT CLUSTER ABS WARNING LAMP ILLUMINATION LOGIC UPDATE (RECALL CAMPAIGN 134)

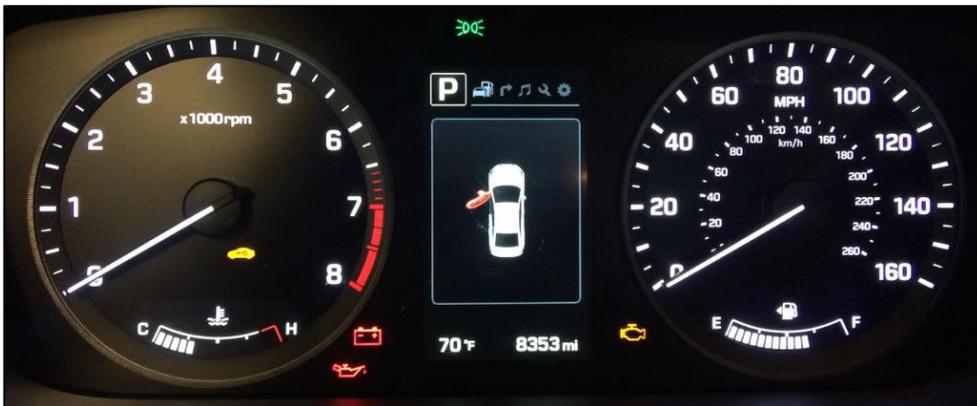
Base Supervision
Instrument Cluster

Description: This bulletin describes the procedure to update the instrument cluster software on certain Sonata (LFa) vehicles. Affected vehicles (those equipped with supervision gauge cluster, both Base and Sport) currently do not illuminate the ABS warning lamp. The software revises the logic to illuminate the ABS warning lamp at vehicle ignition on, or if any ABS system malfunction is detected.
