Reference:

ITB15-031

## VOLUNTARY SAFETY RECALL CAMPAIGN OCCUPANT CLASSIFICATION SYSTEM REPROGRAMMING

CAMPAIGN ID #: PC407  
APPLIED VEHICLES: 2013 JX35 (L50)  
2014 – 2015 QX60 (L50)  
2014 – 2015 QX60 Hybrid (L50)

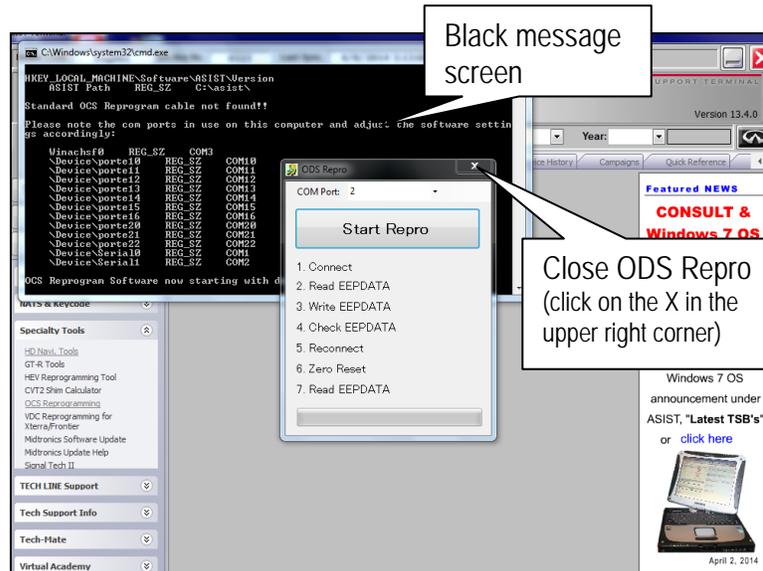
Figure 2

NOTE: If you get a black message screen as shown in Figure 2, this indicates that the reprogramming cable is not connected, or the cable driver did not install correctly.

- a. Close ODS Repro.
- b. Close ASIST.
- c. Start over from step 1.
