# RECALL CAMPAIGN BULLETIN

NTB15-091

## VOLUNTARY SAFETY RECALL CAMPAIGN OCCUPANT CLASSIFICATION SYSTEM REPROGRAMMING

**APPLIED VEHICLES:** 2013 – 2014 Altima Sedan (L33)  
2013 – 2015 Pathfinder (R52)  
2013 – 2015 Sentra (B17)

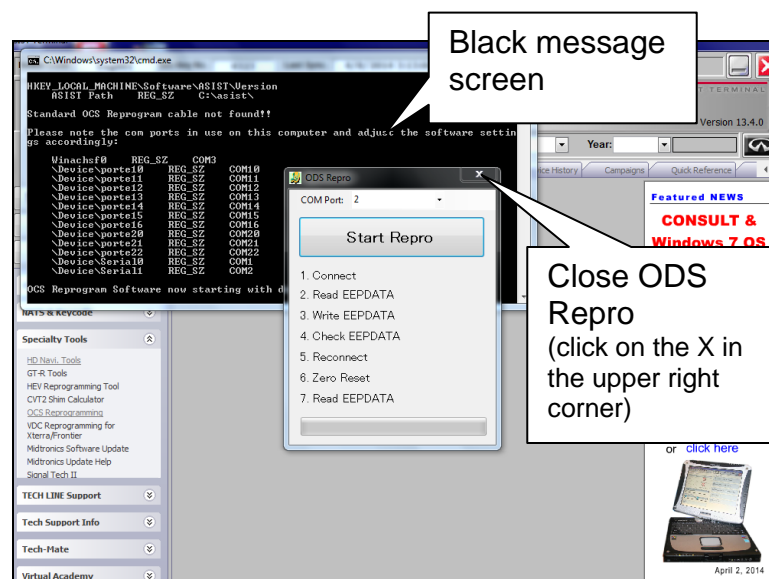
Figure 2

**NOTE:** If you get a black message screen as shown in Figure 2, this indicates that the reprogramming cable is not connected, or the cable driver did not install correctly.

- Close ODS Repro.
- Close ASIST.
- Start over from step 1.

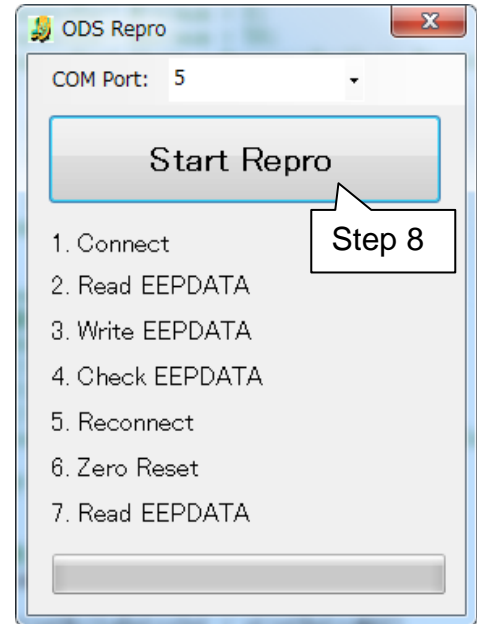
Figure 3

**NOTE:** If the error message “an error occurred on connection” displays:

- a. Disconnect the J-51594 OCS reprogramming cable, both ends.
- b. Reconnect the cable; make sure it is securely connected at both ends.
