Field campaign

Topic	Fastener replacement - Battery cable front bulkhead studbox (RE15/15)
Market area	Bentley: worldwide (2WBE)
Brand	Bentley
Transaction No.	2036868/1
Campaign number	RA36
Note	
Type	Recall Campaign
US code

Continental series and Flying Spur

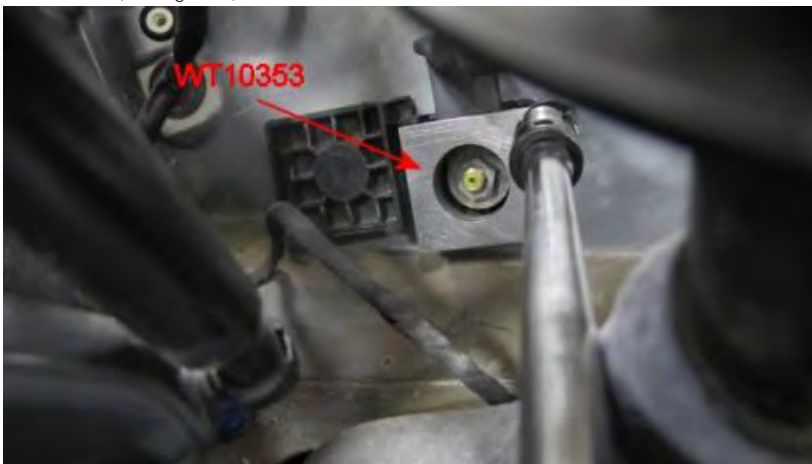
Figure 1

1. Position the right hand front seat fully back and place the windscreen wipers in service position
2. **Disconnect both batteries.** Refer to Batteries– To disconnect and connect Rep.Gr.27
3. Raise the bonnet and remove the plenum cover. Refer to Plenum cover– To remove and fit Rep.Gr.87
4. Remove the cover (1) to access the battery cable securing nut engine side (see Figure 12)
5. **Applicable to LHD cars.** Remove the glovebox assembly. Refer to Glovebox assembly– To remove and fit Rep.Gr.68
6. **Applicable to RHD cars.** Remove the drivers knee roll trim panel and knee roll carrier. Refer to Knee roll assembly–To remove and fit. Rep. Gr.70
7. **Continuation for all cars.** Position counter hold tool WT10353 onto the bulkhead studbox housing engine side using a 3/8 drive extension (see Figure 1)

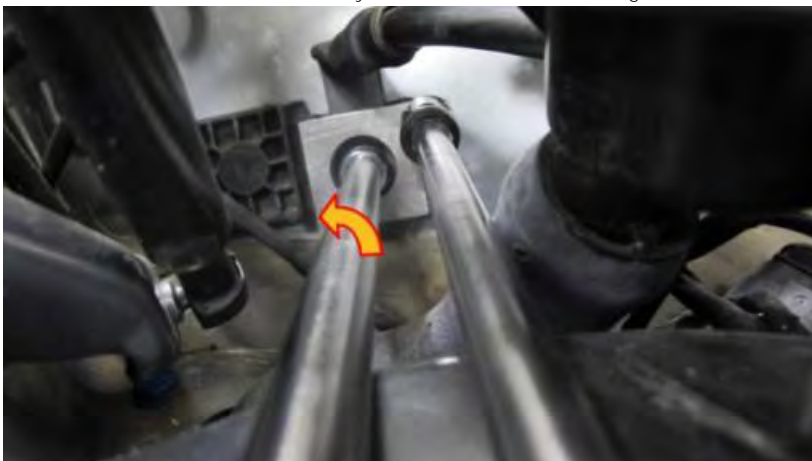
Figure 2

8. Release, remove and discard the 8mm standard nut securing the battery cable connection. Counter the reactive torque using tool WT10353 to avoid unnecessary movement of the housing relative to the bulkhead (see Figure 2)

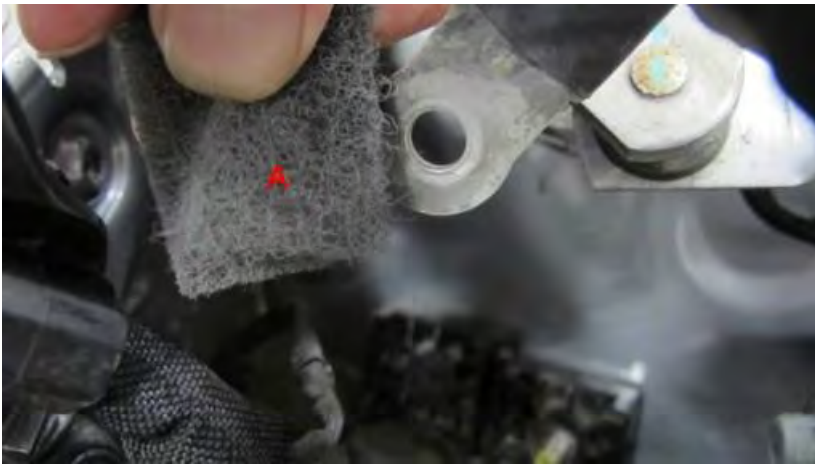
Figure 3

9. Check and if necessary remove any oxidation from the battery cable terminal, a fine paint refinishing scuff pad (A) should be used (see Figure 3)

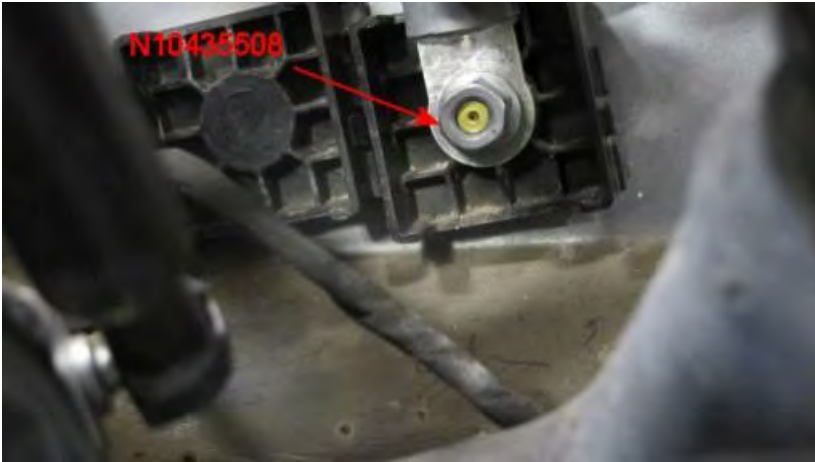
Figure 4

10. Position battery cable terminal and partially fit new prevailing torque M8 flange nut (part number N10435508) onto bulkhead studbox (see Figure 4). Ensure that the power cable terminal is positioned correctly on the studbox and is not partially seated on the housing.

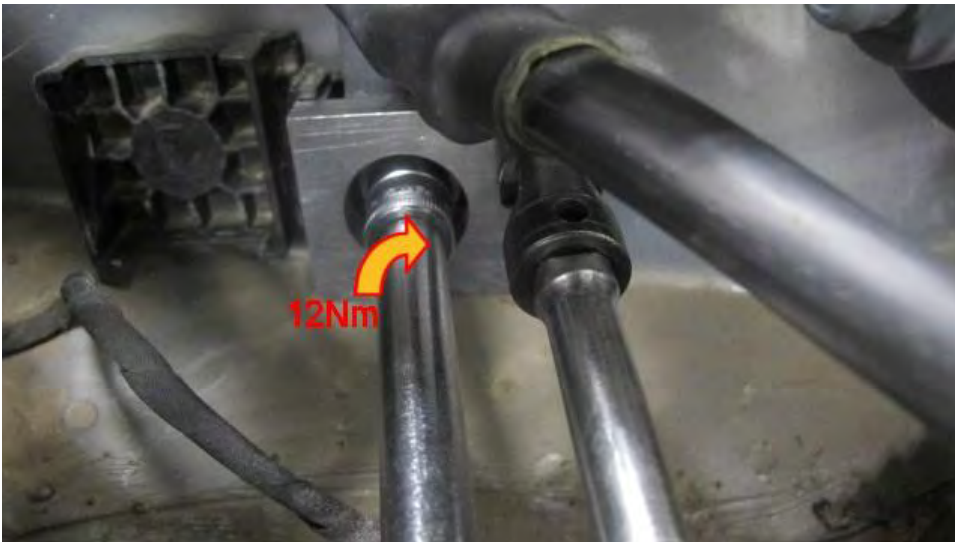
Figure 5

11. Position counter hold tool WT10353 onto the bulkhead studbox housing using a 3/8 drive extension (see Figure 1)
12. Using an 'indate' certified calibrated torque wrench apply 12Nm torque to prevailing torque M8 flange nut engine side. Use the counter hold tool to reduce the tendency of the connector housing to rotate during tightening (see Figure 5)

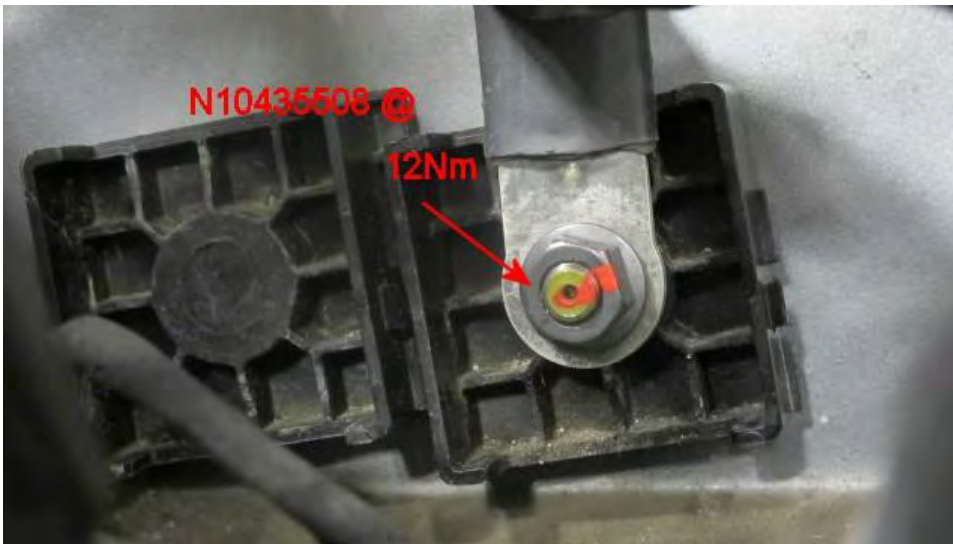
Figure 6

13. Apply a red paint mark to identify the correct prevailing torque nut and 12Nm torque has been applied (see Figure 6)

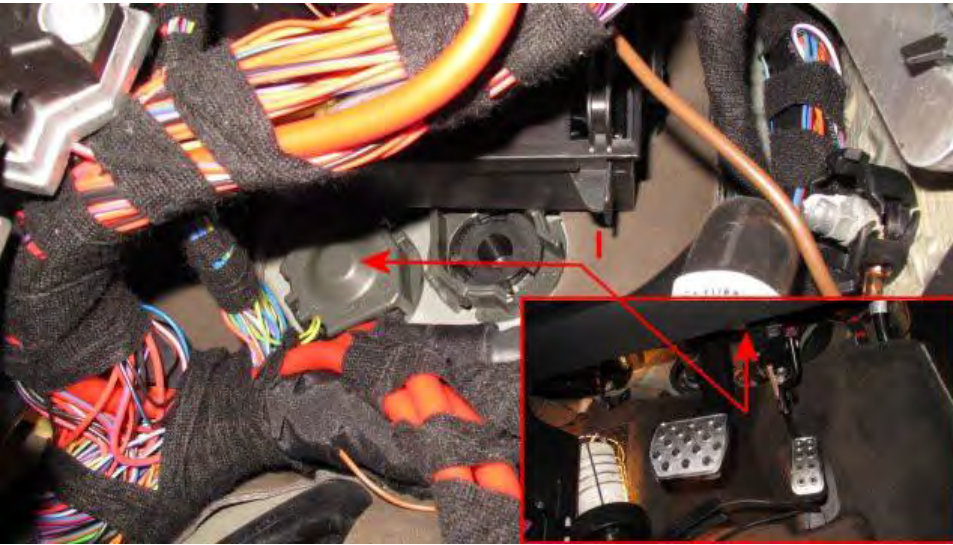
Figure 7

14. Remove the cover (1) to access the battery cable securing nut cabin side (see Figure 7)

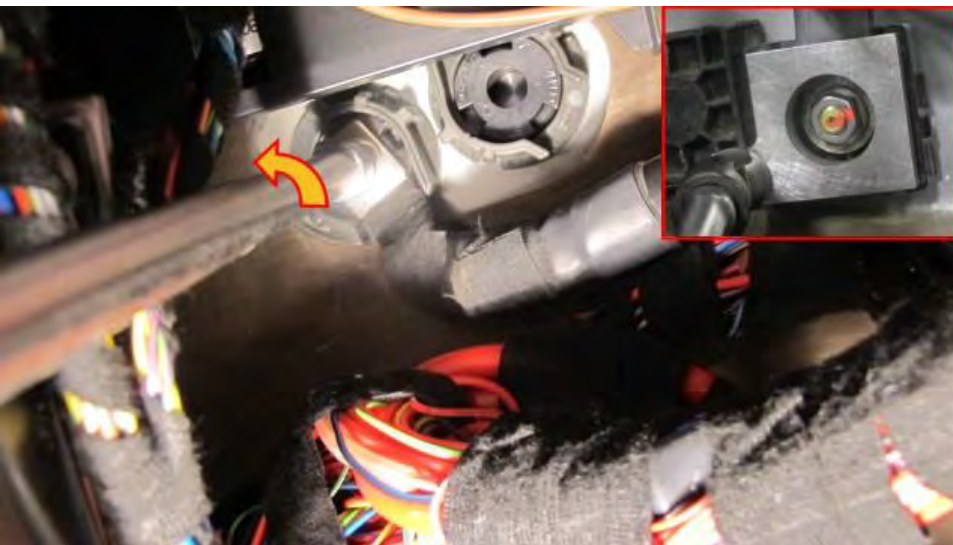
15. An assistant is required to operate the counter hold tool on the engine side throughout the cabin side nut replacement procedure (see Figure 8 inset). Release, remove and discard the 8mm standard nut securing the battery cable connection cabin side. Counter the reactive torque using tool WT10353 on the engine side to avoid unnecessary movement of the housing relative to the bulkhead.

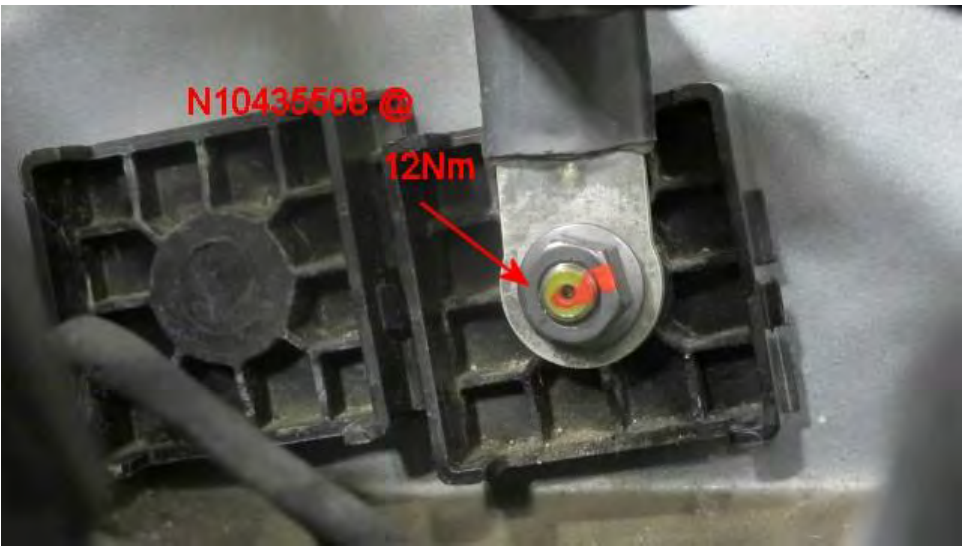
Figure 9

16. Partially fit new prevailing torque M8 flange nut (part number N10435508) onto bulkhead studbox cabin side. Ensure that the power cable terminal is positioned correctly on the studbox and is not partially seated on the locking ring.
17. Again using an 'Indate' certified calibrated torque wrench apply 12Nm torque to prevailing torque M8 flange nut, cabin side. Use the counter hold tool on the engine side to reduce the tendency of the connector housing to rotate during tightening (see Figure 9, right hand drive car)

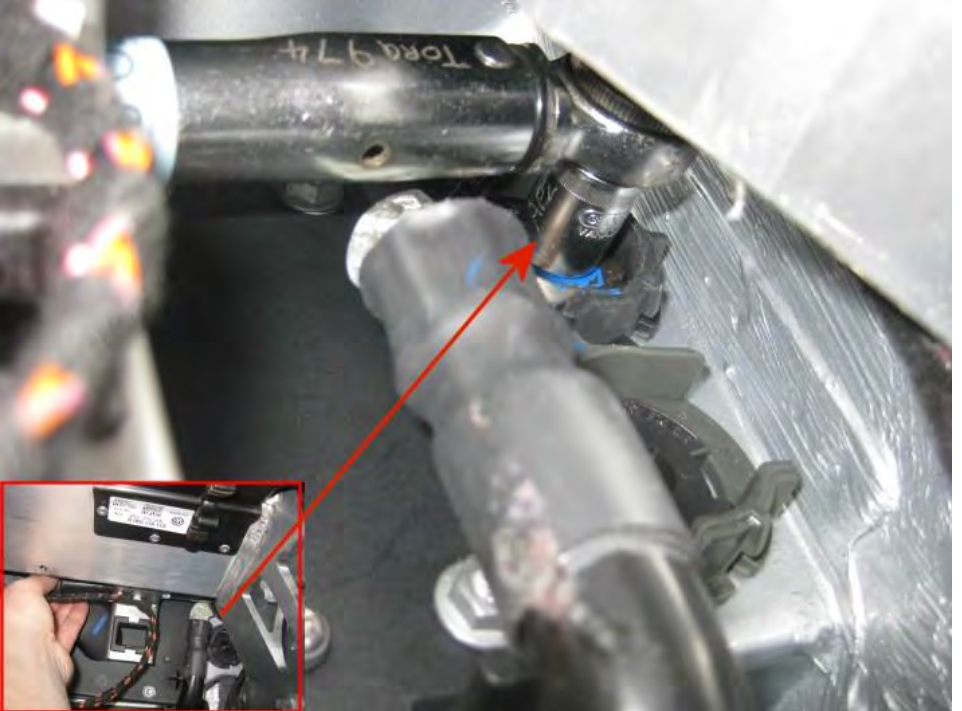
18. Figure 9a shows the torque being applied to the cabin side nut on a left hand drive vehicle

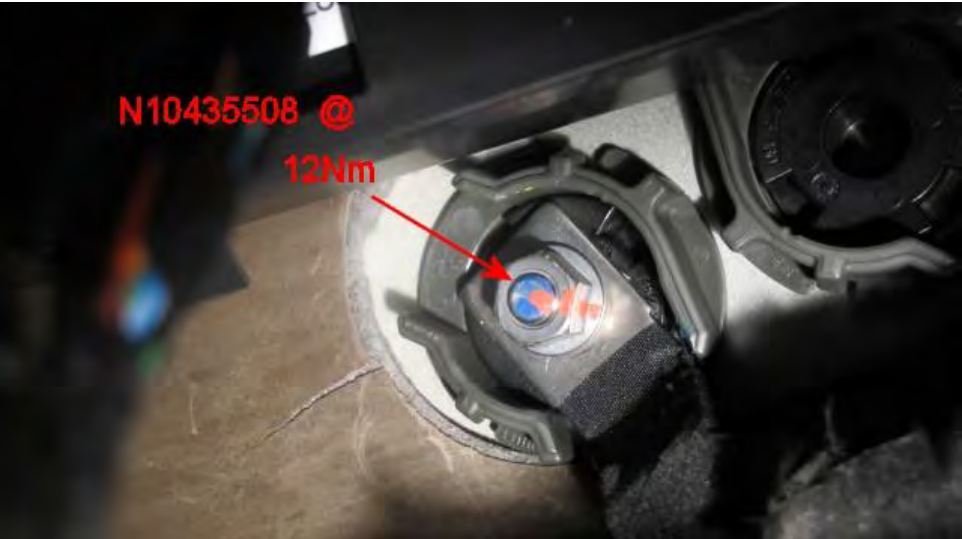
Figure 10

19. Apply a red paint mark to identify the correct prevailing torque nut and 12Nm torque has been applied (see Figure 10)

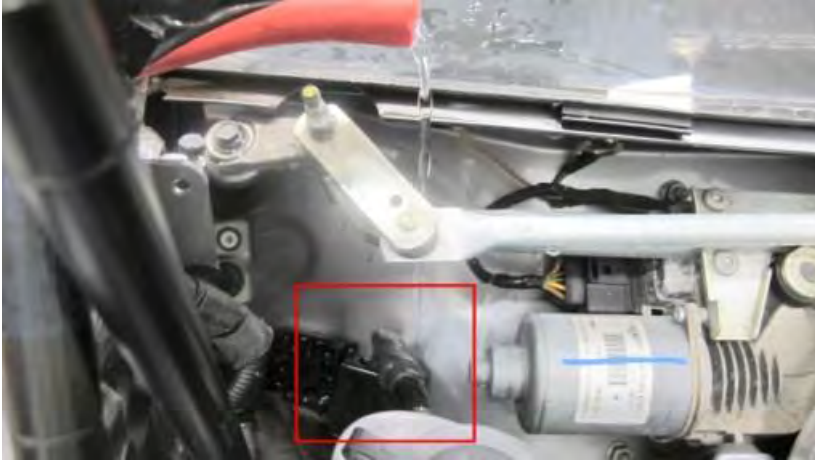
Figure 11

21. Perform a water test to the plenum area. Apply water adjacent to the front windscreen above the bulkhead studbox whilst an assistant checks

for water ingress around the bulkhead studbox inside the cabin (see Figure 11). If the bulkhead studbox housing fails the water test a replacement studbox and seal assembly should be considered. Please note that **any consideration for warranty reimbursement in respect to bulkhead studbox housing replacement during this procedure must be discussed with Bentley Product Support**. In each instance a DISSBAID entry will be required to support your request and photographs should be attached to support the decision.

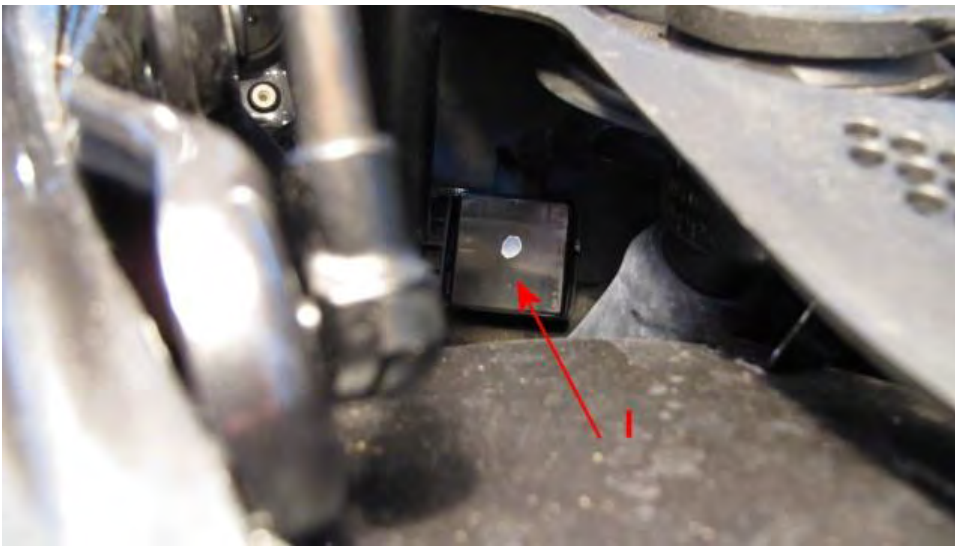
Figure 12

If the vehicle is not already listed as repaired in the "Repair History" (in ElsaPro), check for the presence of a white paint spot on the engine side bulkhead studbox cover (see Figure 12)

On completion apply a white campaign completion mark to the stud cover engine side (see Figure 12)
