Recall Bulletin

PRODUCT SAFETY RECALL

SUBJECT: Power Window Master Switch Failure

MODELS: 2009-2010 Pontiac Vibe

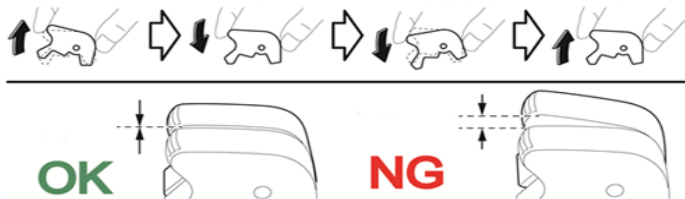
3021149

2. Check all switches (1) that do not have AUTO function (2) for the catching condition.

- All switches that ARE NOT AUTO MUST be inspected.
- The switches MUST be operated slowly otherwise the catching cannot be noticed.
- The switches MUST be operated with two fingers otherwise the catching cannot be noticed.
- The switches may feel unsmooth this DOES NOT mean the switch is no good.

4. Operate each switch in the down direction, and then slowly return the switch using two fingers.
 - If none of the switches are catching, proceed to the Check Resistance of the Switches procedure in the bulletin.
 - If one or more of the switches are catching, replace the accessory switch circuit board. For removal, refer to steps 1-4 of the Check Resistance of the Switches procedure in this bulletin. For installation, refer to the Switch Reassembly procedure in this bulletin. DO NOT reuse the screws that have been removed, new one-way screws MUST be used.

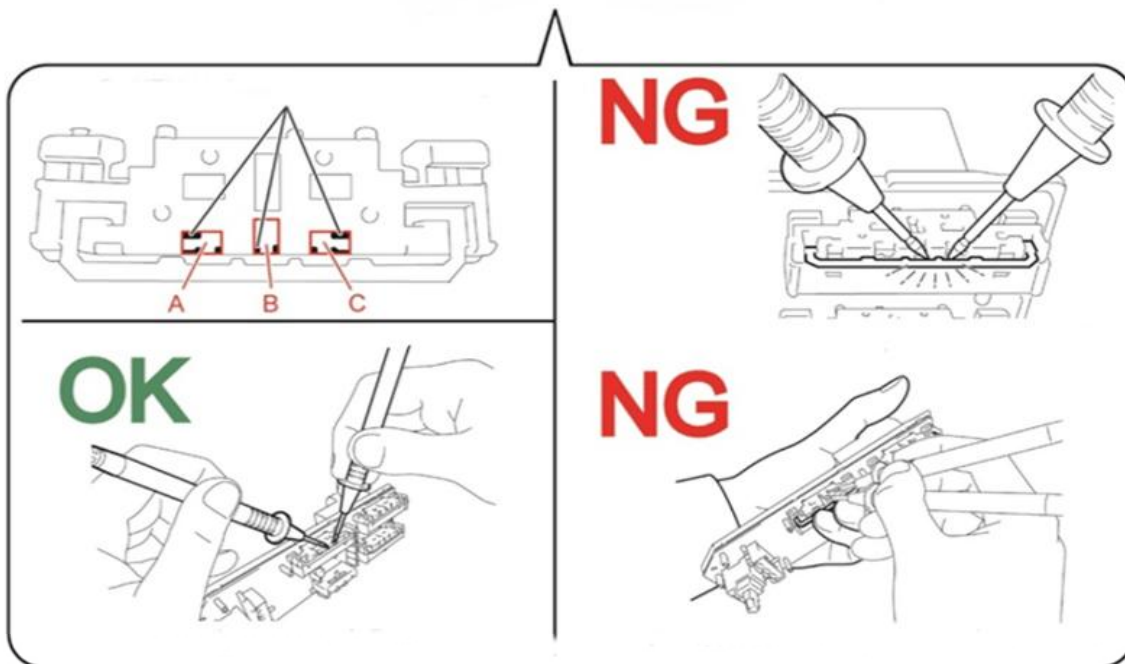
3021162

9. Measure the resistance between points A-B and points B-C.

- If the ZERO calibration function is not performed, the readings may be inaccurate.
- Set the DVOM to the maximum resistance range.
- DO NOT touch any metal other than the points A, B, C on the circuit board when checking resistance.
- The points being checked are small, confirm the probes are contacting the correct points

- If the resistance value for ALL switches is infinite, fill the switches with grease. Refer to the Grease Application procedure in this bulletin.
- If one or more resistance value IS NOT infinite, replace the accessory switch circuit board. Refer to the Switch Reassembly procedure in this bulletin.

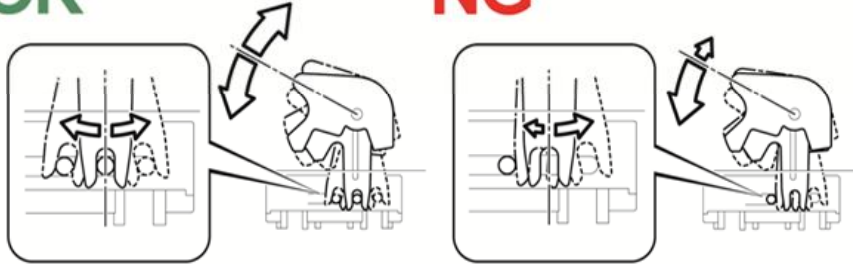
3021212

4. While holding the circuit board in the switch case, check the operation of the switches. The movement up/down and lock/unlock position should be equal in both directions.
 - If movement is equal in ALL switches, the circuit board is positioned correctly. Proceed to step 5.
 - If movement in one or more switch IS NOT equal, one or more switch pin is misaligned. Repeat steps 2-4.
