**November 6, 2015**

02635 Version 2

## Safety Recall: Rear Grab Handle Brackets

This bulletin supersedes S/B 15-079, dated October 23, 2015, to include the Repair Procedure, Parts Information, and Warranty Claim Information

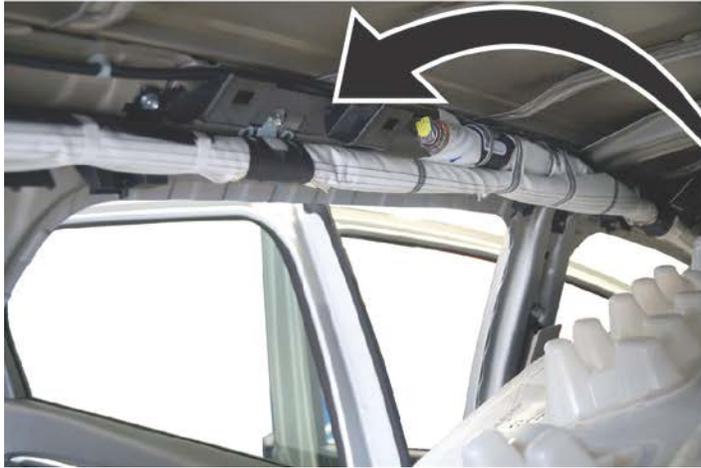
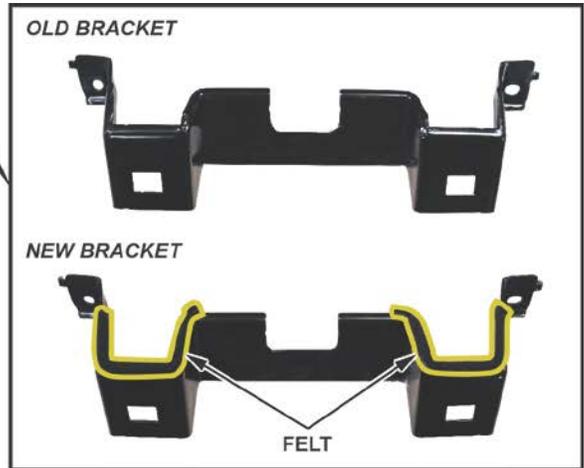
Certain 2015–16 model year Honda Fit vehicles were equipped with a rear grab rail bracket that was not manufactured to design specifications and may interfere with side curtain airbag deployment. In the event of a collision, if the side curtain airbag does not deploy as designed, the vehicle may fail to comply with the requirements of FMVSS 214, FMVSS 226, and the risk of injury is increased.

- Replace the rear grab handle brackets and torque the bolts to **4.4 N·m (3.2 lb-ft)**.

NOTE: Make sure you install the new grab handle brackets in the correct direction.
