Eaton Hydraulics LLC Service Bulletin

Service Bulletin #: W2-14-0033

Product: Hydraulic Gear Pump

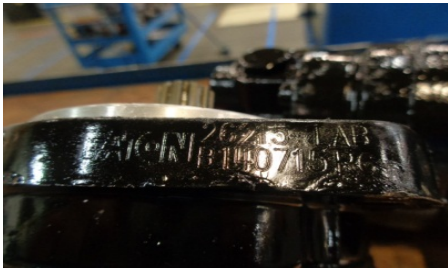
Figure 1: Part Number and Date Code Location

How to Read the Pump Date Code: Date codes are located on the gear pump flange. See Figure 1:

Build Date: B130816RL

B = Gear pump revision

130816 = Year 13, Month 08, Day 16

RL = Test operator

Action: Follow the Procedure in this Bulletin to identify any gear pumps within the affected date code range. Affected product can only be identified by the product number and date code stamped on the gear pump flange.
