SI B52 09 15
Seats

October 2015
Technical Service

NEW Recall 15V-XXX: ISOFIX Bracket

F10 (5 Series Sedan)

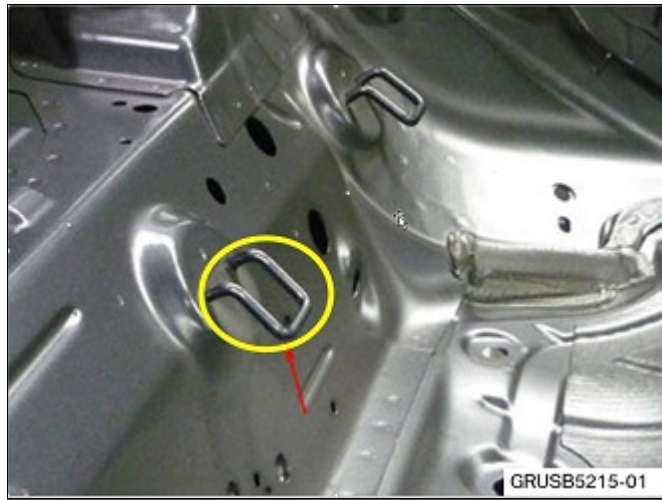
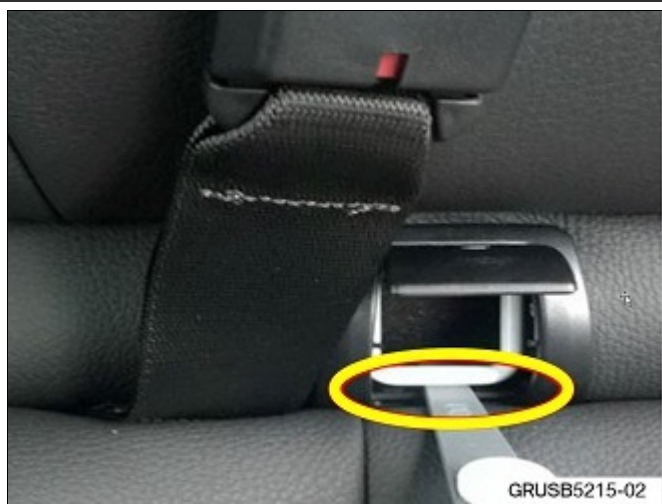
NEW Inboard bracket (anchor) in the left rear seating position may be deformed.

<ol style="list-style-type: none"> 1. Check the gap on the right side bracket of the left side rear seat. <p>The bracket to be checked is shown.</p>
--	---

NEW Inboard bracket (anchor) in the left rear seating position must be adjusted into correct position.

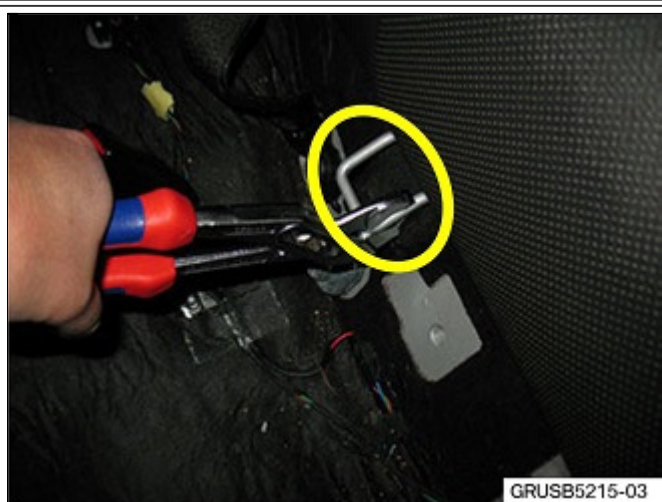
2. Check the gap between the seat bottom and ISO bracket using an appropriate measuring tool.

Note: The seat bottom to bracket gap must be 4 mm to 6 mm.

3. If the gap is not correct, adjust the bracket by bending the uprights.
4. After the rework, recheck the gap measurement.
