RECALL CAMPAIGN BULLETIN

NTB15-105

VOLUNTARY SAFETY RECALL CAMPAIGN 2016 MAXIMA AND 2015 ALTIMA; FRONT CALIPER TORQUE MEMBER BOLTS

CAMPAIGN ID #: PC412

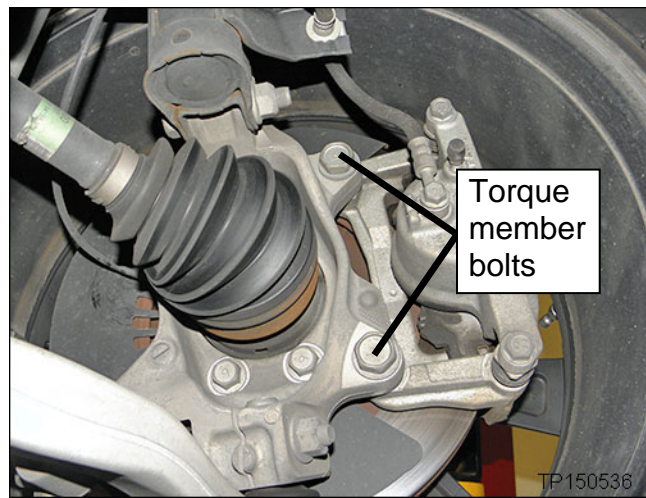
Nissan is conducting a Voluntary Safety Recall Campaign on certain specific Model Year 2016 Maxima and 2015 Altima vehicles to re-torque the front torque member bolts. The total population of vehicles covered by this campaign is approximately 112. This service will be performed at no charge for parts or labor.

1. Lift the vehicle.
2. Locate and re-torque both torque member bolts on each front wheel hub assembly (see Figure 1).
 - Figure 1 shows the Driver side; the passenger side is a mirror image.
 - Turning the wheel to the left (for the left side), or to the right (for the right side), will give better access to the torque member bolts.
 - Torque to 144.5 N·m (15 kg-m, 107 ft-lb).

- Make sure to perform the above torque procedure on BOTH (driver and passenger side) front torque members.
- If a bolt is found missing, replace it with a new bolt and washer.
