SI M65 12 15
Audio, Navigation, Monitors, Alarms, SRS

NEW **Recall 15V-739: Front Passenger Seat Cushion with Capacitive Interior Sensing (CIS) Mat – Prior Parts Replacement**

F56 (Hardtop 2-door)

F55 (Hardtop 4-door)

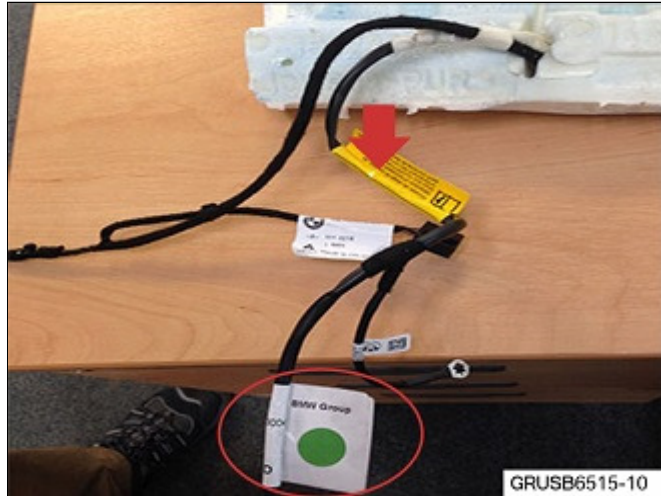
As a result of a prior repair by a MINI dealer to replace the front passenger's seat cushion, some vehicles may have received an "incorrectly" programmed seat mat sensor.

- Inspect the label on the seat-occupancy mat harness for a green dot.
- If the label has a green dot (as shown in the picture), no further action is required.
- If the label does not have a green dot, replace the seat cushion including the front passenger seat's seat-occupancy mat per repair instruction "65 77 610 Replacing seat occupancy mat (CIS) for front passenger seat SBE". Order 1 of the listed parts numbers and the appropriate number of clips listed below in the parts information.
- **Note: After the CIS mat is installed, connect the vehicle to ISTA and enable the new mat by performing the test plan linked to the CIS fault stored. Do not perform programming as recommended by the repair manual.**

Inspect CIS Mat Sensor label for a "green dot" and replace it when it is not present.
