**HYUNDAI**NEW THINKING.  
NEW POSSIBILITIES.**Technical Service Bulletin**

**15-01-056**

**SONATA (YF)****SUBJECT:** SONATA (YF) BRAKE PEDAL STOPPER REPLACEMENT  
(RECALL CAMPAIGN 136)**★ IMPORTANT****\*\*\* Retail Vehicles \*\*\***

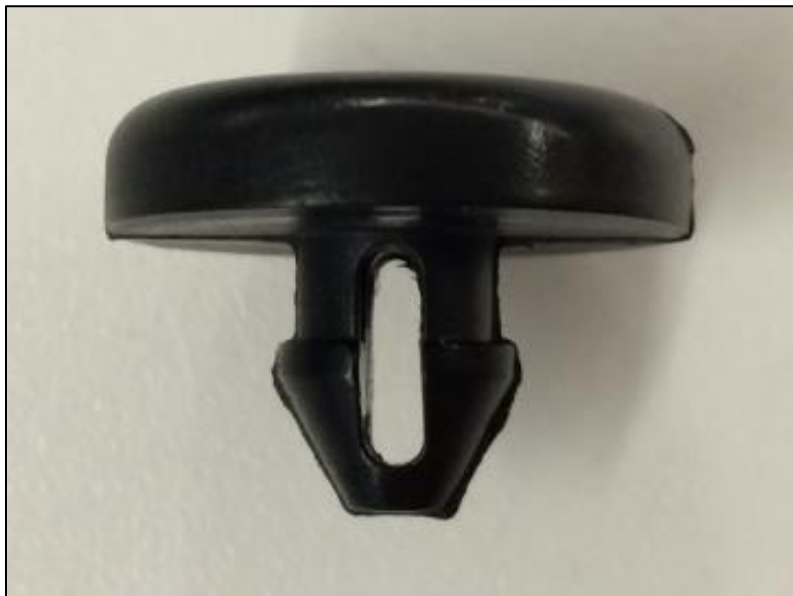
**Description:** The brake pedal stopper pad is located between the stop lamp switch and the brake pedal arm. The brake pedal stopper pad material in the affected vehicles can deteriorate allowing the stop lamp switch plunger to remain extended when the brake pedal is released. A deteriorated pad can result in the stop lamps illuminating continuously, illumination of the traction control warning lamp, the ability to move the shift lever without depressing the brake pedal, or activation of the engine management system's brake pedal override feature.

Any of the described symptoms can increase the risk of a crash.
