**NEW** Recall 15V-782 – Checking Driveshaft Universal Joint

F80 (M3 Sedan)

F82 (M4 Coupe)

F83 (M4 Convertible)

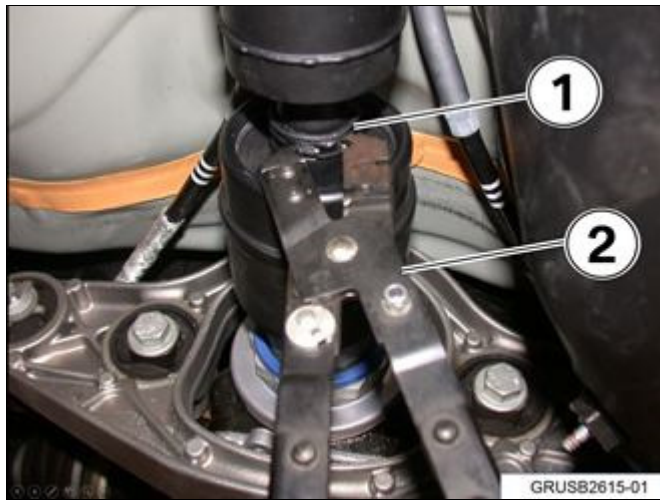
Unlock the clamp on the front of the universal joint (1) with special tool 11 9 160 (2). Reference SI B 04 01 01 for tool information.

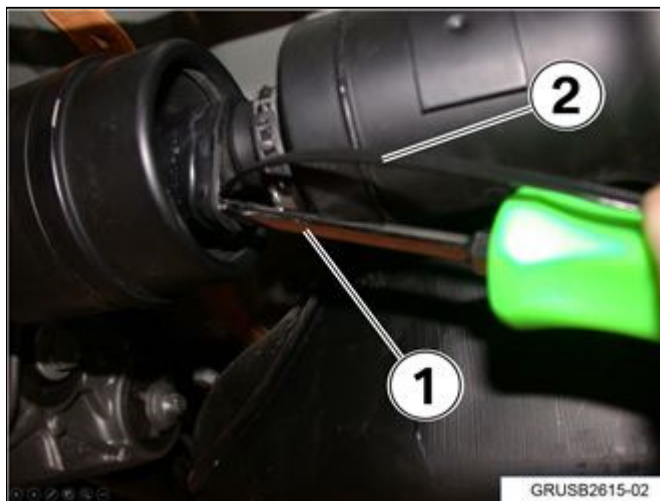
Move the clamp away from the rubber gator and carefully insert a flathead screwdriver to access the inside of the joint. Insert a wire tie into the joint and push it until it bottoms out in the universal joint (approximately 9cm)

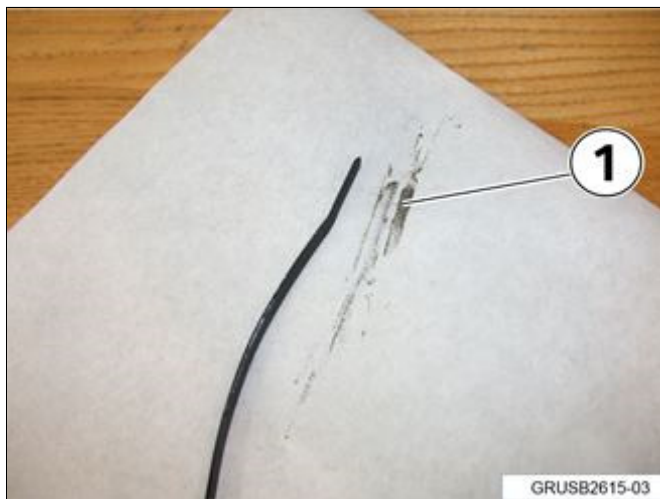
Remove the wire tie from inside the universal joint and check for grease (1).

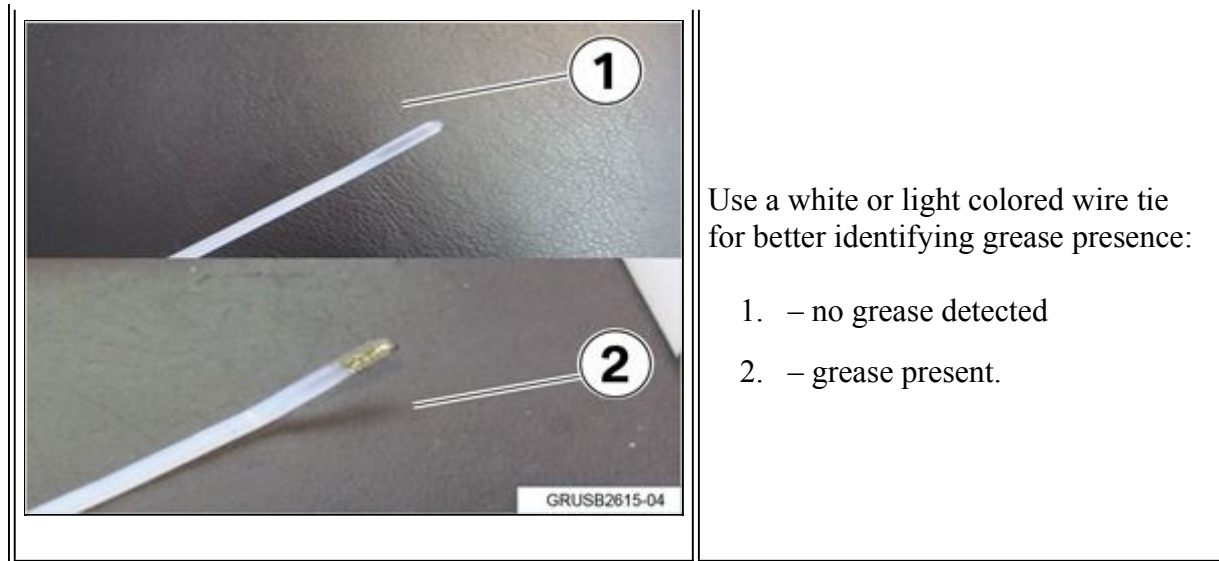
Use a white or light colored wire tie for better identifying grease presence:

1. – no grease detected
2. – grease present.

If grease is present, reinstall the clamp with special tool 11 9 160 and reinstall all removed components

If there is no grease on the wire tie, the drive shaft will need to be replaced.
