PRODUCT CAMPAIGN BULLETIN

APPLICABILITY: 2016MY Legacy and Outback Models
SUBJECT: Propeller Shaft Attaching Bolt Torque

NUMBER: WQV-57
DATE: December 09, 2015
NHTSA ID: 15V-794

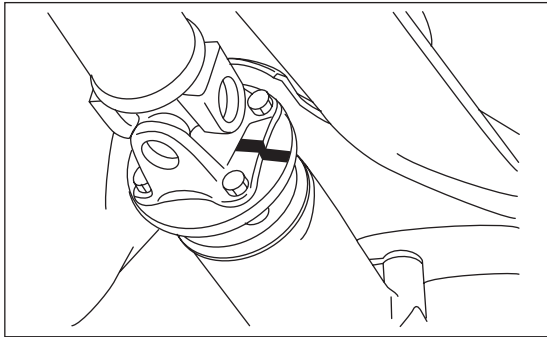
- Due to the location of the nuts, extra care must be used to avoid damage to the dust cover on the differential seal due to contact with tightening tool. If the dust cover is deformed or damaged, differential replacement may be required as this cover is not serviceable. To avoid this condition, SOA recommends the use of an appropriate torque extension tool along with a standard torque wrench. When using a torque extension, be sure to adjust the torque value appropriately to compensate for the length of the extension used. A formula is provided below.

TIGHTENING TORQUE
31 N.m (3.2 kfg-m, 22.9 ft-lb)
