APPLICABILITY: All Affected 2016MY Legacy and Outback Models

NUMBER: WQV-57

SUBJECT: Repair Procedure for Subaru Recall Campaign Stop Sale WQV-57 Propeller Shaft Attaching Bolt Torque

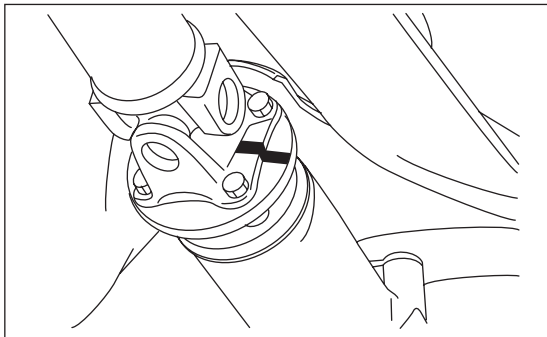
- If any of the nuts are found to be loose or only finger-tight, thread damage may have occurred to the bolt and replacement of that bolt, nut and washer is required.

- If all 4 nuts, bolts and washers require replacement, always confirm the paint marks of the flange and yoke (A) are aligned as shown in the illustration below before reinstalling the new hardware.

- Once it has been confirmed the bolts / nuts are not loose or any bolts / nuts found to be loose have been replaced (including a new washer), torque the 4 flange nuts to the specified value in the Service Manual: 31Nm (22.9 ft. lbs.) to complete the procedure.

TIGHTENING TORQUE 31 N.m (3.2 kfg-m, 22.9 ft-lb)

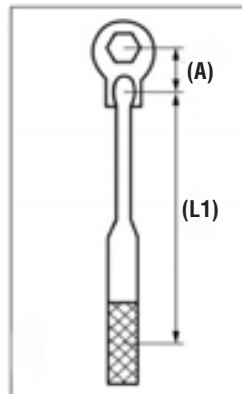
- Due to the location of the nuts, extra care must be used to avoid damage to the dust cover on the differential seal due to contact with tightening tool. If the dust cover is deformed or damaged, differential replacement may be required as this cover is not serviceable. To avoid this condition, SOA recommends the use of an appropriate torque extension tool along with a standard torque wrench. When using a torque extension, be sure to adjust the torque value appropriately to compensate for the length of the extension used. A formula is provided below.

$T = L1 / (A + L1) \times T1$
T = New Torque Specification
L1 = Length of the torque wrench from the center of the handle to the center of the socket mount.
A = Length of the adapter from the middle of the socket mount to the middle of the wrench.
T1 = Original torque specification
Example: $T = 37.5 / (4+37.5) \times 420$
 $T = 37.5 / 41.5 \times 420$
 $T = .90 \times 420$
 $T = 378$
