SAFETY RECALL BULLETIN

SUBJECT:			No: SR-16-001
SRS CONNECTOR CORROSION – SAFETY RECALL CAMPAIGN			DATE: February, 2016
			MODEL: 2014-15 Mirage
CIRCULATE TO:	<input checked="" type="checkbox"/> GENERAL MANAGER	<input checked="" type="checkbox"/> PARTS MANAGER	<input checked="" type="checkbox"/> TECHNICIAN
<input checked="" type="checkbox"/> SERVICE ADVISOR	<input checked="" type="checkbox"/> SERVICE MANAGER	<input checked="" type="checkbox"/> WARRANTY PROCESSOR	<input checked="" type="checkbox"/> SALES MANAGER

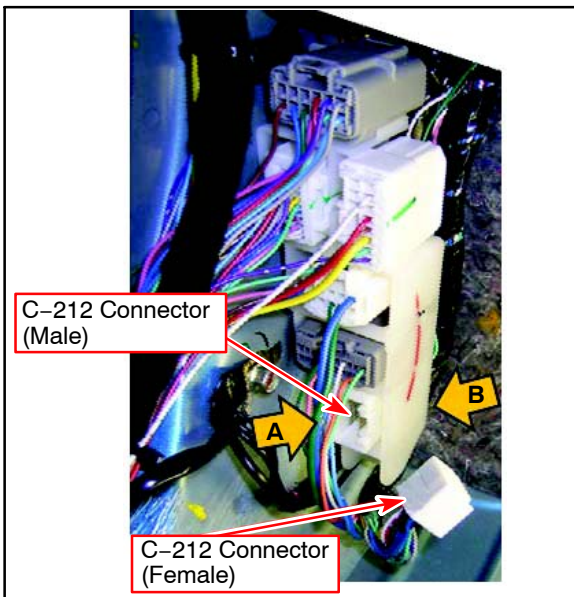
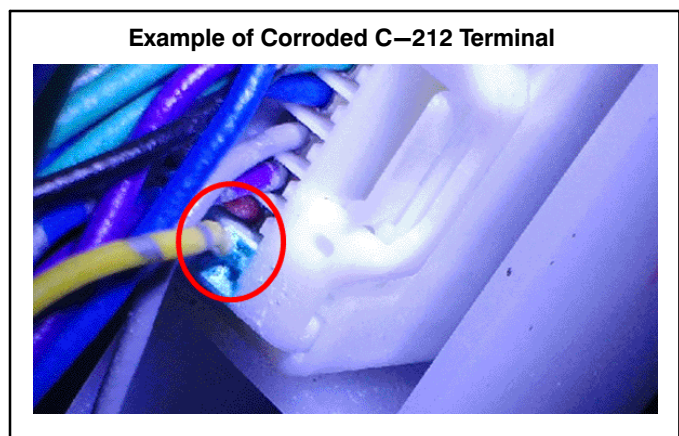
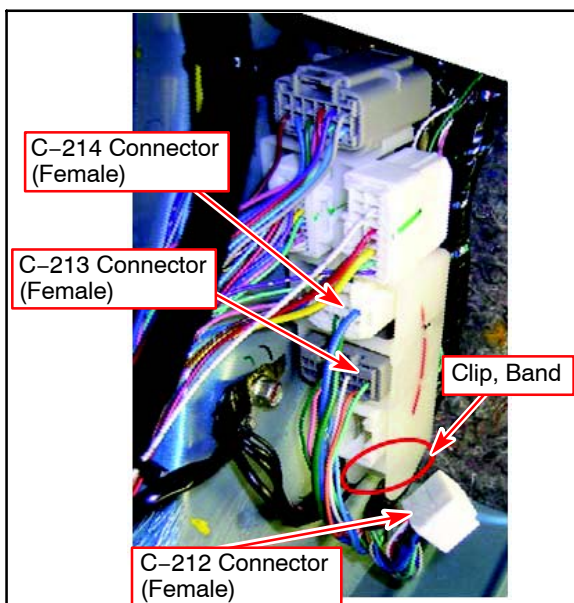
5. Inspect the condition of the C-212 connectors and terminals.
 - a. Disengage the C-212 female connector.
 - b. Check the condition of the connector and terminals to see if they are discolored, rusted, or corroded (see Example of Corroded C-212 Terminal).
 - c. Confirm condition of male connector from front (A) direction.
 - d. Confirm condition of male connector using an inspection mirror from the back (B) direction.

Does either connector show any discoloration or corrosion?

- **YES** – Go to step 6 and replace both male and female connectors.
- **NO** – **DO NOT** replace the C-212 connector. If the connector is **not** discolored or corroded – Reconnect the connector, then **go to step 11** to install the protective waterproof PVC sheet.
