Service Bulletin No. 429

<i>MODEL</i>	D Series	<i>TYPE</i>	Field Change Program	<i>SECTION/GROUP</i>	2-Drive Axle	<i>DATE</i>	Jan. 4, 2016
<i>SUBJECT</i>	MERITOR DRIVE AXLE HANGER BRACKET WELD						
<i>CONDITIONS</i>

Ref. MCI NHTSA Recall No.:15V-837

Bracket Weld Inspection

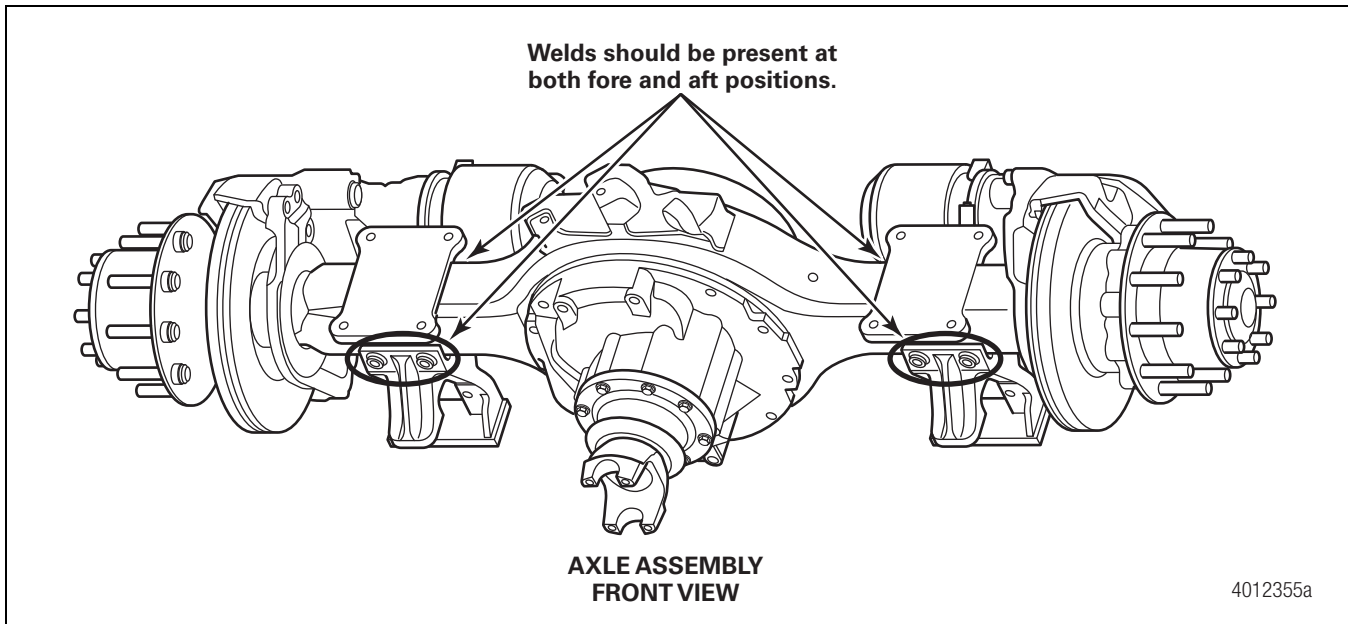
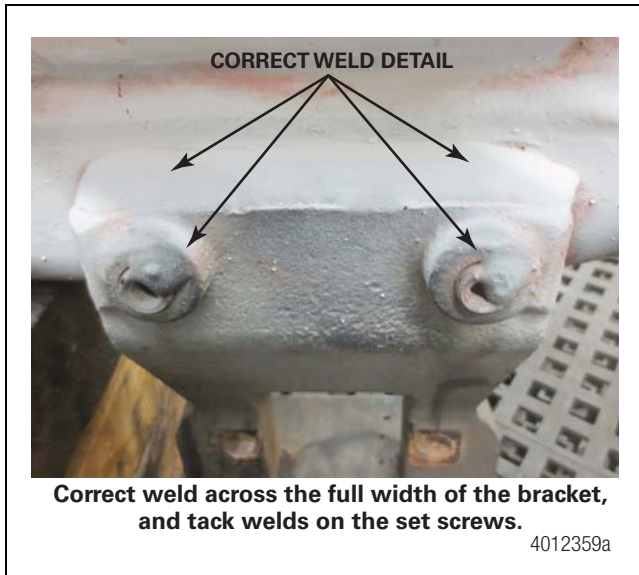
1. Wear safe eye protection. Park the vehicle on a level surface. Block the wheels to prevent the vehicle from moving. An observer should ensure there is a clear view of the RH and LH suspension brackets.
2. From underneath the vehicle, inspect the bracket-to-axle housing interface for the presence of the weld. Figure 2 and Figure 3 outline the bracket locations and the minimum weld presence requirements.

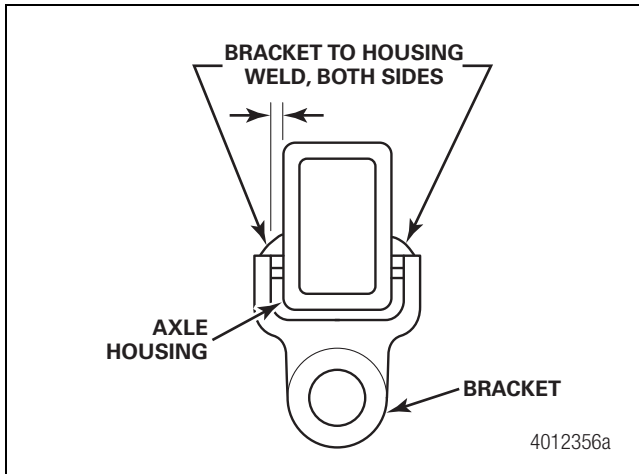
Figure 4

3. Visually inspect the weld to ensure the bracket-to-axle housing is welded on both the front and rear sides of the bracket to the axle housing. Figure 4.

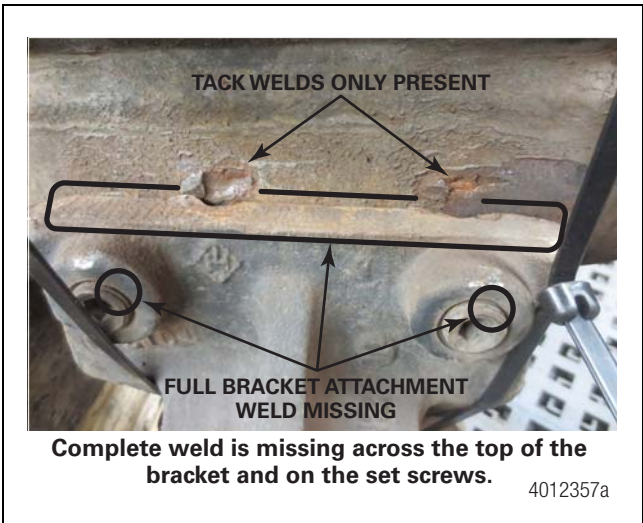
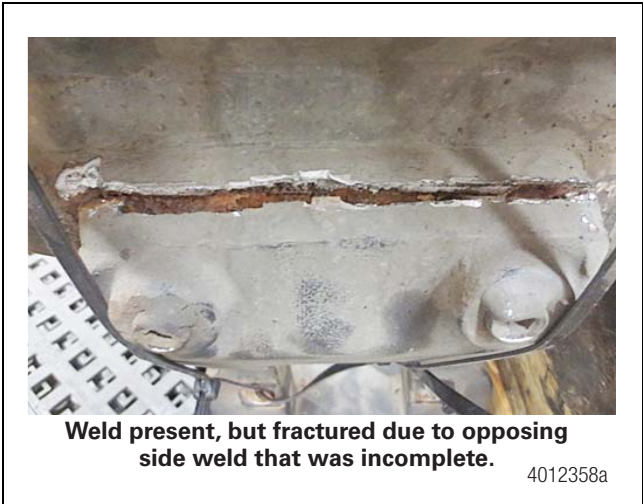
4. If the weld is not present completely around the remaining perimeter, or if any unusual bracket deformation is noted, contact the Meritor OnTrac™ Customer Call Center for further assistance. Do not drive the vehicle. Figure 5 and Figure 6.
