# Service Bulletin No. 429

| SUBJECT | MERITOR DRIVE AXLE HANGER BRACKET WELD | | | | | |

Ref. MCI NHTSA Recall No.:15V-837

### Bracket Weld Inspection

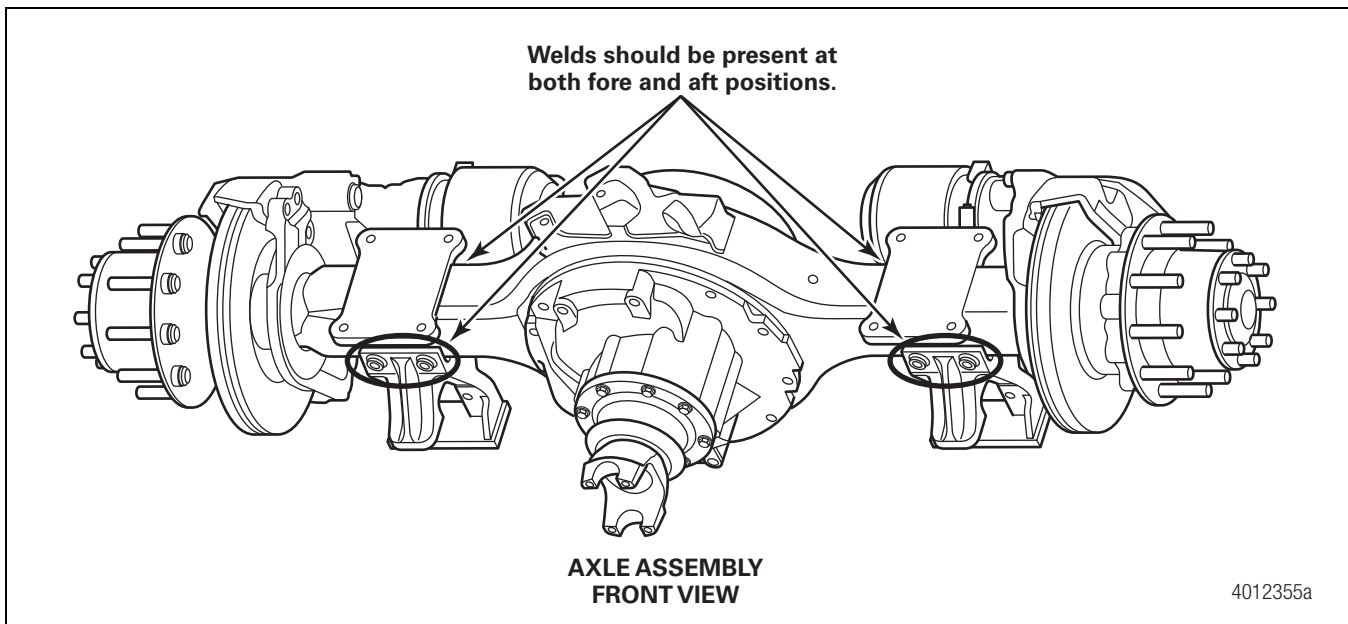
**Figure 2**

1. Wear safe eye protection. Park the vehicle on a level surface. Block the wheels to prevent the vehicle from moving. An observer should ensure there is a clear view of the RH and LH suspension brackets.
2. From underneath the vehicle, inspect the bracket-to-axle housing interface for the presence of the weld. Figure 2 and Figure 3 outline the bracket locations and the minimum weld presence requirements.

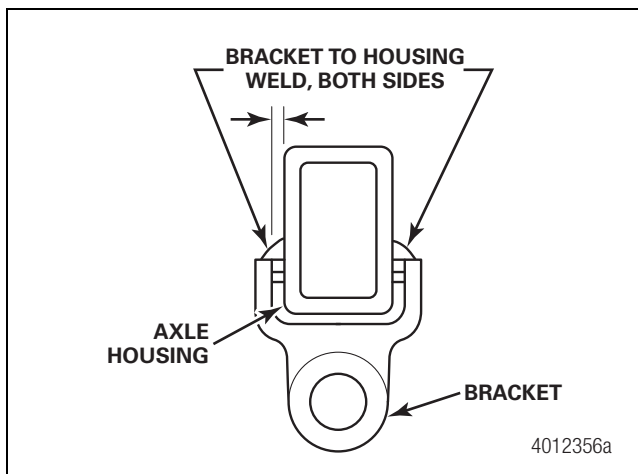
**Figure 4**

3. Visually inspect the weld to ensure the bracket-to-axle housing is welded on both the front and rear sides of the bracket to the axle housing. Figure 4.

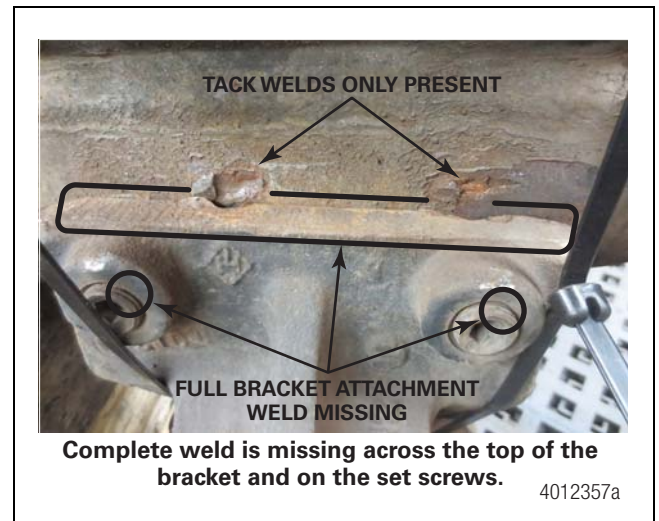
**Figure 5**

4. If the weld is not present completely around the remaining perimeter, or if any unusual bracket deformation is noted, contact the Meritor OnTrac™ Customer Call Center for further assistance. Do not drive the vehicle. Figure 5 and Figure 6.
