Subject: Marmon-Herrington Front Drive Axle Hex Nuts

Models Affected: Specific Freightliner Business Class M2 and Coronado 108SD and 114SD vehicles and Western Star 4900 vehicles manufactured September 26, 2014, through November 6, 2015, equipped with Marmon-Herrington front drive axles.

Recall Campaign

January 2016
FL699A
NHTSA #15V-859
TC #2015-603

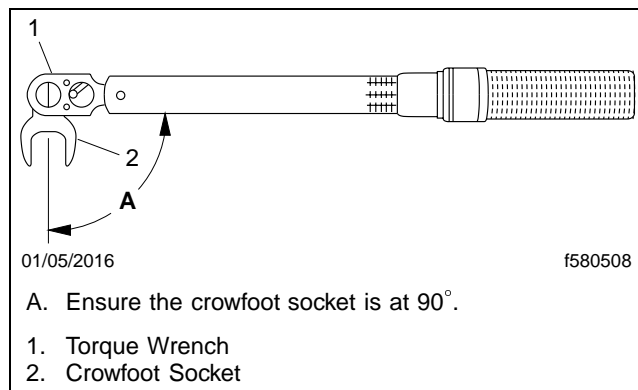
Fig. 1, Wrench Setup

On specific vehicles, the front drive axle hex nuts on the flange yoke assembly were not torqued to specification. If the hex nuts are not tightened to specification, the driveshaft may disconnect from the front drive axle, potentially resulting in damage to the road surface or large debris on the road which may increase the risk of crash.

4. For each of the eight sets of fasteners at the flange yoke joint, use a 9/16" combination wrench to hold the bolt and a calibrated torque wrench (equipped with a crowfoot or box-end socket) to torque the nut to 45 to 50 lbf-ft (60 to 68 N·m)]. See **Fig. 1** and **Fig. 2**.
