Service Bulletin

SAFETY RECALL

2010-2016 VT750 SERIES - BANK ANGLE SENSOR REPLACEMENT

(This bulletin supersedes VT750C/C2B #5, dated June 2011)

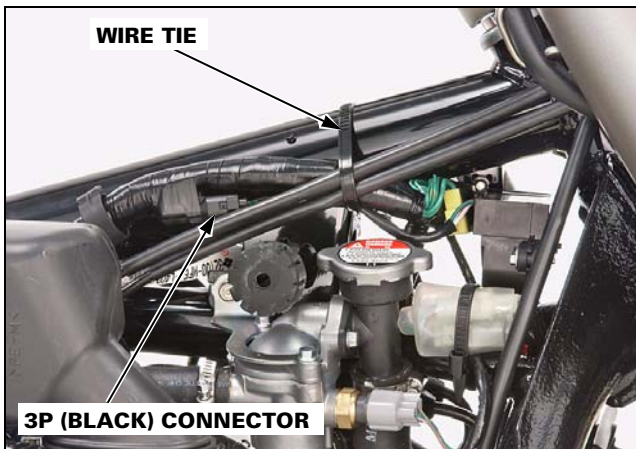
Honda has determined that continuous engine vibration may cause the bank angle sensor wires to break, resulting an open circuit in the bank angle sensor. If an open in the bank angle sensor electrical circuit develops, the engine may stall.

6. Remove the wire tie and disconnect the bank angle sensor 3P (Black) connector.
