Revised August 2016

Dealer Service Instructions for:

Safety Recall R71 / NHTSA 15V-879

Sun Visor Wiring

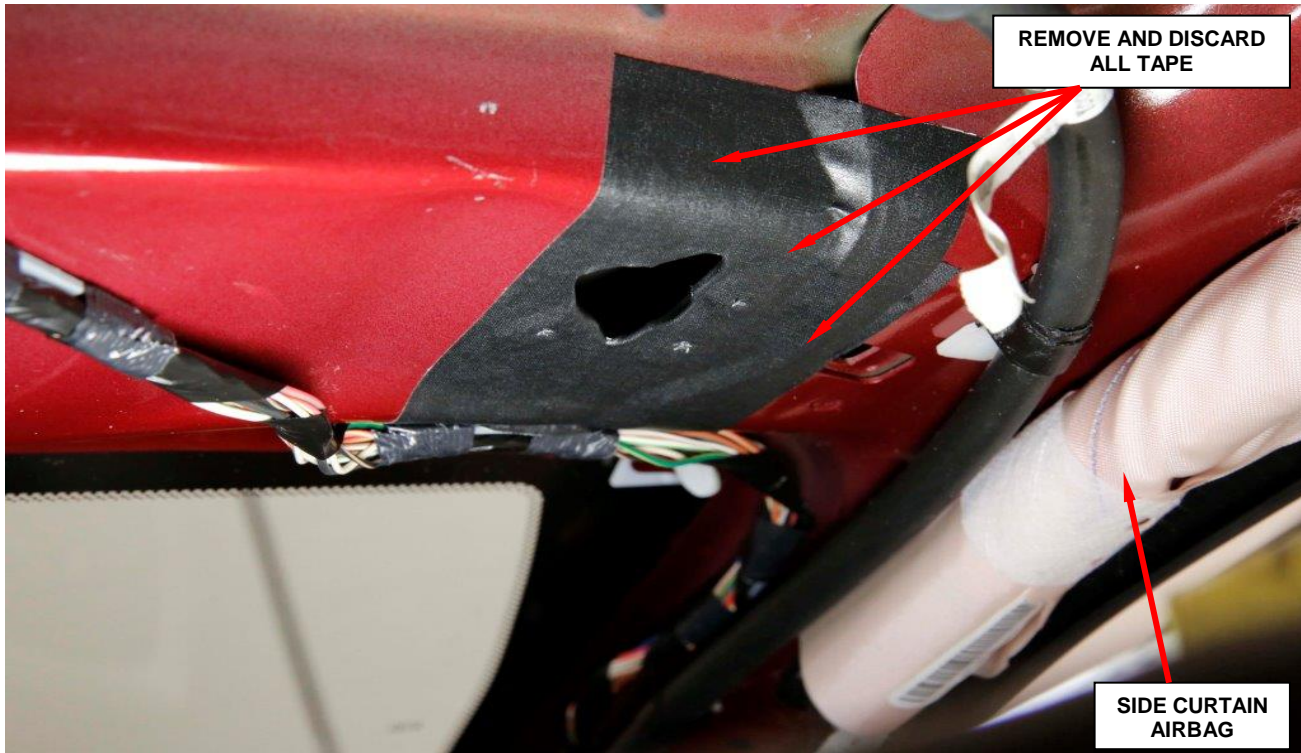
Figure 11 – Remove and Discard the Abrasion Tape and Tape Patches from Left and Right Visor Hole Openings (right side shown)

30. For vehicles that had Safety Recall P36 performed, remove all protective and abrasion tape applied to the right and left visor hole openings (Figure 11).

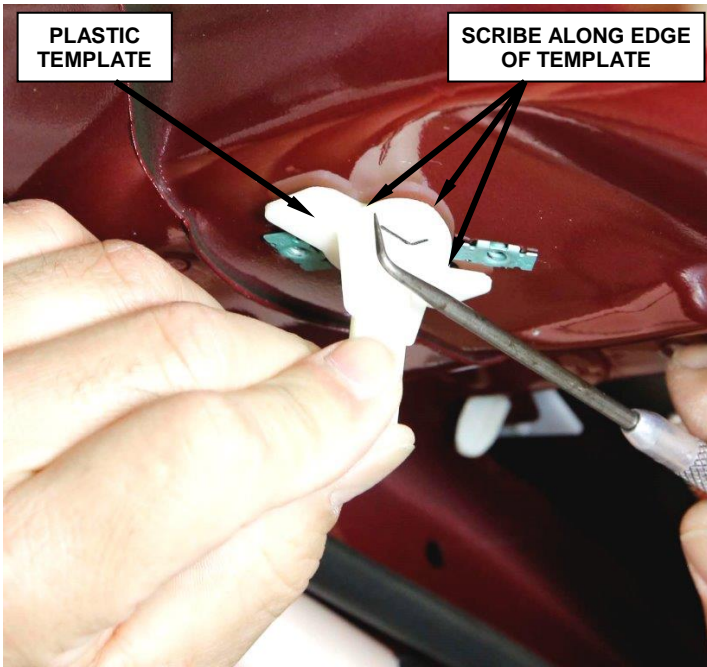
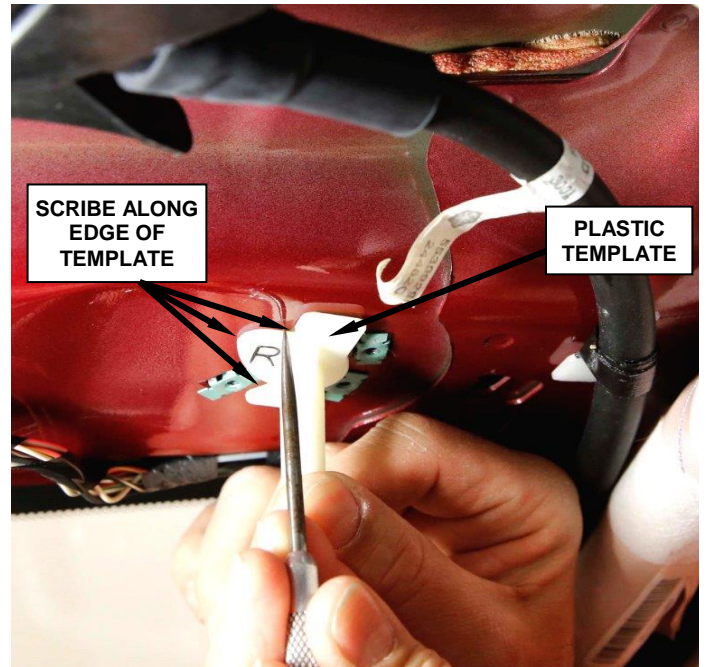
Figure 12 – Install Template and Scribe Cut Line

31. Hold the plastic template marked “L” into the left visor hole opening in the roof panel and scribe a line on the sheet metal (Figure 12).
32. Remove and save the left template. Verify that the scribe mark is visible (Figure 13).
33. Hold the plastic template marked “R” into the right visor hole opening in the roof panel and scribe a line on the sheet metal (Figure 12).
34. Remove and save the right template. Verify that the scribe mark is visible (Figure 13).

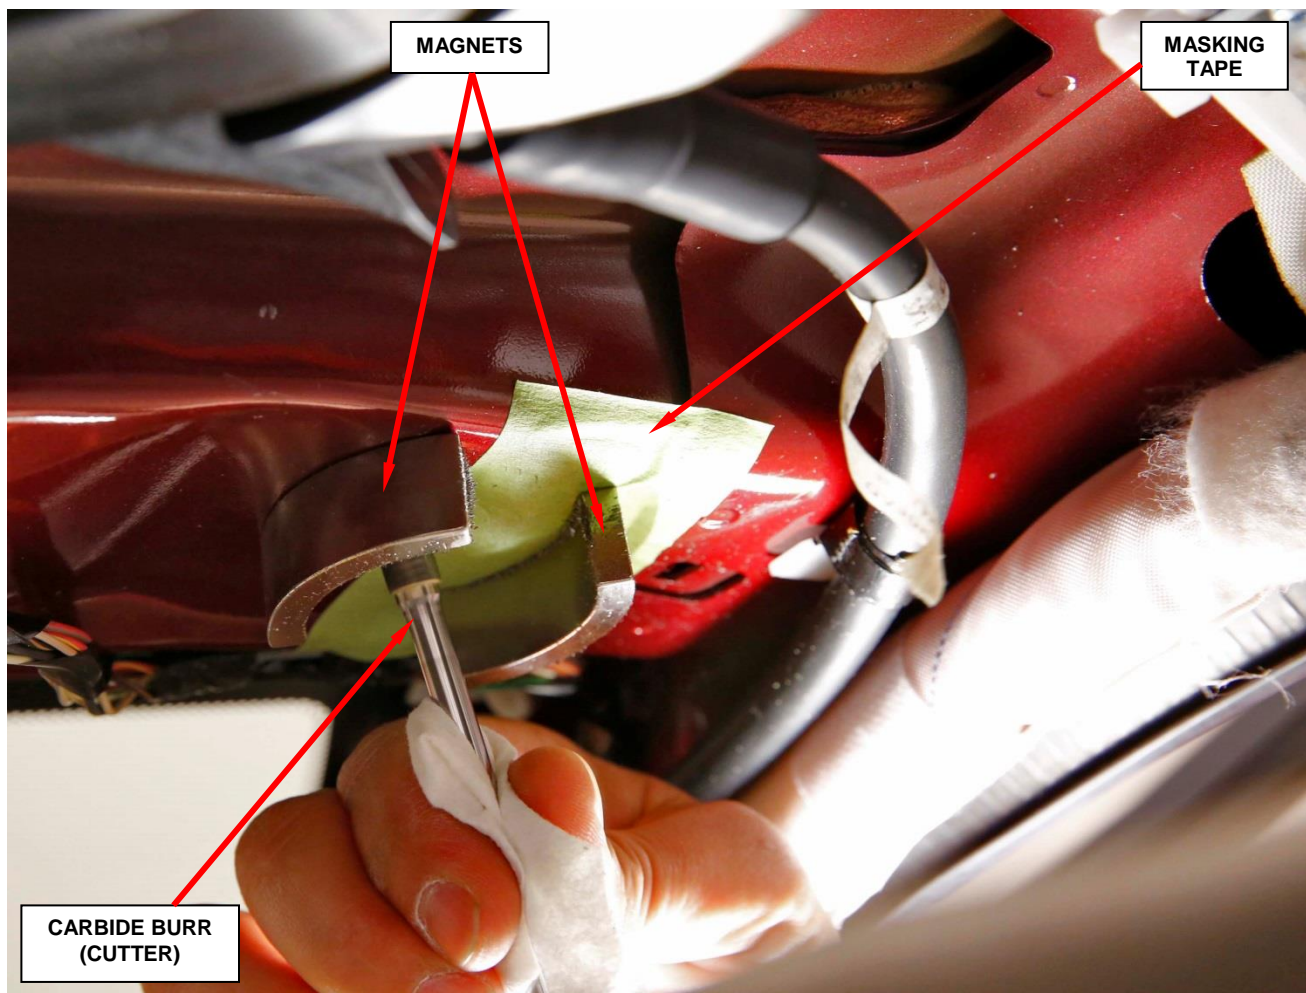
**Figure 16 – Grind Away Sheet Metal Inside Scribe Mark
(right side shown)**

38. Using the supplied carbide burr and a die grinder, grind a relief in the left visor hole opening (Figure 16).

CAUTION: Do not grind beyond the scribe marks made in Steps 31 and 33.

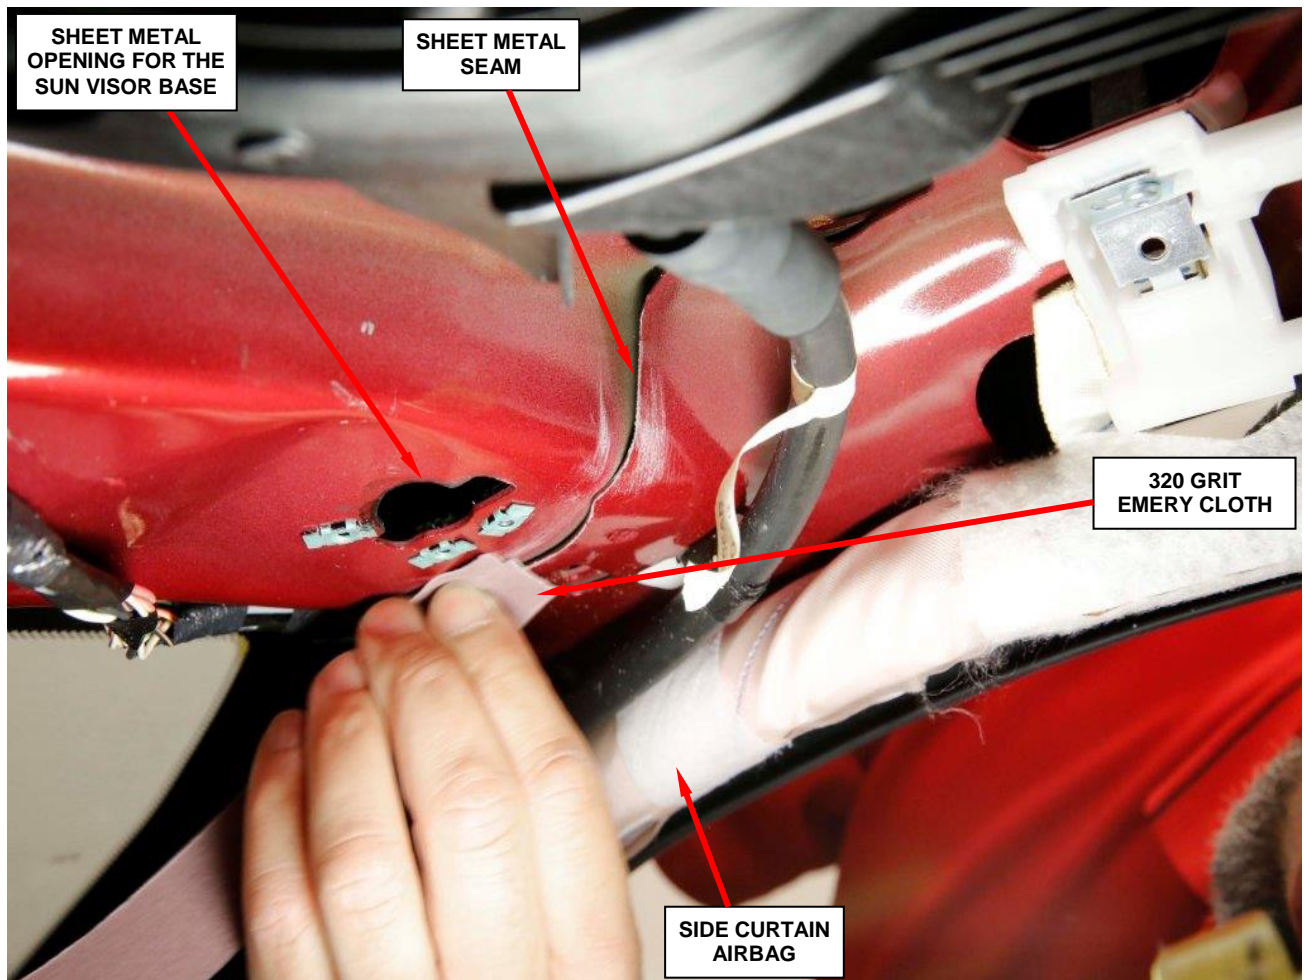
**Figure 17 – Dull Sheet Metal Seam Edge
(right side shown)**

43. Using 320 grit emery cloth, dull the edge of the sheet metal seam on the right and left upper “A” pillar (Figure 17).

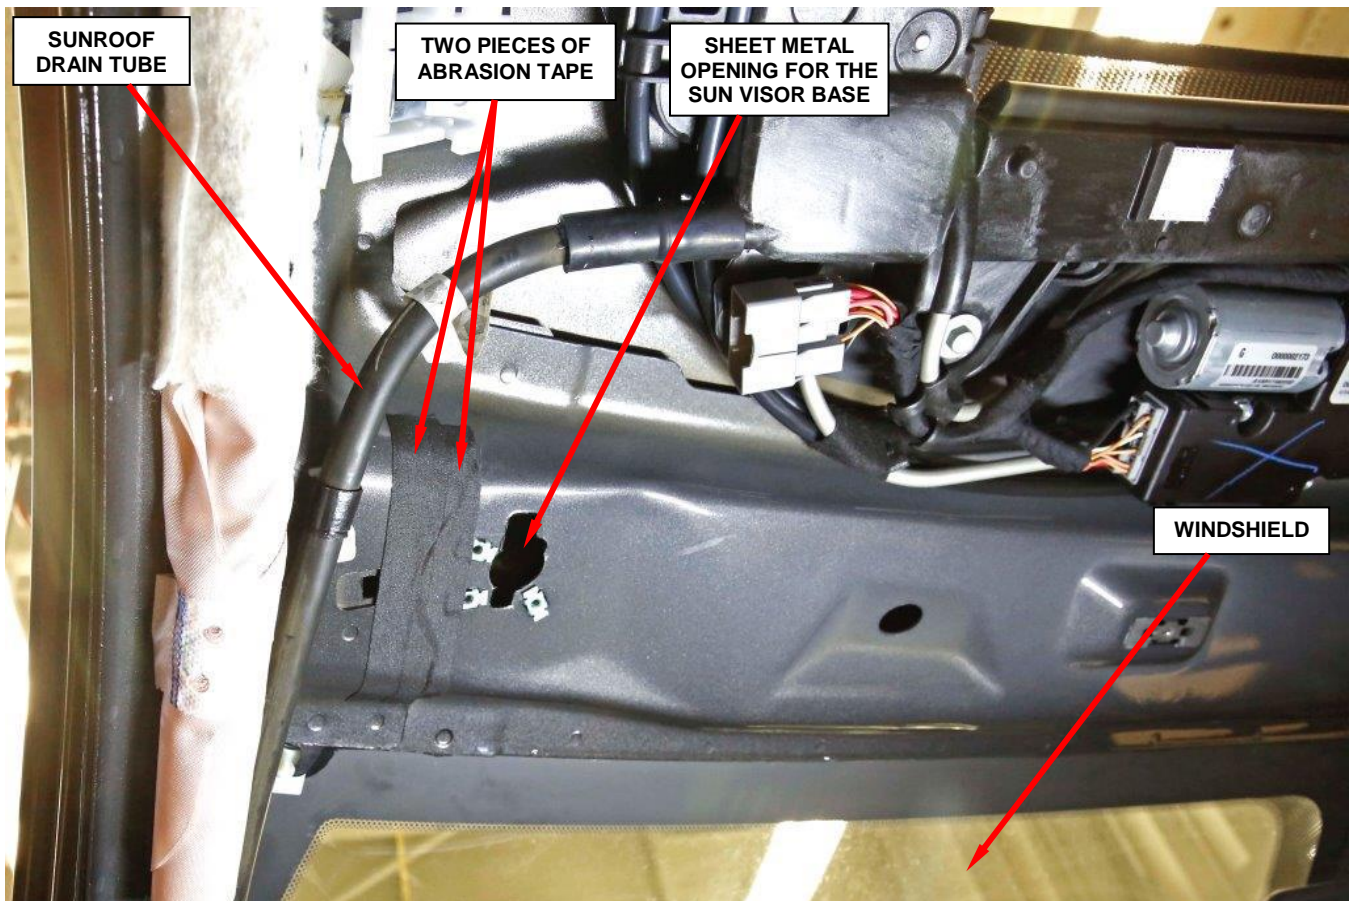
Figure 20 – Apply the Two 5 Inch Strips of Tape Over Sheet Metal Seam (left side shown)

46. Apply the two pieces of cloth abrasion tape over the sheet metal seam located at the top of the “A” pillar (Figure 20).

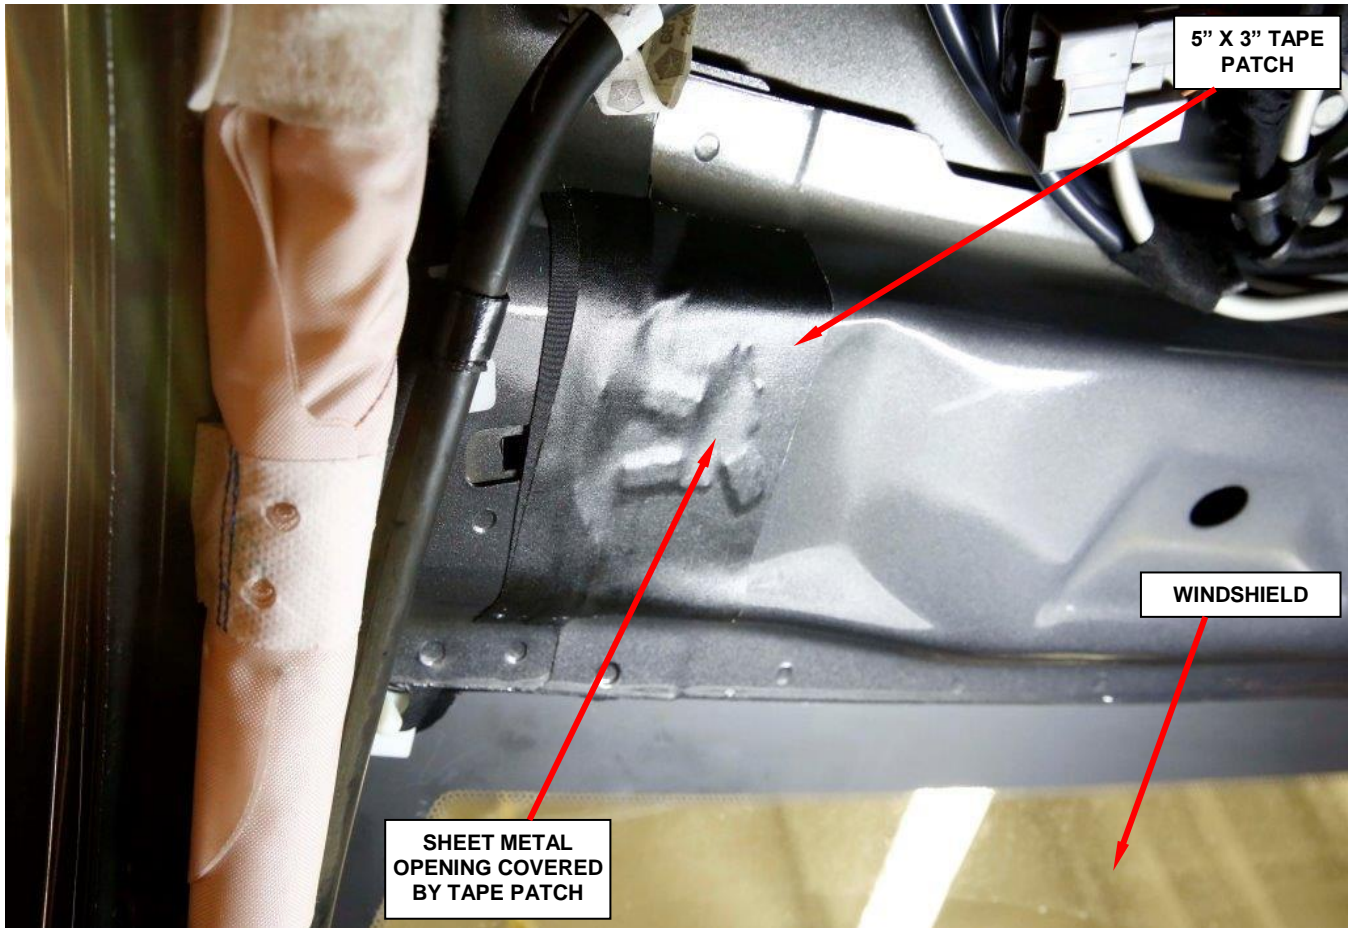
Figure 21 – Apply 5”x 3” Tape Patch over the Abrasion Tape (left side shown)

47. Apply one piece of (5”x 3”) tape patch over the tape applied in Step 46 (Figure 21).

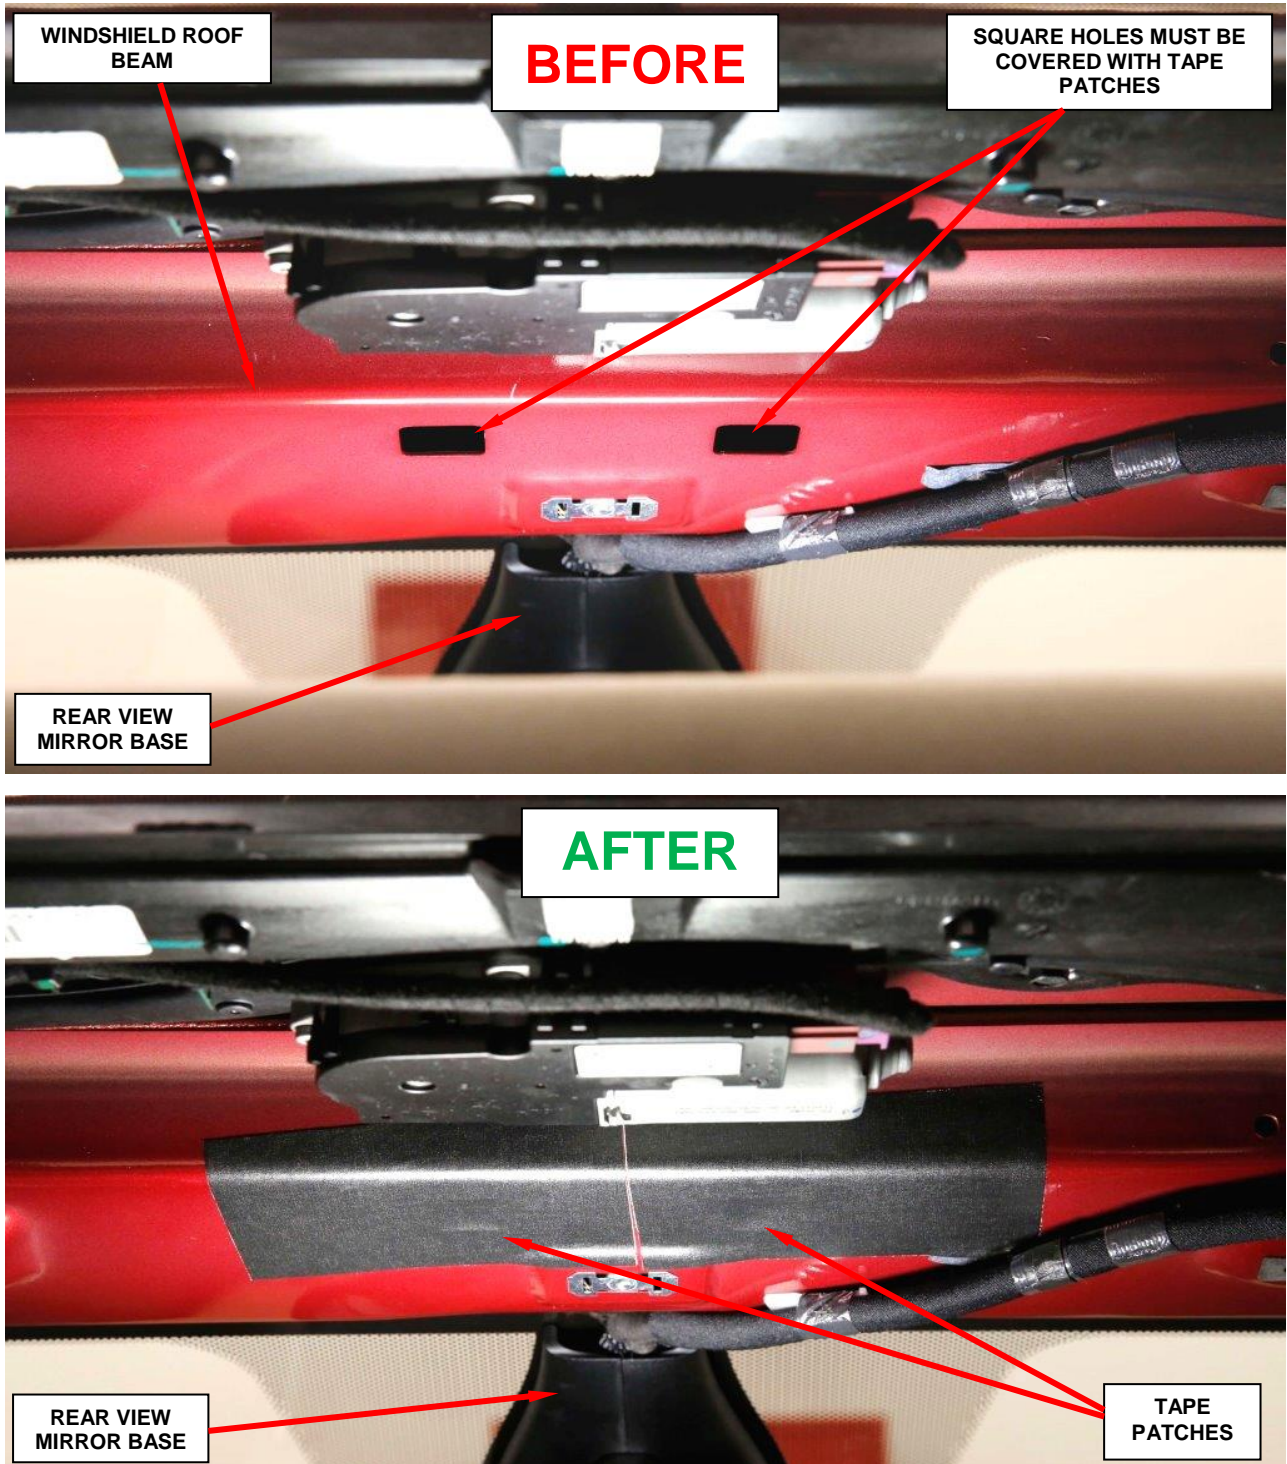
Figure 24 – Apply One Tape Patch Over Each Square Hole in the Windshield Roof Beam (vehicle with sunroof option shown)

- 51. Apply two tape patches over the square holes in the center of the windshield roof beam (Figure 24).

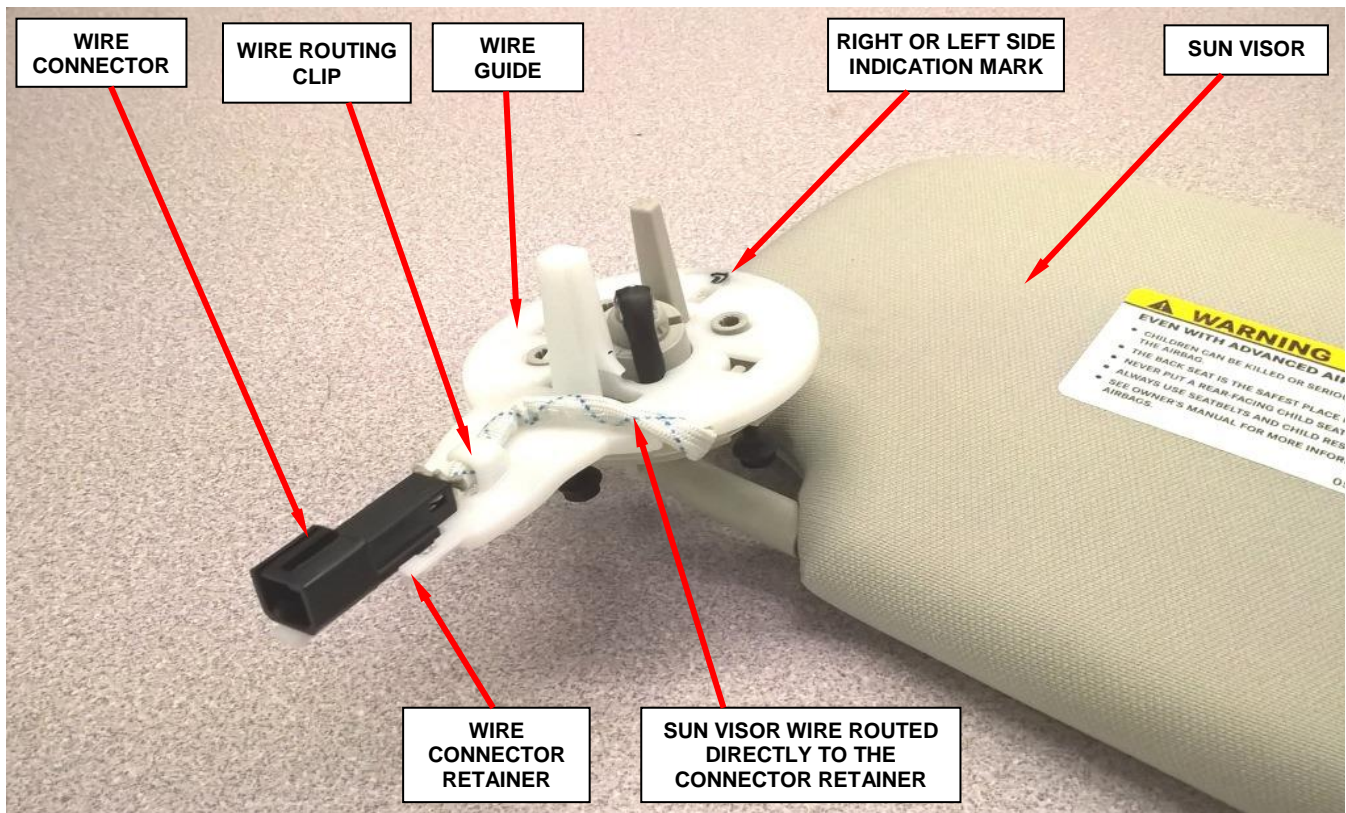
Figure 28 - Sun Visor Wire Routing
(Parts removed from vehicle for photographic purposes only)

56. Route the sun visor wire as shown in Figure 28. Then connect the sun visor wire harness electrical connector to the wire guide connector retainer.

CAUTION: Be sure to route the sun visor wire in the wire groove on the plastic wire guide (Figure 28).

CAUTION: It is critical that the sun visor wire remains under the wire routing clip shown in Figure 28 when reinstalling the visor to prevent improper wire routing.

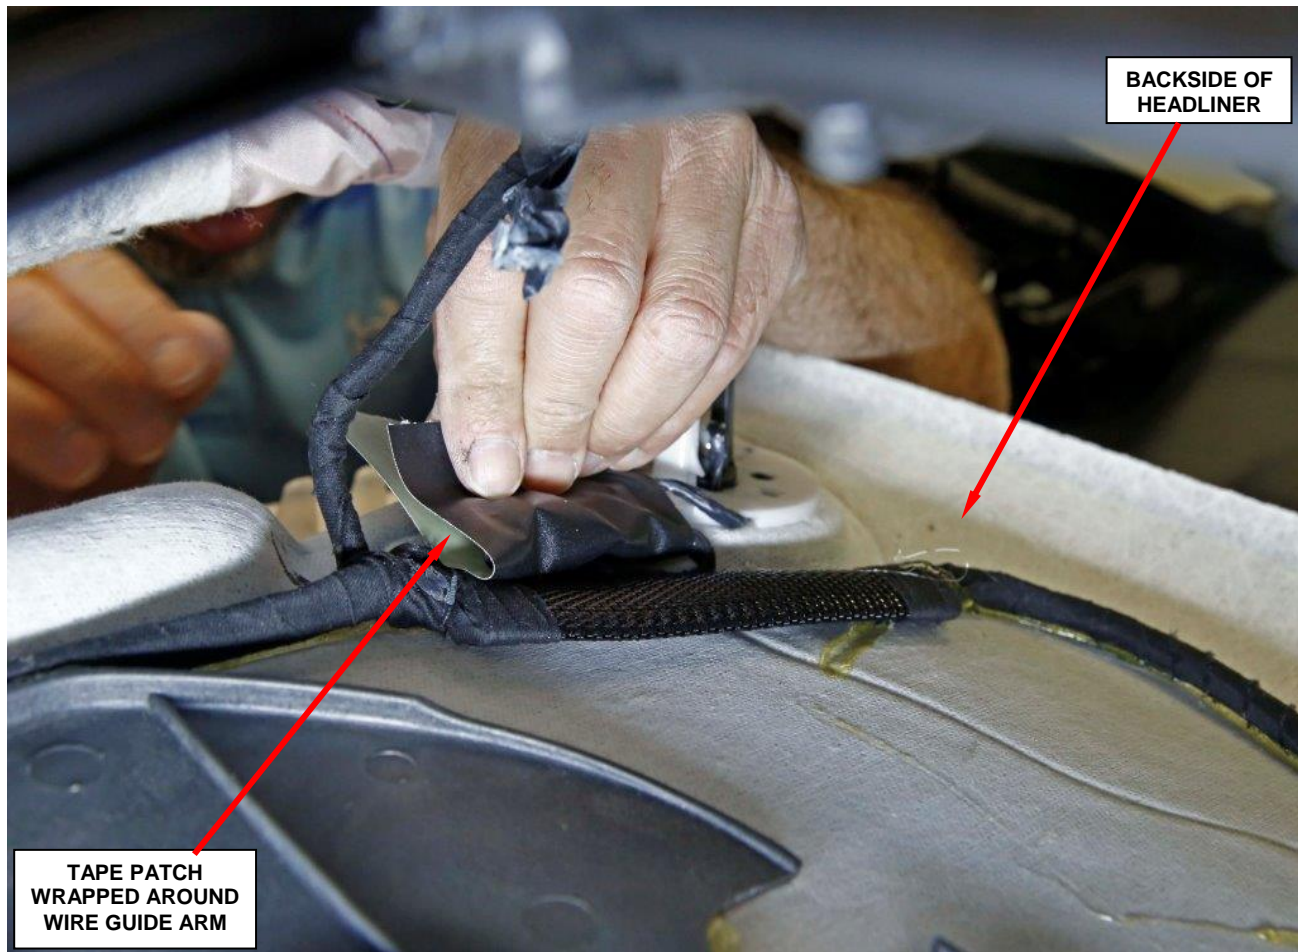
Figure 30 – Wrap Tape Patch Around the Right and Left Wire Guide Arms

58. Apply a piece of (5" x 3") tape patch around the right and left side wire guide arm as shown in Figure 30.
59. Carefully lift the headliner into position and snap the wire guides into the roof structure.
60. Install the right and left side sun visor anchors (Figure 8).
61. **For vehicles equipped with a dual pane sunroof**, remove and save right and left headliner opening supports (Special Tool 2021400230).
62. Install the three sun visor retaining screws for the right and left side sun visors (Figure 8).
