Dealer Service Instructions for:

Safety Recall R71 / NHTSA 15V-879

Sun Visor Wiring

2011 – 2012 (WD) Dodge Durango

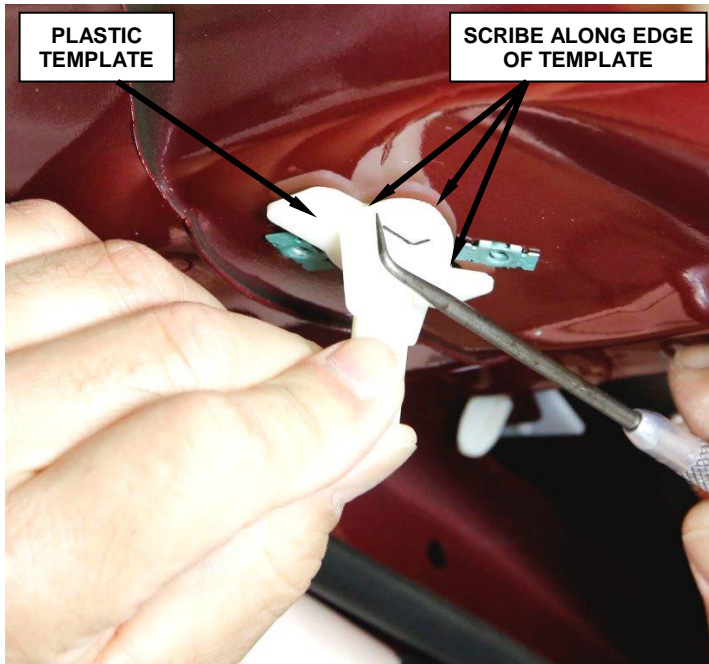
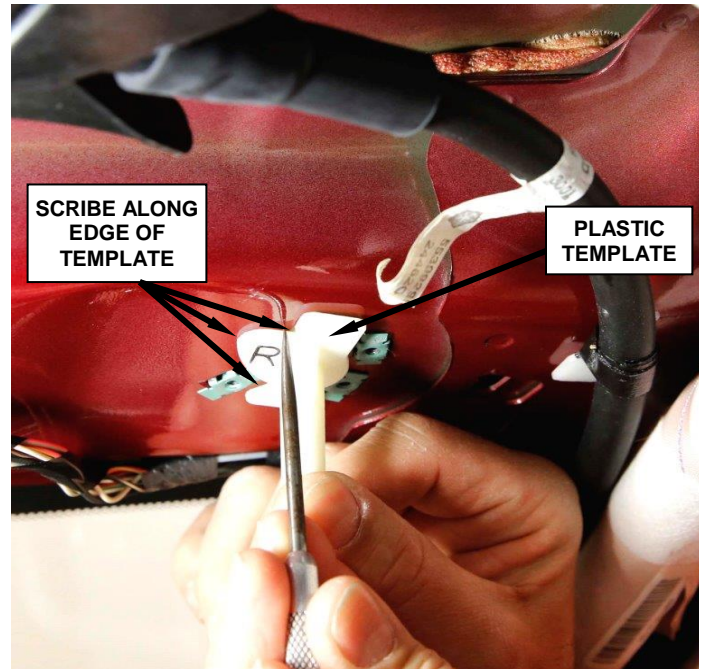
Figure 12 – Install Template and Scribe Cut Line

31. Hold the plastic template marked “L” into the left visor hole opening in the roof panel and scribe a line on the sheet metal (Figure 12).
32. Remove and save the left template. Verify that the scribe mark is visible (Figure 13).
33. Hold the plastic template marked “R” into the right visor hole opening in the roof panel and scribe a line on the sheet metal (Figure 12).
34. Remove and save the right template. Verify that the scribe mark is visible (Figure 13).

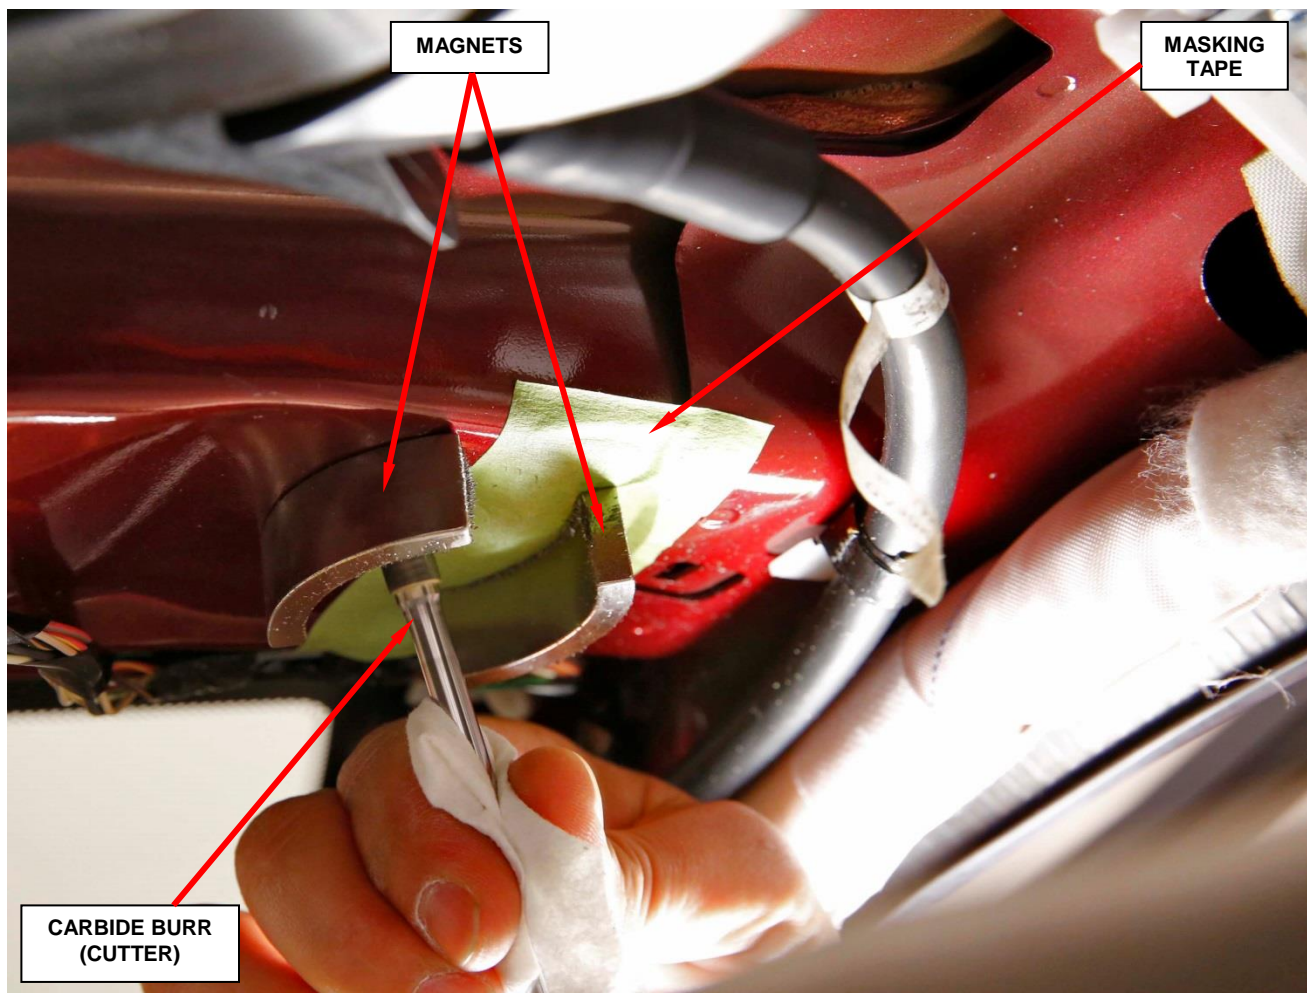
Figure 16 – Grind Away Sheet Metal Inside Scribe Mark (right side shown)

38. Using the supplied carbide burr and a die grinder, grind a relief in the left visor hole opening (Figure 16).

CAUTION: Do not grind beyond the scribe marks made in Steps 31 and 33.

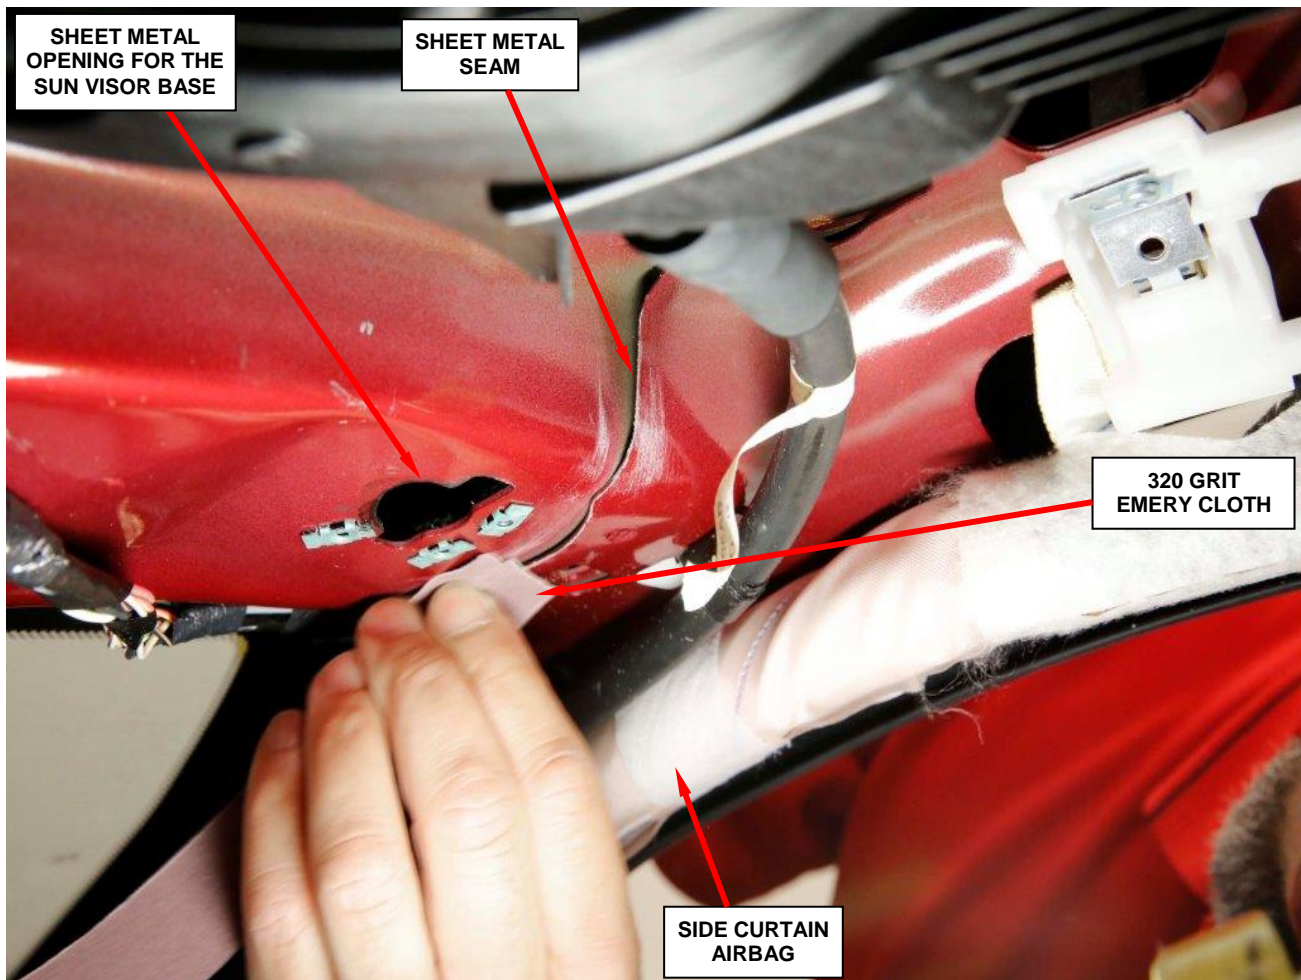
**Figure 17 – Dull Sheet Metal Seam Edge
(right side shown)**

43. Using 320 grit emery cloth, dull the edge of the sheet metal seam on the right and left upper “A” pillar (Figure 17).

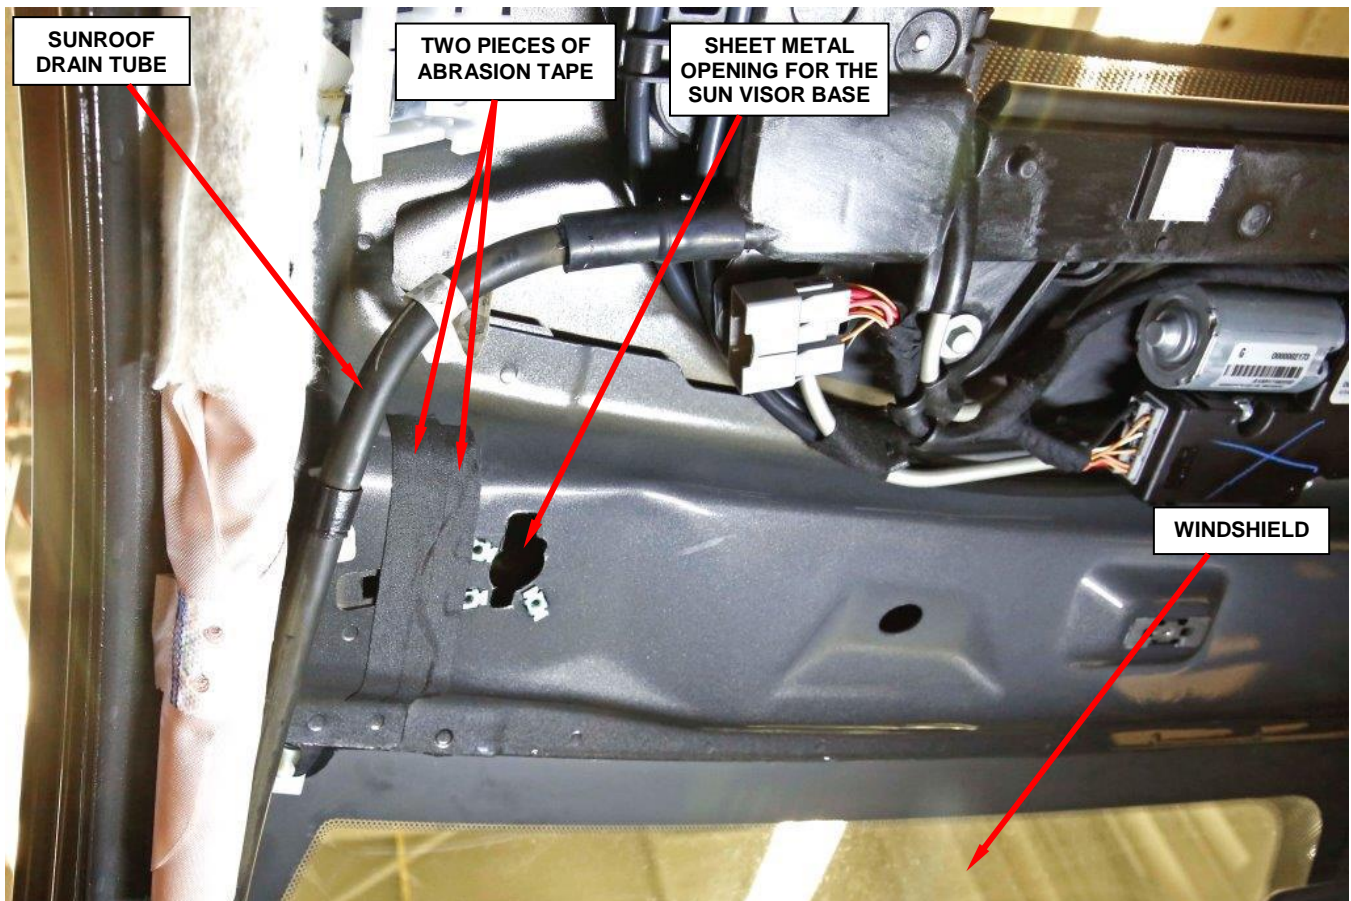
Figure 20 – Apply the Two 5 Inch Strips of Tape Over Sheet Metal Seam (left side shown)

46. Apply the two pieces of cloth abrasion tape over the sheet metal seam located at the top of the “A” pillar (Figure 20).

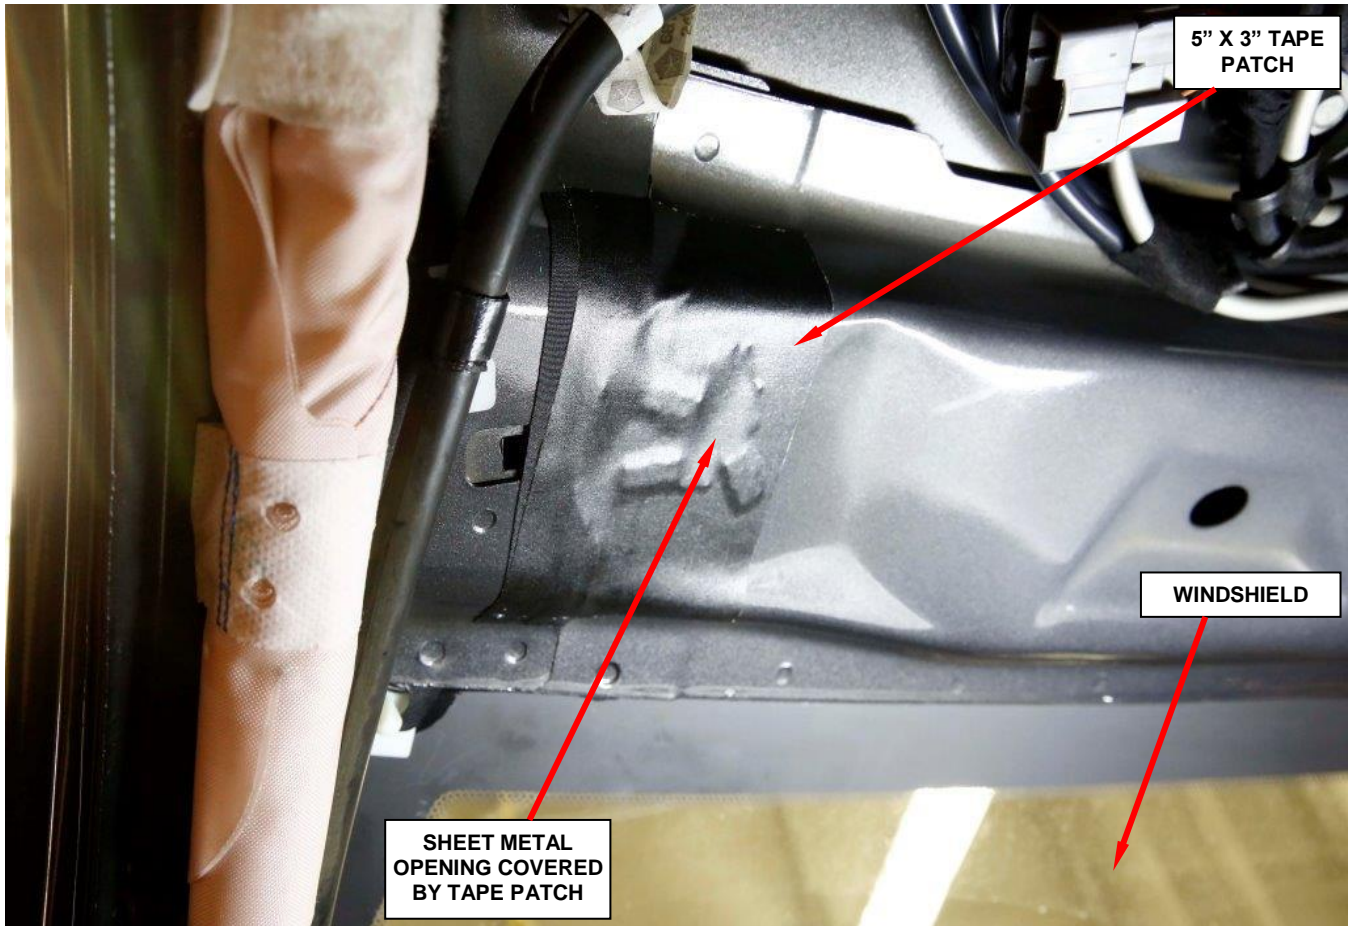
Figure 21 – Apply 5”x 3” Tape Patch over the Abrasion Tape (left side shown)

- 47. Apply one piece of (5”x 3”) tape patch over the tape applied in Step 46 (Figure 21).

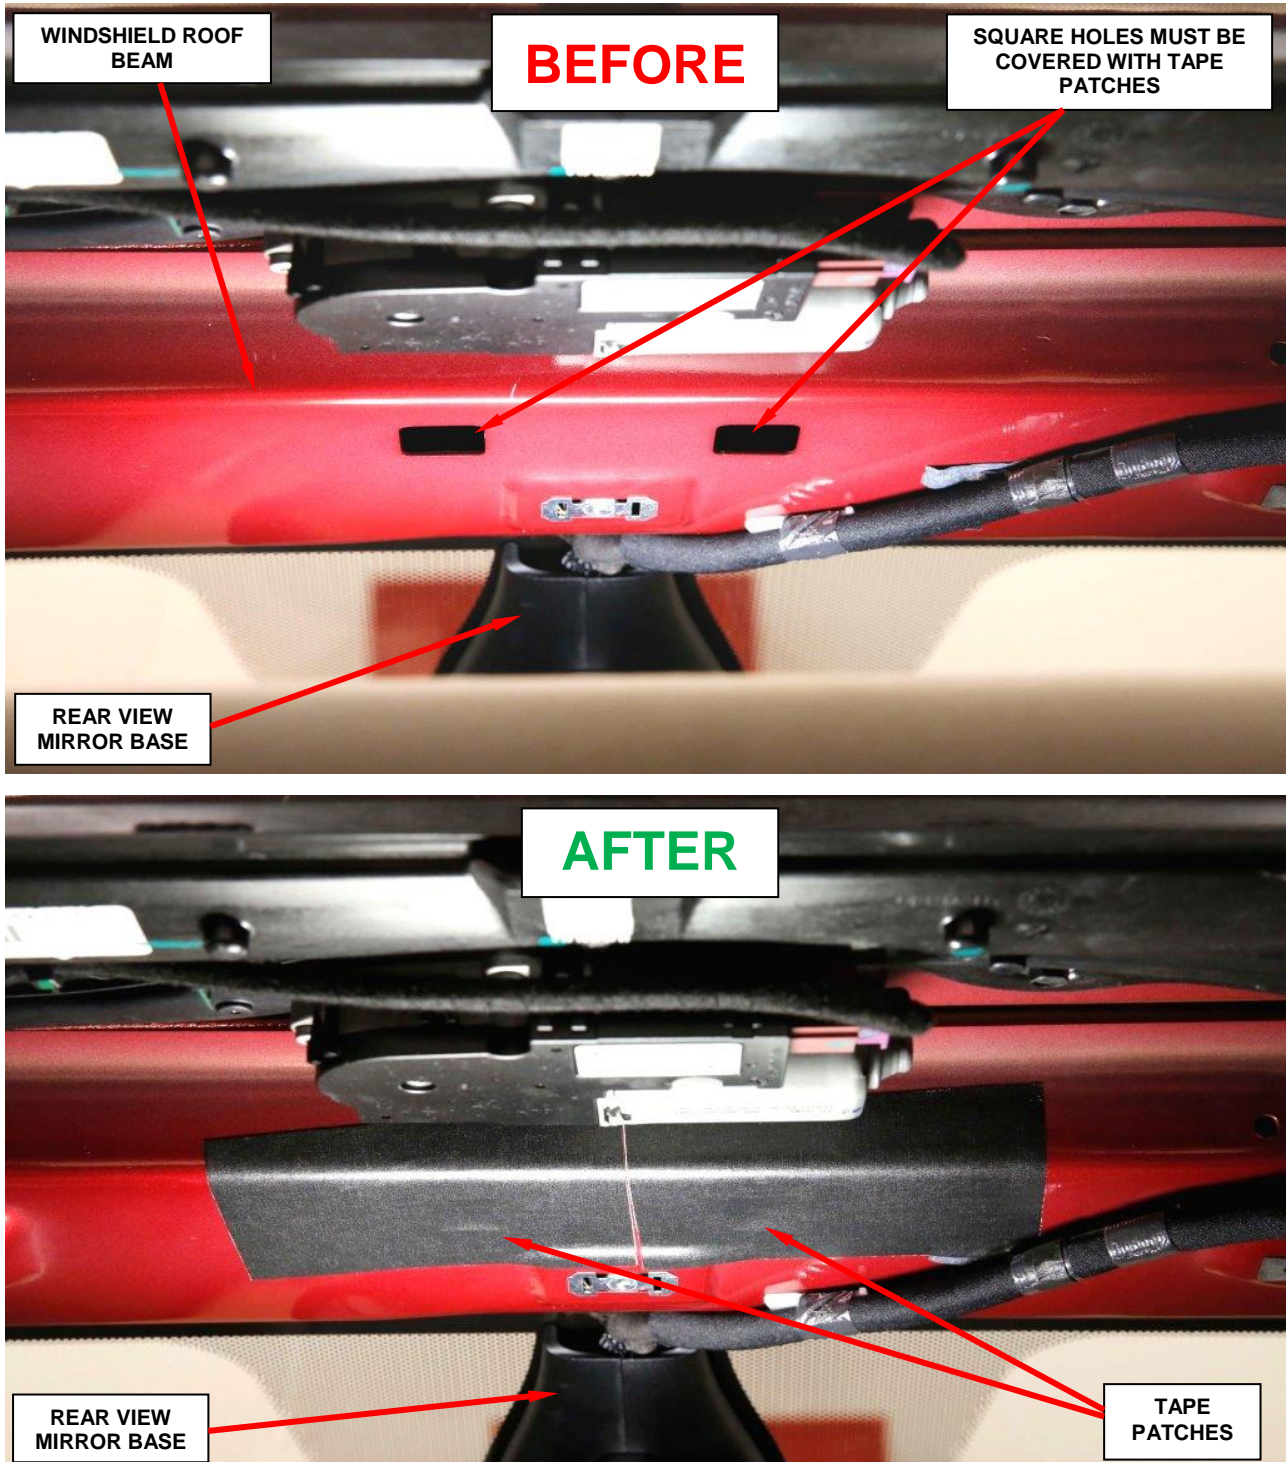
Figure 24 – Apply One Tape Patch Over Each Square Hole in the Windshield Roof Beam (vehicle with sunroof option shown)

51. Apply two tape patches over the square holes in the center of the windshield roof beam (Figure 24).

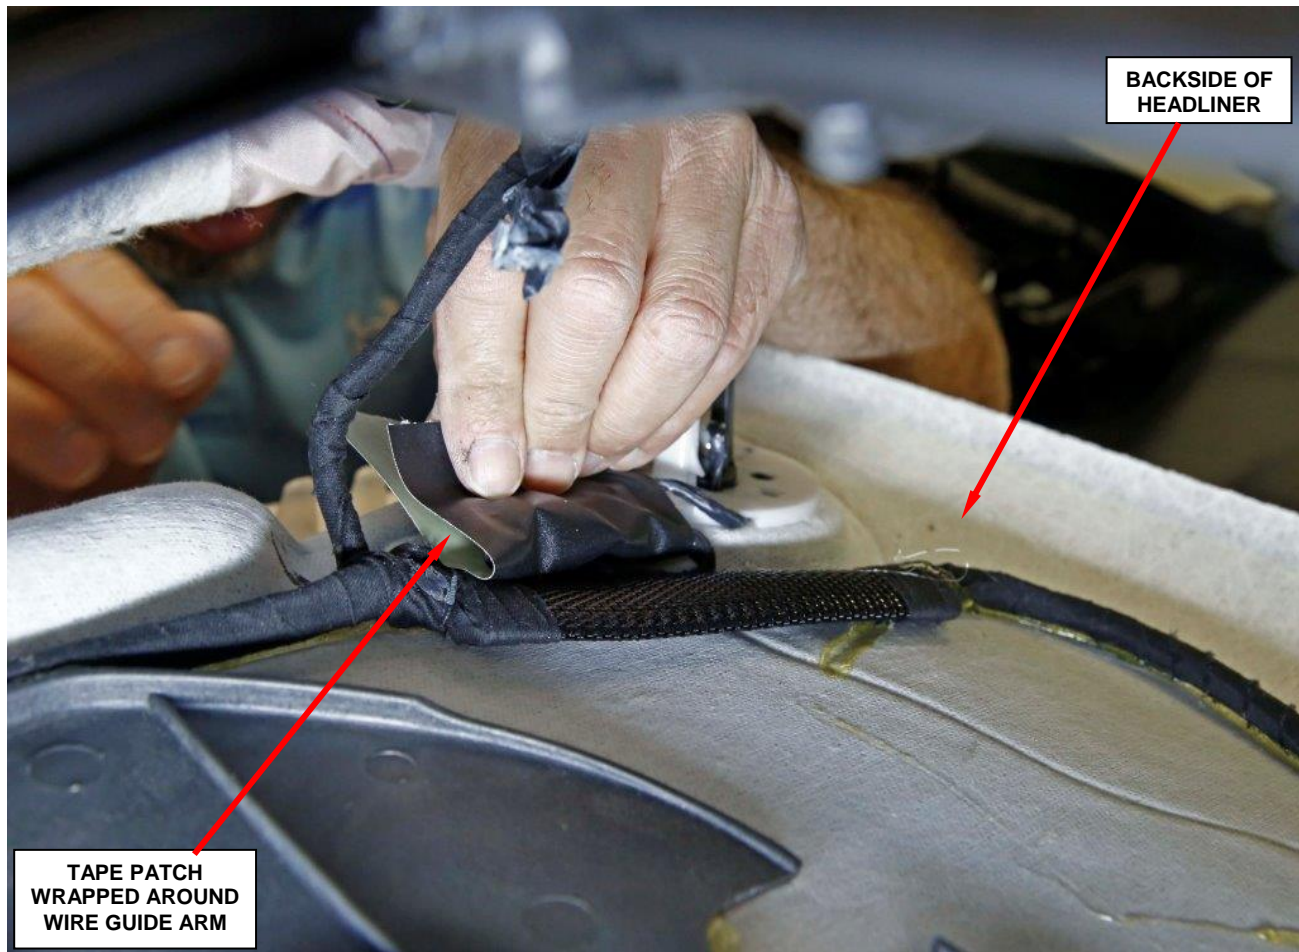
Figure 30 – Wrap Tape Patch Around the Right and Left Wire Guide Arms

58. Apply a piece of (5" x 3") tape patch around the right and left side wire guide arm as shown in Figure 30.
59. Carefully lift the headliner into position and snap the wire guides into the roof structure.
60. Install the right and left side sun visor anchors (Figure 8).
61. **For vehicles equipped with a dual pane sunroof**, remove and save right and left headliner opening supports (Special Tool 2021400230).
62. Install the three sun visor retaining screws for the right and left side sun visors (Figure 8).
