DATE: SEPTEMBER 14, 2015
TO: BLUE BIRD OWNERS
SUBJECT: RECALL R14XE
STEERING SHAFT CLAMP MAY CONTACT RUBBER
CLOSEOUT BOOT

IMPORTANT SAFETY RECALL NOTICE

**NHTSA RECALL NO. 15V-124 SCHOOL BUS
NHTSA RECALL NO. 15V-118 NON-SCHOOL BUS**

Steering Shaft Floor Boot Seal

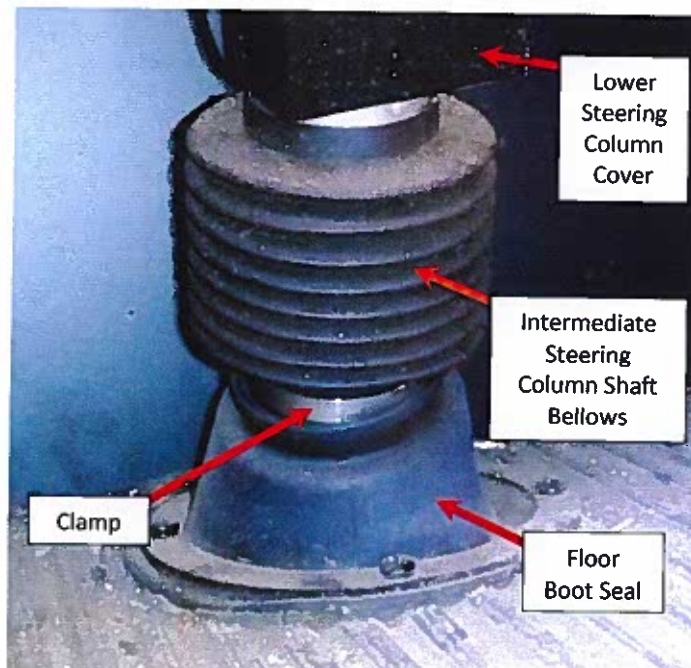
Fig. 1

Clamp on intermediate steering column shaft bellows may contact steering shaft floor boot seal and tear floor boot seal and bind steering shaft causing difficulty in steering.

1. Park bus on a level surface, apply parking brake, turn off ignition, remove ignition key and chock rear wheels.
2. Inspect steering shaft floor boot seal for wear or damage and slit is toward front of bus.
3. If damaged or worn, complete section **Steering Shaft Floor Boot Seal Replacement** before continuing.
4. After completing section **Steering Shaft Floor Boot Seal Replacement** or if there is no damage or wear to the floor boot seal, complete section **Intermediate Steering Column Shaft Bellows Adjustment**.
