**IMPORTANT SAFETY RECALL SC0395  
NHTSA RECALL # 15V-644 – 2<sup>nd</sup> notice**

Mack Trucks, Inc. has decided that a defect, which relates to motor vehicle safety, exists in certain 2011-2014 Mack CHU and CXU model trucks manufactured from September 20, 2010 through June 17, 2013 with a Fontaine Ultra LT fifth wheel.

Subject: Service Bulletin - Ultra LT Fifth Wheel Damage Caused by Improper Coupling

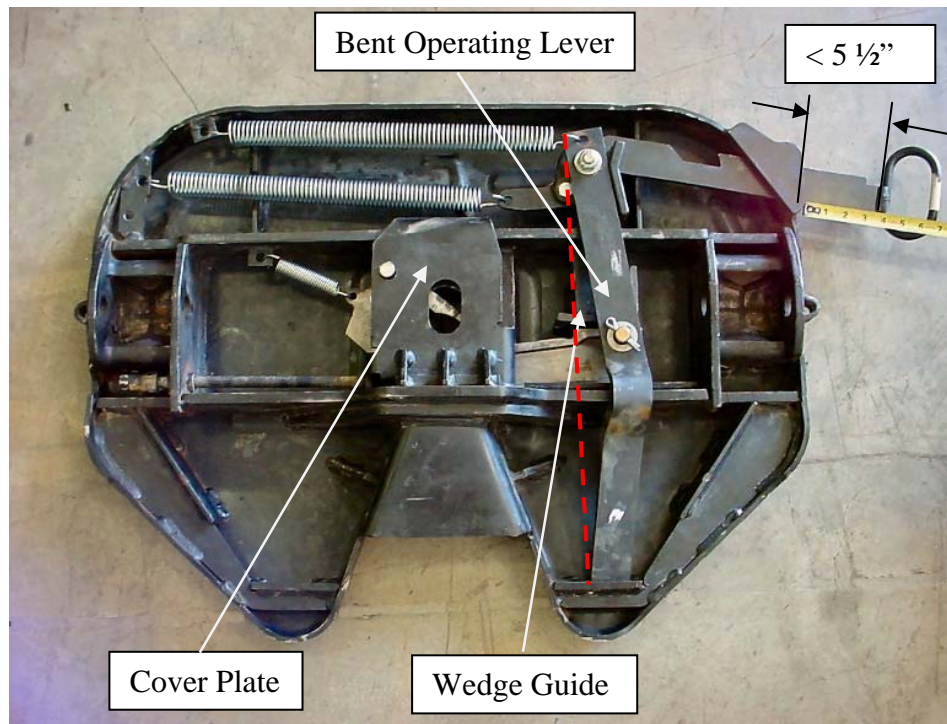
Bent Operating Lever – Pull Handle Dimension < 5 1/2"  
Figure 1

1) Perform a thorough visual inspection of the fifth wheel, including underneath, looking for bent or damaged components. Pay particular attention to the operating lever (Figures 1 & 2), the rotating jaw and cover plate (Figures 3, 4, & 5), and the wedge guide (Figure 6). If any components are bent or damaged replace the fifth wheel.

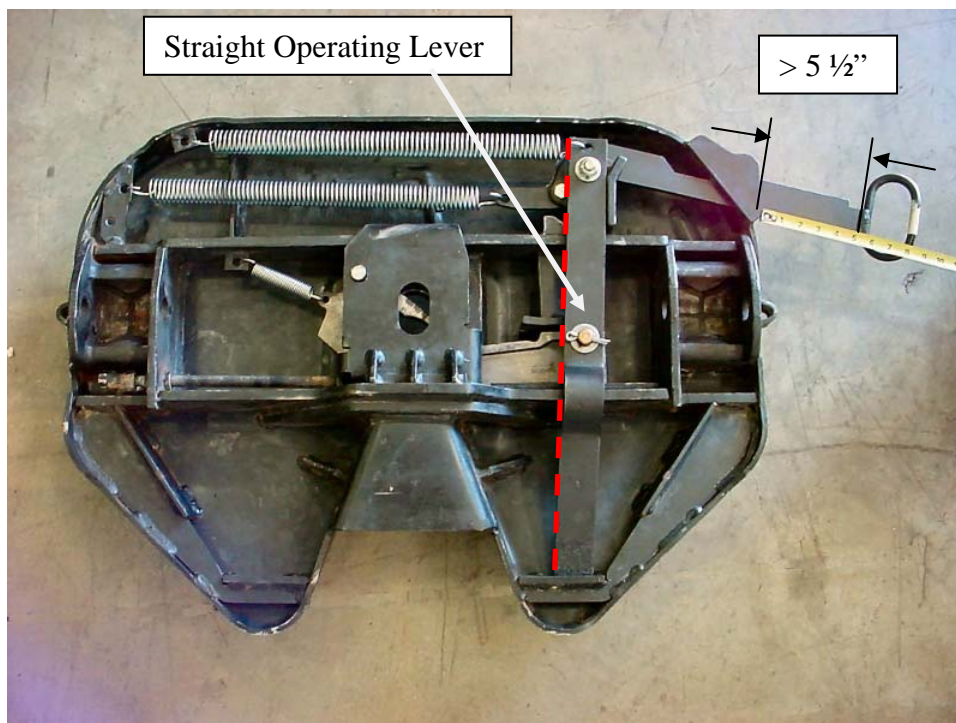
Undamaged Operating Lever – Pull Handle Dimension > 5 1/2"  
Figure 2

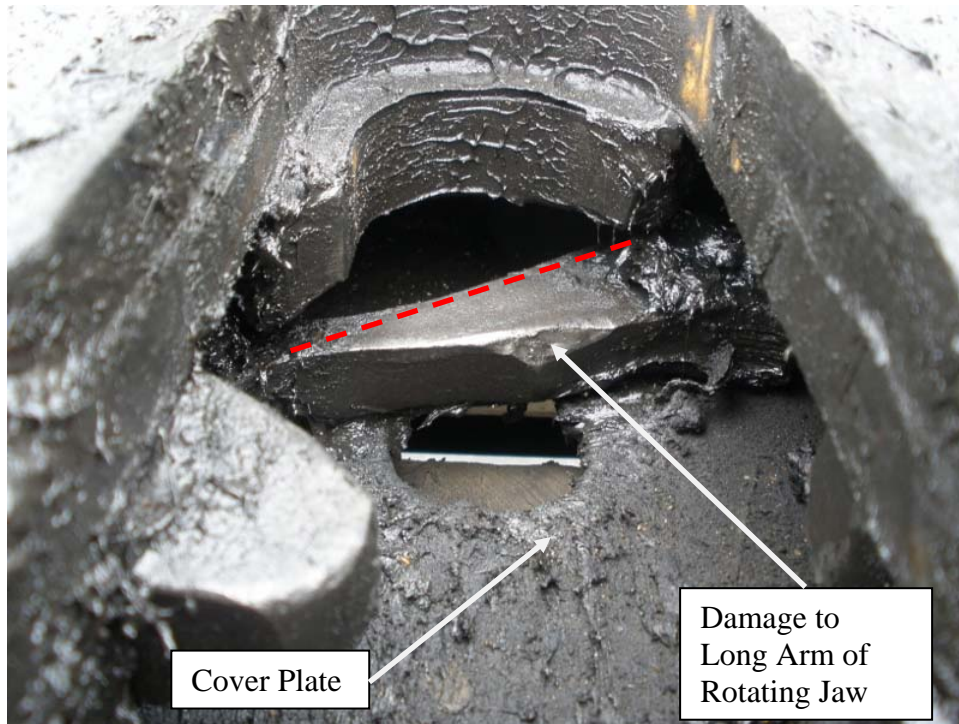
Damage to Rotating Jaw Caused By High Coupling, Resulting in a Bent Cover Plate  
Figure 3

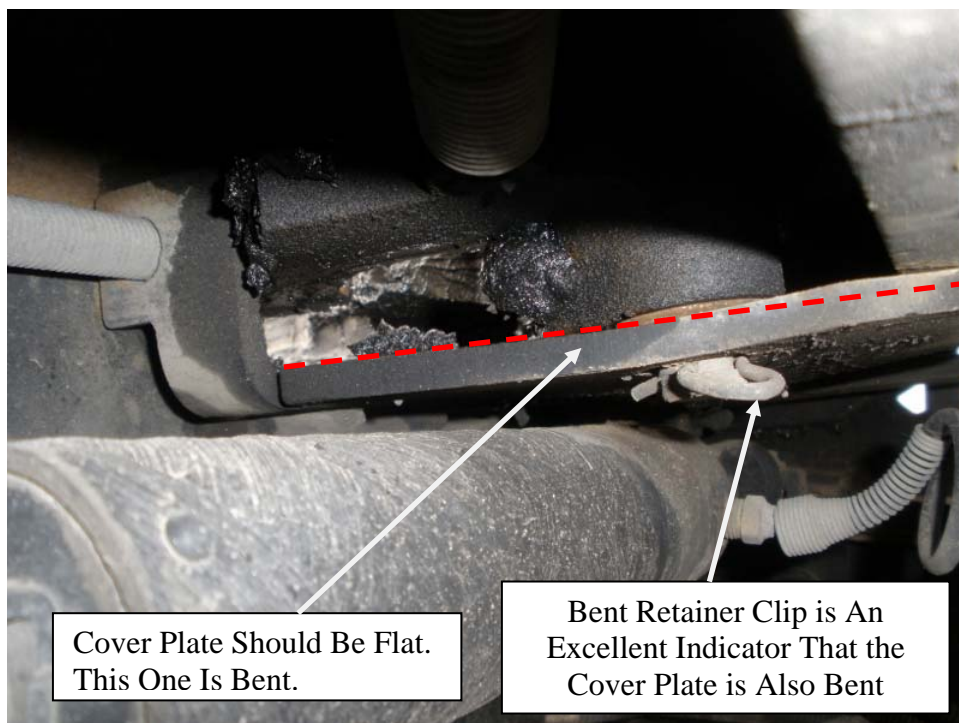
Bent Cover Plate  
Figure 4

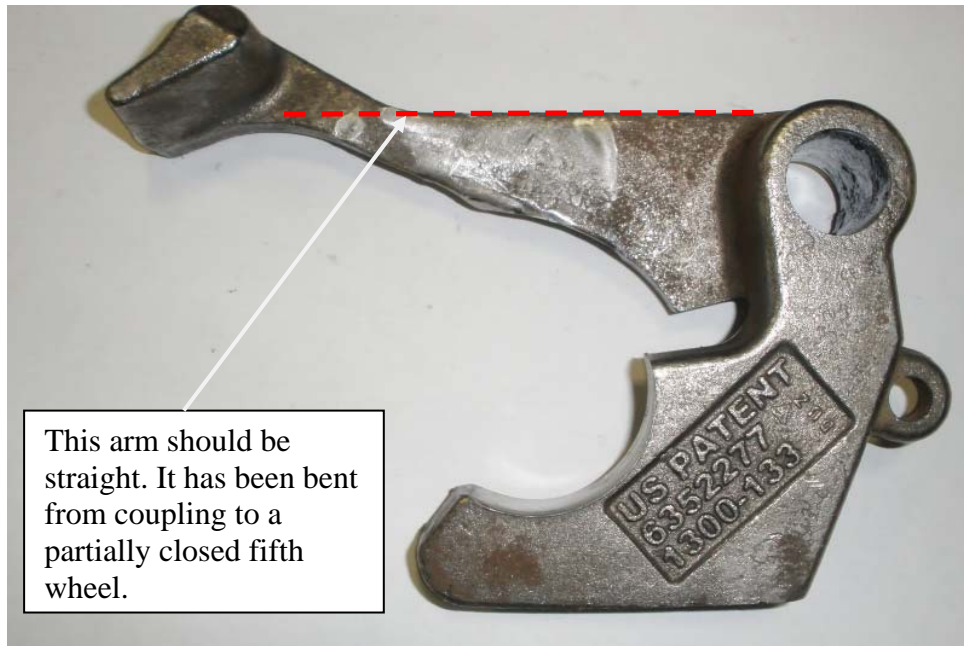
Damaged Rotating Jaw Caused By Improper Coupling  
Figure 5

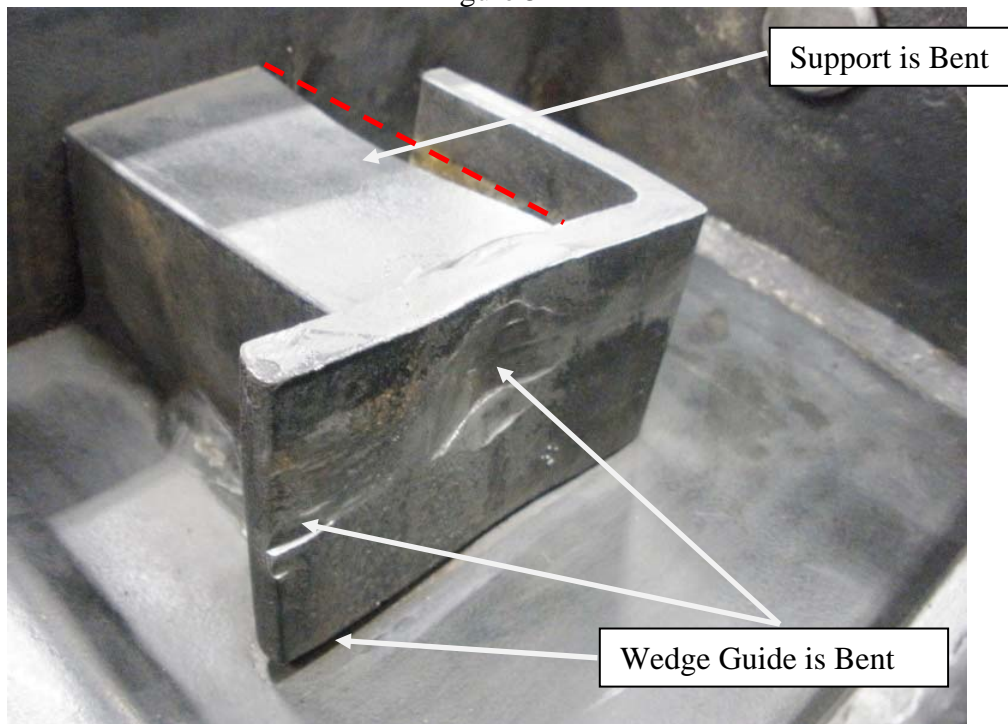
Wedge Guide Damage  
Figure 6
