# Safety Notice

# SN-614-14

Models Affected: HR, HRX, TC, TCX, OM, TLM, Units with side mount rotating platform

SUBJECT: Platform rotate cylinder

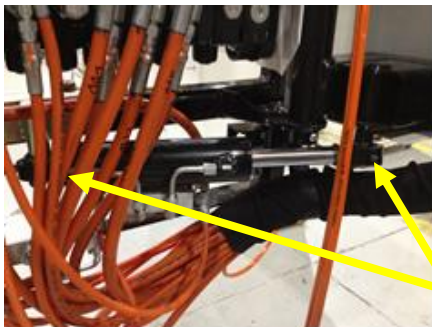
Cylinder with covers removed.

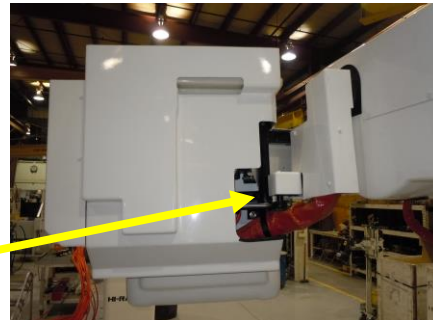
Location at boom tip behind cover

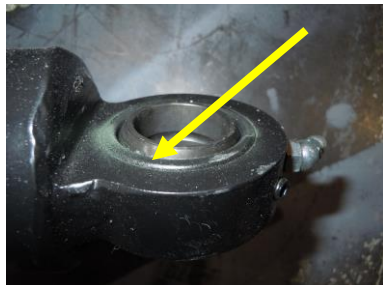
1. Immediately inspect the platform rotation cylinder ball bushings at the boom tip on all affected machines. Verify that the ball bushing outer race is centered in the cylinder rod and base ends. The base end will be flush and the rod end will be recessed .13 inch on each side as shown in the pictures below.

Base end - bearing outer race flush

2. If the ball bushing is not centered in the cylinder rod or base ends, or the ball bushing is loose in either the cylinder rod or base ends and has moved so that the ball bushing are not in the positions shown above do not operate the unit, take it out of service immediately. Contact your local Terex dealer or TEREX Utilities at 605-882-4000 or email machine information to [utilities.warranty@terex.com](mailto:utilities.warranty@terex.com) to arrange repair before further use.
3. Destroy the affected cylinder once the new cylinder has been installed.

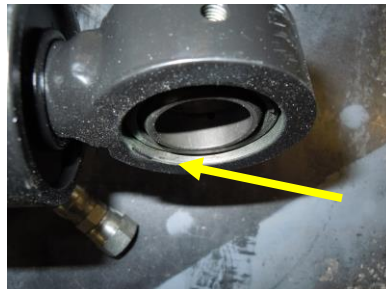
Rod end - recessed .13 inch each side
