F/CMVSS NONCOMPLIANCE RECALL

SUBJECT: Rear Parking Brake Cable Bracket Bolts Loose

MODELS: 2015 Chevrolet Cruze

GM Recall #15135

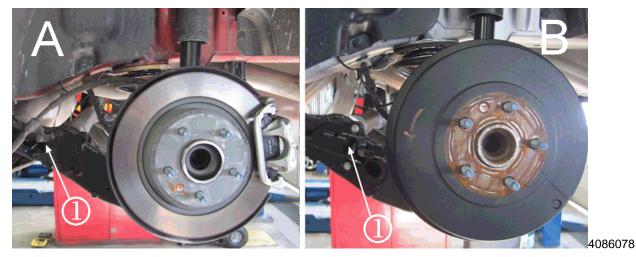
(A) Vehicles equipped with disc brakes. (B) Vehicles equipped with drum brakes.
(1) Location of rear park brake cable bracket bolts. Note: Vehicles equipped with disc brakes have one rear park brake cable bracket bolt per side. Vehicles equipped with drum brakes have three bolts per side.

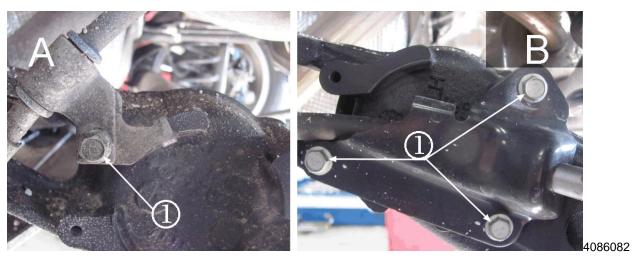
(A) Location of rear park brake cable bracket bolt (1) for vehicles equipped with disc brakes.(B) Location of rear park brake cable bracket bolts (1) for vehicles equipped with drum brakes.

- Inspect the left and right rear park brake cable bracket bolt torque and tighten the bolts to 9 N*m (80 lb-in) if required.
 - If the vehicle is equipped with rear disc brakes, remove the tire and wheel assembly. Refer to *Tire and Wheel Removal and Installation* in SI.
 - If the vehicle is equipped with rear drum brakes, there is enough clearance between the tire and wheel assembly and vehicle frame to verify bolt torque and, if necessary, tighten the rear park brake cable bracket bolts.
- 4. If the vehicle is equipped with rear disc brakes, install the rear tire and wheel assembly on the left and right side of vehicle. Refer to *Tire and Wheel Removal and Installation* in SI.
- 5. Lower the vehicle. Refer to Lifting and Jacking the Vehicle in SI.
