# Recall Bulletin

## F/CMVSS NONCOMPLIANCE RECALL

**SUBJECT:** Sunroof Switch Compliance

**MODELS:** 2013-2015 Chevrolet Malibu  
Equipped with Power-Operated Roof Panel System (RPO CF5)

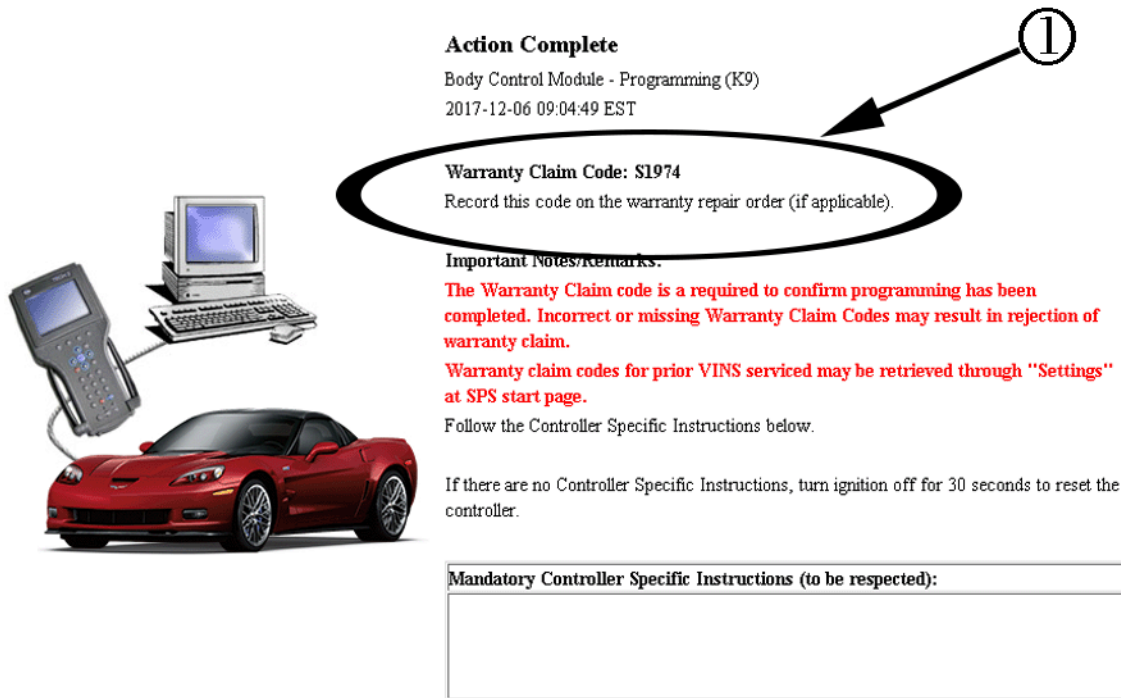
**Action Complete**  
 Body Control Module - Programming (K9)  
 2017-12-06 09:04:49 EST

**Warranty Claim Code: S1974**  
 Record this code on the warranty repair order (if applicable).

**Important:** Technicians MUST record the Warranty Claim Code (1) on the Job Card. To avoid warranty transaction rejection, this information must be entered when submitting the transaction.
