Recall Bulletin

F/CMVSS NONCOMPLIANCE RECALL

SUBJECT: Sunroof Switch Compliance

MODELS: 2013-2015 Chevrolet Malibu
Equipped with Power-Operated Roof Panel System (RPO CF5)

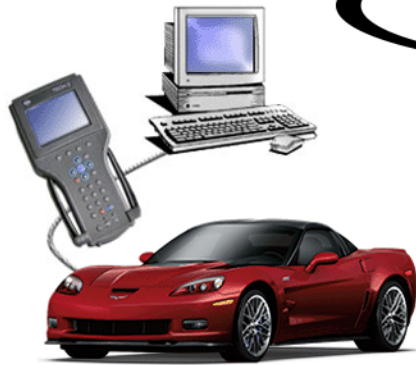
Note: If the Same Calibration/Software Warning is noted on the SPS Controller screen, continue with the programming event using SPS to ensure a Warranty Claim Code is displayed on screen. Technicians **MUST** record the Warranty Claim Code (1) on the Job Card. To avoid warranty transaction rejection, this information must be entered when submitting the transaction.
