Recall Bulletin

PRODUCT SAFETY RECALL

SUBJECT: Engine Oil Leak on Exhaust Manifold

MODELS: 2004 Buick Regal
2004 Chevrolet Impala
2004 Chevrolet Monte Carlo
2004 Pontiac Grand Prix
Equipped with a 3.8L V6 engine (RPO L26, L32, L36 or L67)

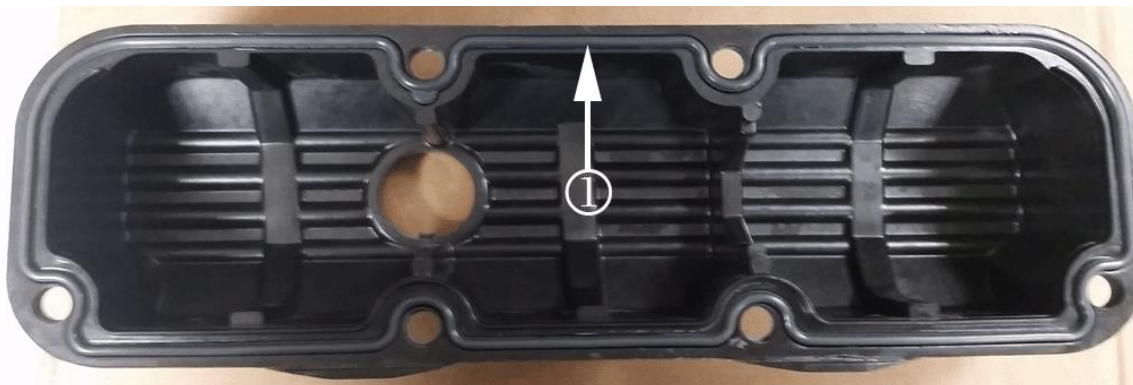
4596904

Warning: Ensure the new valve cover gasket is fully seated into the new valve cover groove. Use due care when installing the valve cover and gasket to the engine ensuring not to bump the valve cover or drag it over top of the rocker arms causing the gasket to come out of the groove. Inspect the mating surfaces of the valve cover and cylinder head to ensure the valve cover gasket is installed properly. Failure to do so may result in an oil leak and/or an engine fire.

7. Install a new left or front valve cover gasket (1) into the new valve cover and make sure that the valve cover gasket is seated properly in the valve cover groove.
 - 7.1. Install the six valve cover bolts and the six grommets into the valve cover.
 - 7.2. Apply medium strength thread lock compound (blue) to the six valve cover bolt threads.

- 7.3. Install the NEW valve cover and gasket (1) to the cylinder head.
- 7.4. Tighten the valve cover bolts to 10 Nm (89 lb in).
- 7.5. Verify that the valve cover gasket is properly installed (see the warning above).

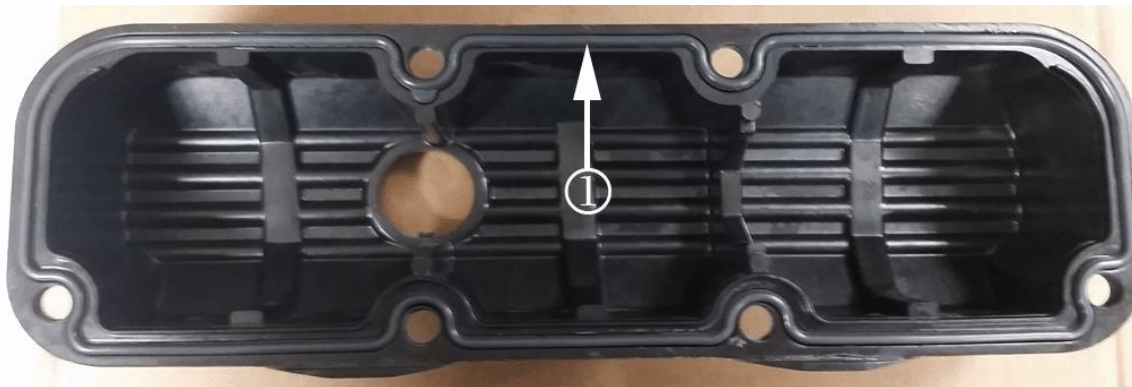
4596904

Warning: Ensure the new valve cover gasket is fully seated into the new valve cover groove. Use due care when installing the valve cover and gasket to the engine ensuring not to bump the valve cover or drag it over top of the rocker arms causing the gasket to come out of the groove. Inspect the mating surfaces of the valve cover and cylinder head to ensure the valve cover gasket is installed properly. Failure to do so may result in an oil leak and/or an engine fire.

6. Install a new left or front valve cover gasket (1) into the new valve cover and make sure that the valve cover gasket is seated properly in the valve cover groove.
 - 6.1. Install the six valve cover bolts and the six grommets into the valve cover.
 - 6.2. Apply medium strength thread lock compound (blue) to the six valve cover bolt threads.
 - 6.3. Install the NEW valve cover and gasket (1) to the cylinder head.

- 6.4. Tighten the valve cover bolts to 10 Nm (89 lb in).
- 6.5. Verify that the valve cover gasket is properly installed (see the warning above).
7. Install the 1-3-5 spark plug wires to the ignition coils.
