MANDATORY SERVICE RECALL

RECALL NO: 2015APR22.RC-001
 SUBJECT: TRAILER COMPLETE
 HARDWARE REPLACEMENT
 MODEL(S): SELECT 2015 TRAILERS

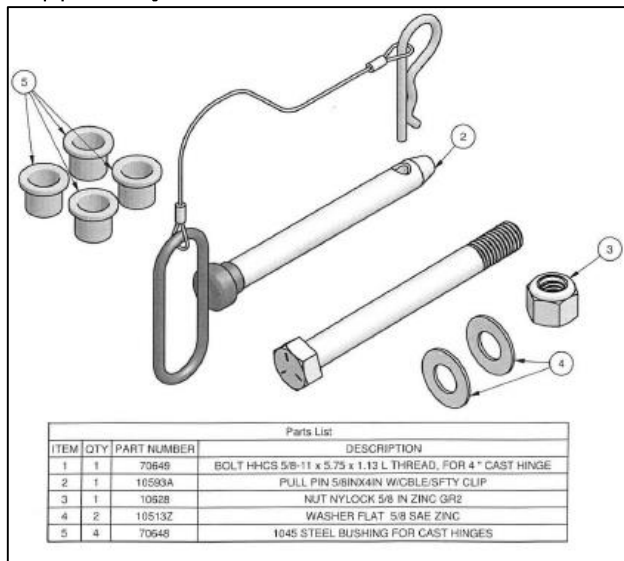
4" Frame Repair Kit

Recent testing on the swing tongue system used in our trailers indicated that some of the material properties of the bolt are under specification and the bushing is incorrect. This condition can potentially lead to the bushing and the bolt breaking which causes the swing tongue system to become ineffective and may result in some loss of vehicle control. This is a registered DOT recall and needs your immediate attention.

All 2015 trailers identified in the list that will be provided to you separately by MasterCraft are considered 'suspect' to the aforementioned condition and require a pivot bolt replacement. The pivot bolt sent will be certified Grade 5 without a drilled grease hole, and the bronze bushing will be replaced with a painted steel bushing. Pull pins will be replaced with certified diameter pull pins.

MasterCraft Part Number 650713
 Supplied by Vendor via MasterCraft
