# Product Safety Recall

## 15438 Front Passenger Air Bag Inflator

**Reference Number:** N15043800

**Release Date:** May 2018

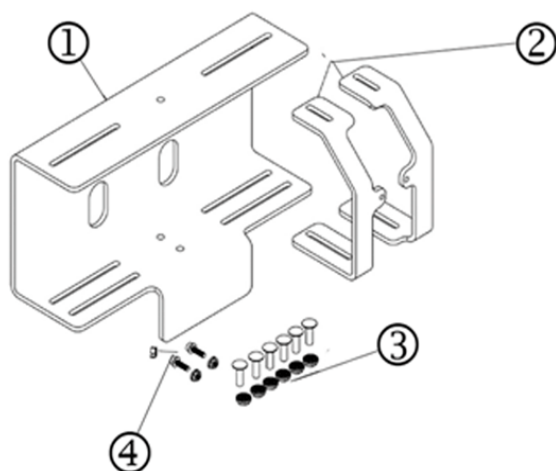
4006668

(1) Mounting Bracket (2) Support Bars (3) Support Bar Hardware (4) Air bag Mounting Hardware.

All U.S. dealers have been shipped the required air bag mounting bracket, shown below, to replace the front passenger air bag inflator module. These brackets were provided to dealers by General Motors through Bosch Automotive Service Solutions in late 2015. The Bosch tool number is EL-51377. If your dealership does not have the air bag mounting bracket, do not attempt to perform this service procedure and immediately contact Bosch at 1-800-GM-TOOLS for assistance. Attempting to replace the front passenger air bag inflator module without using the bracket poses a safety risk for the technician and anyone else in the area.

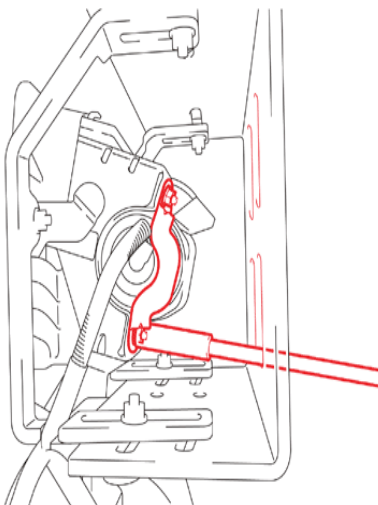
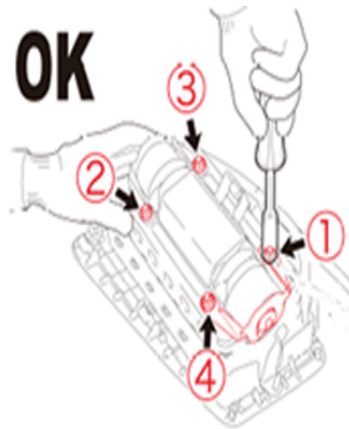
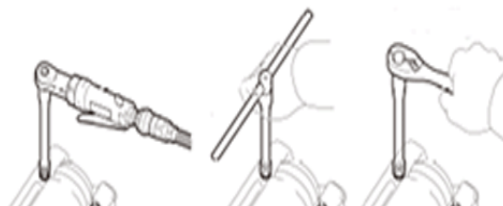
3610416

**Warning:** *DO NOT* pinch the harness between the inflator and the Position Orientating Plate.

18. Rotate the inflator until the harness connector aligns with the Position Orientating Plate.
