# Product Safety Recall

## 15438 Front Passenger Air Bag Inflator

Reference Number: N15043800

Release Date: April 2018

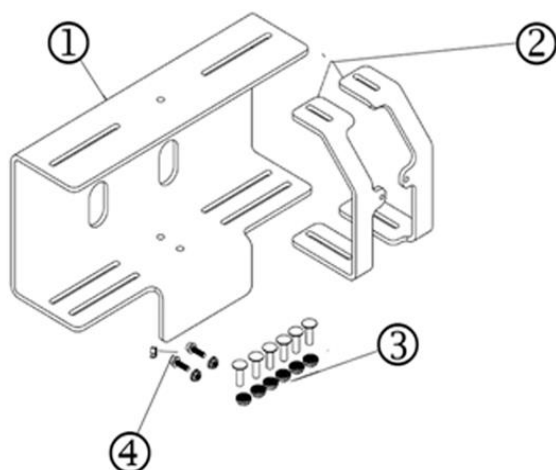
4006668

(1) Mounting Bracket (2) Support Bars (3) Support Bar Hardware (4) Air bag Mounting Hardware.

All U.S. dealers have been shipped the required air bag mounting bracket, shown below, to replace the front passenger air bag inflator module. These brackets were provided to dealers by General Motors through Bosch Automotive Service Solutions in late 2015. The Bosch tool number is EL-51377. If your dealership does not have the air bag mounting bracket, do not attempt to perform this service procedure and immediately contact Bosch at 1-800-GM-TOOLS for assistance. Attempting to replace the front passenger air bag inflator module without using the bracket poses a safety risk for the technician and anyone else in the area.

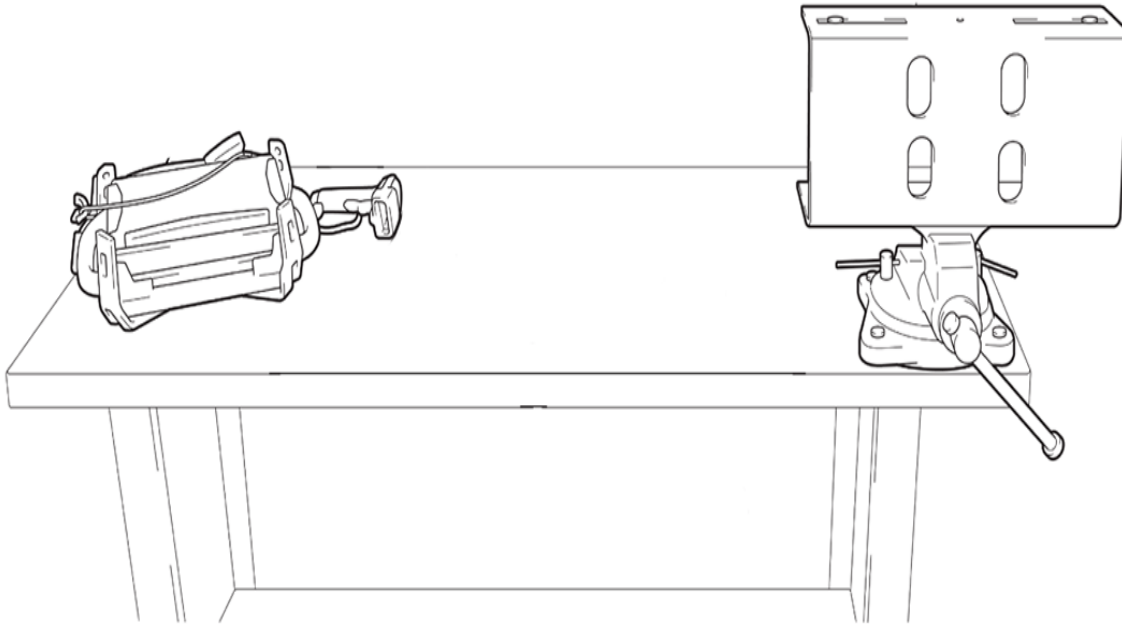
3607819

**Danger:** To avoid personal injury or death, it is critical to use an air bag module bracket when replacing an inflator module. Carefully read and follow the instructions below:

1. Confirm the bracket assembly is installed securely in the vice.
2. Confirm there are no loose objects or people exposed to the back side of the bracket for safety in the unlikely event of air bag deployment due to improper work procedures. The air bag is NOT being replaced due to an inadvertent deployment concern.
3. Confirm that no objects, tools or people are within 3 feet (1 meter) of the back side of the bracket.
4. Confirm that no objects, tools or people are within 2 feet (0.6 meters) of the sides of the bracket.
5. BEFORE starting work and periodically while working on the air bag module, touch a metallic part of the work bench to discharge static electricity in the body.

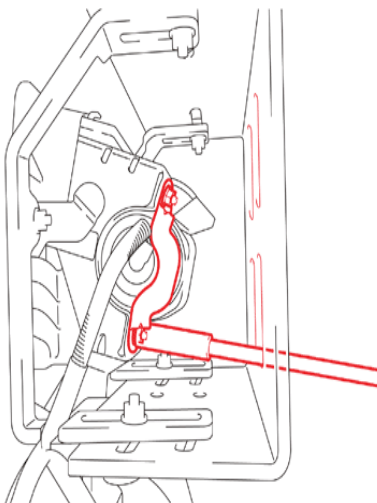
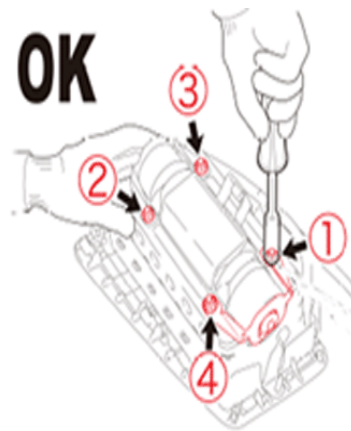
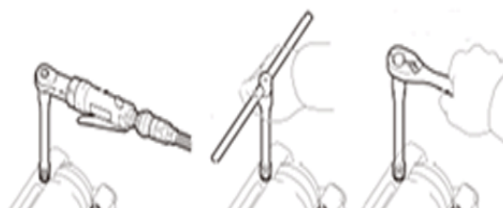
3610416

**Warning:** *DO NOT* pinch the harness between the inflator and the Position Orientating Plate.

**NG NG NG**

18. Rotate the inflator until the harness connector aligns with the Position Orientating Plate.
