Product Safety Recall

15817 Front Passenger Air Bag Inflator

Reference Number: N150817000

Release Date: April 2018

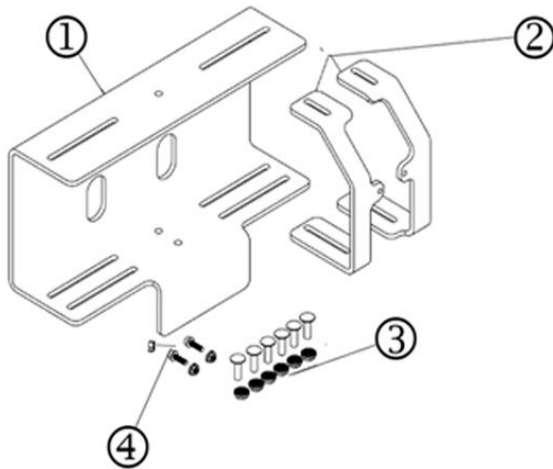
4006668

(1) Mounting Bracket (2) Support Bars (3) Support Bar Hardware (4) Air bag Mounting Hardware.

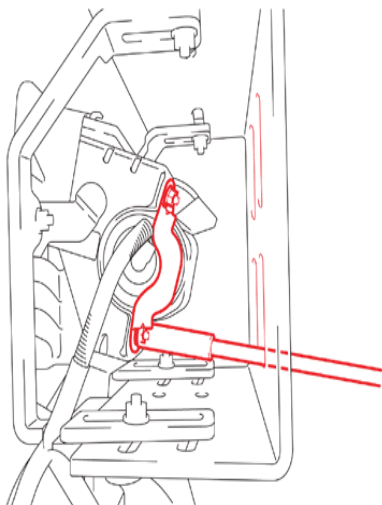
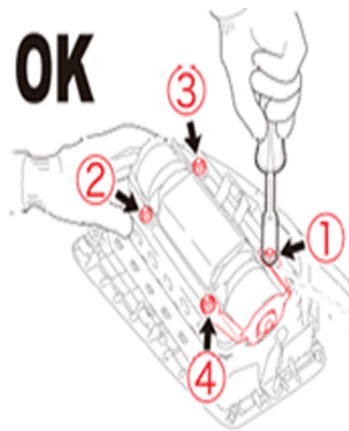
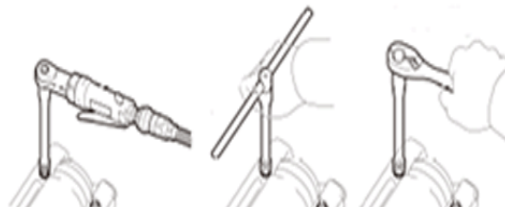
3610416

NG NG NG

18. Rotate the inflator until the harness connector aligns with the Position Orientating Plate.

Warning: *DO NOT* pinch the harness between the inflator and the Position Orientating Plate.
