Product Safety Recall

15438 Front Passenger Air Bag Inflator

Reference Number: N1504380

Release Date: January 2017
Revision: 00

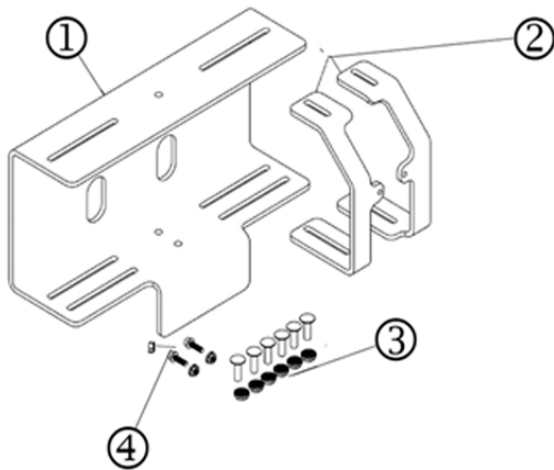
4006668

(1) Mounting Bracket (2) Support Bars (3) Support Bar Hardware (4) Air bag Mounting Hardware.

Dealers are required to use the air bag mounting bracket, shown below, to replace the front passenger air bag inflator module. These brackets were previously provided to dealers by General Motors through Bosch Automotive Service Solutions. The Bosch tool number is EL-51377. If your dealership does not have the air bag mounting bracket, do not attempt to perform this service procedure and immediately contact charles.berecz@gm.com for assistance. Attempting to replace the front passenger air bag inflator module without using the bracket poses a safety risk for the technician and anyone else in the area.
