# Recall Bulletin

**SUBJECT:** Power Lift Gate Prop Rod Recovery

**MODELS:** 2008-2012 Buick Enclave  
2009-2012 Chevrolet Traverse  
2007-2012 GMC Acadia  
2007-2010 Saturn Outlook  
Built Prior to March 10, 2012 Equipped with Power Lift Gate (TB5 or E61)

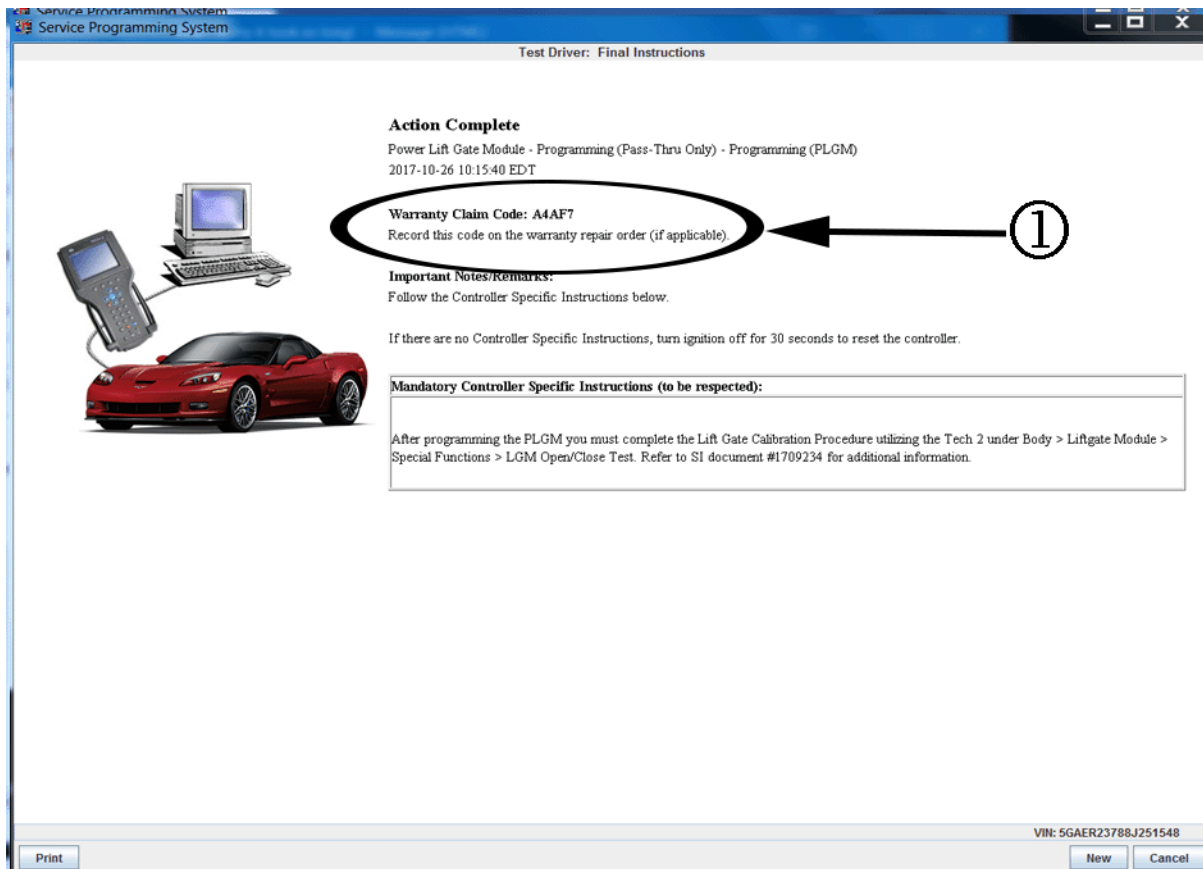
4896639

**Important:** Technicians **MUST** record the SPS Warranty Claim Code (1) on the job card. To avoid warranty transaction rejection, this information must be entered when submitting the transaction.

1. Reprogram the Power Lift Gate Module (PLGM). Refer to *Lift Gate Control Module Programming and Setup* in SI.
2. Record SPS Warranty Claim Code on job card for warranty transaction submission.
3. After the new programming is installed, verify the function of the lift gate.
  - If the lift gate **DOES** function properly, insure that both lift gate struts are installed with the rod end facing downward. See the Lift Gate Strut Orientation section below for proper strut orientation.
  - If the lift gate **DOES NOT** function properly as demonstrated in the training video referenced at the beginning of this service procedure:
    - One or both struts fail to hold the lift gate open – replace both lift gate struts.
    - Lift gate only opens partially and then reverses to close - replace both lift gate struts.

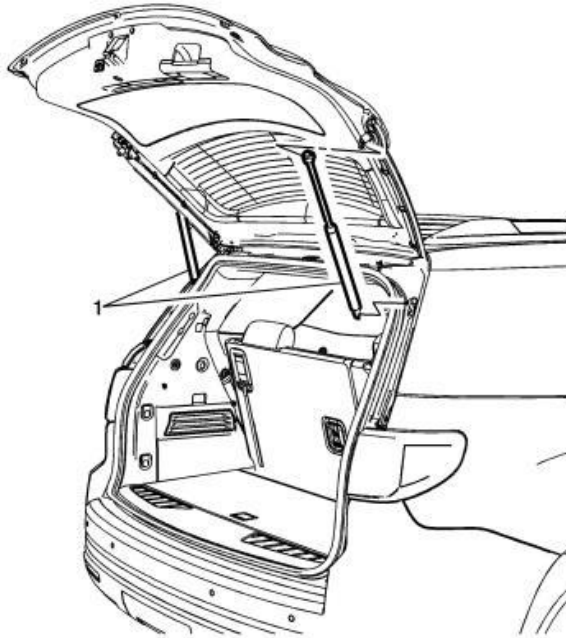
2878222

**Note:** GM engineering has determined that improved durability of the lift gate strut can be realized by installing the strut assembly with the rod end facing downward (attached to the lift gate) when the lift gate is in the closed position. In this orientation, dust and dirt does not collect on the strut housing to rod seal, which can cause wear on the seal.

**Note:** When replacing or repositioning the lift gate struts, install the strut assembly with the strut body end attached to the vehicle body and the rod side attached to the lift gate (1).
