Recall Bulletin

PRODUCT SAFETY RECALL

SUBJECT: Power Lift Gate Prop Rod Recovery

MODELS: 2008-2012 Buick Enclave
2009-2012 Chevrolet Traverse
2007-2012 GMC Acadia
2007-2010 Saturn Outlook
Built Prior to March 1, 2012 and Equipped with Power Lift Gate (TB5 or E61)

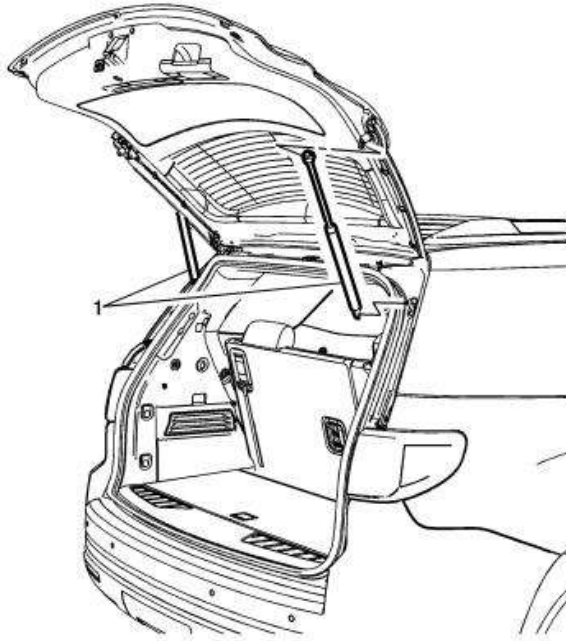
2878222

Note: GM engineering has determined that improved durability of the lift gate strut can be realized by installing the strut assembly with the rod end facing downward (attached to the lift gate) when the lift gate is in the closed position. In this orientation, dust and dirt does not collect on the strut housing to rod seal, which can cause wear on the seal.

Note: When replacing or repositioning the lift gate struts, install the strut assembly with the strut body end attached to the vehicle body and the rod side attached to the lift gate (1).
