Recall Bulletin

PRODUCT SAFETY RECALL

SUBJECT: Power Lift Gate Prop Rod Recovery

MODELS: 2008-2012 Buick Enclave
2009-2012 Chevrolet Traverse
2007-2012 GMC Acadia
2007-2010 Saturn Outlook
Built Prior to March 10, 2012 Equipped with Power Lift Gate (TB5 or E61)

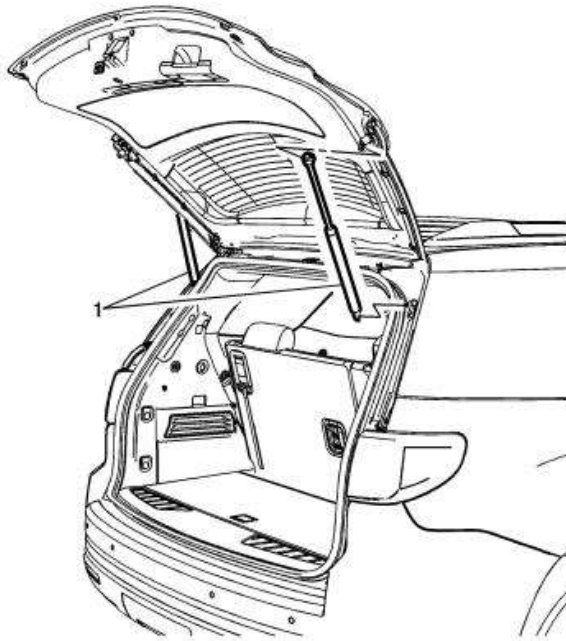
2878222

Note: GM engineering has determined that improved durability of the lift gate strut can be realized by installing the strut assembly with the rod end facing downward (attached to the lift gate) when the lift gate is in the closed position. In this orientation, dust and dirt does not collect on the strut housing to rod seal, which can cause wear on the seal.

Note: When replacing or repositioning the lift gate struts, install the strut assembly with the strut body end attached to the vehicle body and the rod side attached to the lift gate (1).
