Recall Bulletin

SUBJECT: Side Impact Sensor (SIS) Wire Chafe at Window Regulator

MODELS: 2010 Chevrolet Cobalt 4-Door Sedan

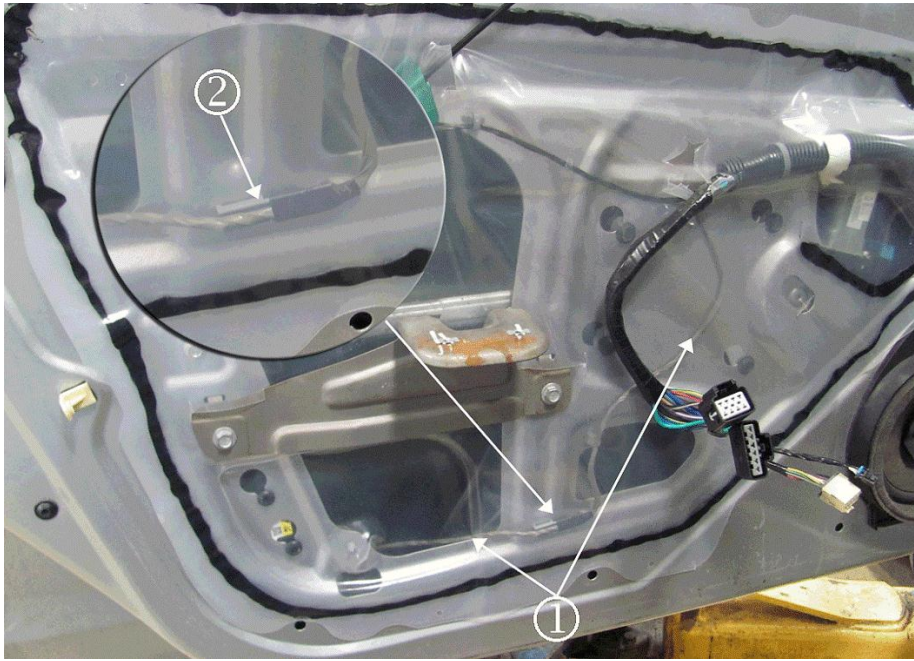
4141990

2. Locate the side impact sensor (SIS) wire harness (1).
3. Determine if the SIS wire harness clip is in the horizontal or vertical position.
 - If the SIS wire harness clip is positioned in the horizontal position (2), cycle the window to ensure that the SIS wire does NOT contact the window regulator.
 - If the SIS wire harness does NOT contact the window regulator, no further action is required. Re-install the front driver side door trim panel. Refer to *Front Side Door Trim Panel Replacement* in SI.
 - If the SIS wire harness does contact the window regulator, proceed to step 4.

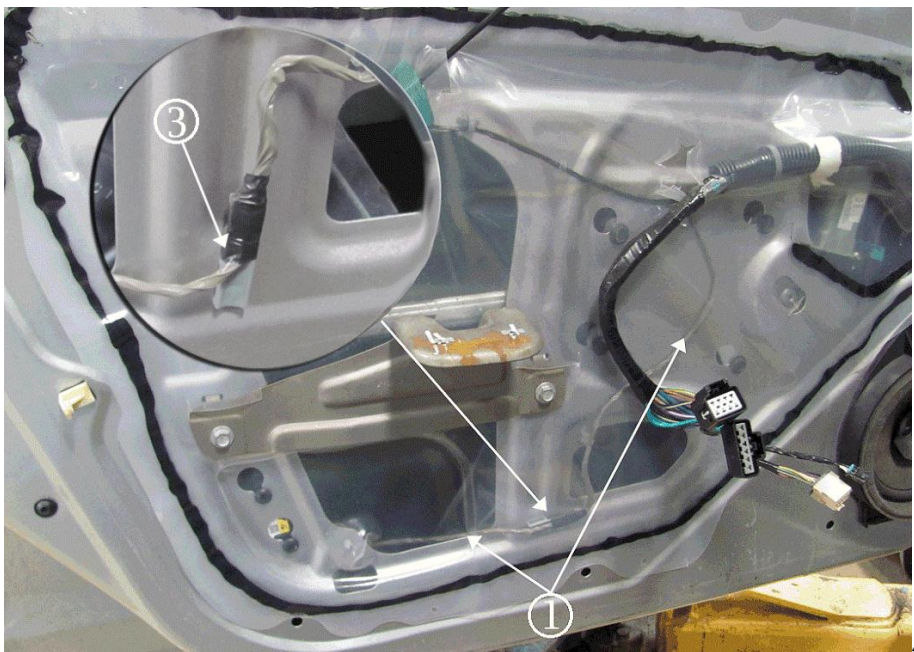
4141996

- If the SIS wire harness clip is positioned in the vertical position (3), partially remove the vapor barrier to gain access to the SIS wiring harness and clip. Remove the pull cup bracket to partially remove the vapor barrier. Proceed to step 4.

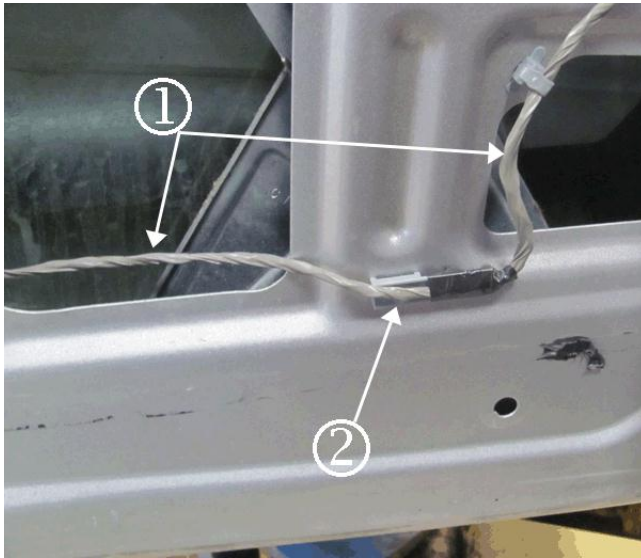
4142109

4. Determine if the SIS wire harness (1) is damaged.
 - If the SIS wire harness (1) is NOT damaged, proceed to step 5.
 - If the SIS wire harness (1) is damaged, repair the wire harness. Refer to *Repairing Damaged Wire Insulation* and/or *Wiring Repairs* in SI. Proceed to step 5 after completing the wire repair.
5. Install the SIS wiring harness clip in the horizontal position (2).

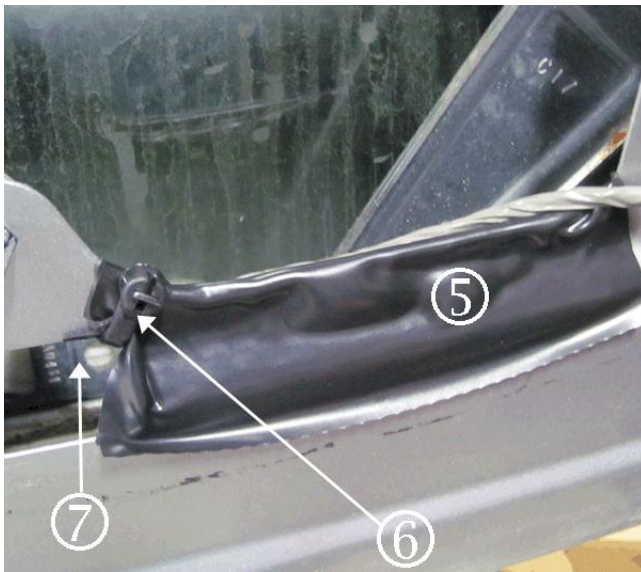
4142125

Note: Ensure the SIS wire harness does not contact the window regulator.

7. Secure SIS wire harness to the inside of the door metal using a tie strap (6). Use the access hole (7) to route the tie strap and secure the SIS wire harness.
8. Install the vapor barrier and pull cup bracket.
