Recall Bulletin

SUBJECT: Driver Side Rear Pillar Interior Fires

MODELS: 2013-2016 Cadillac ATS Sedan

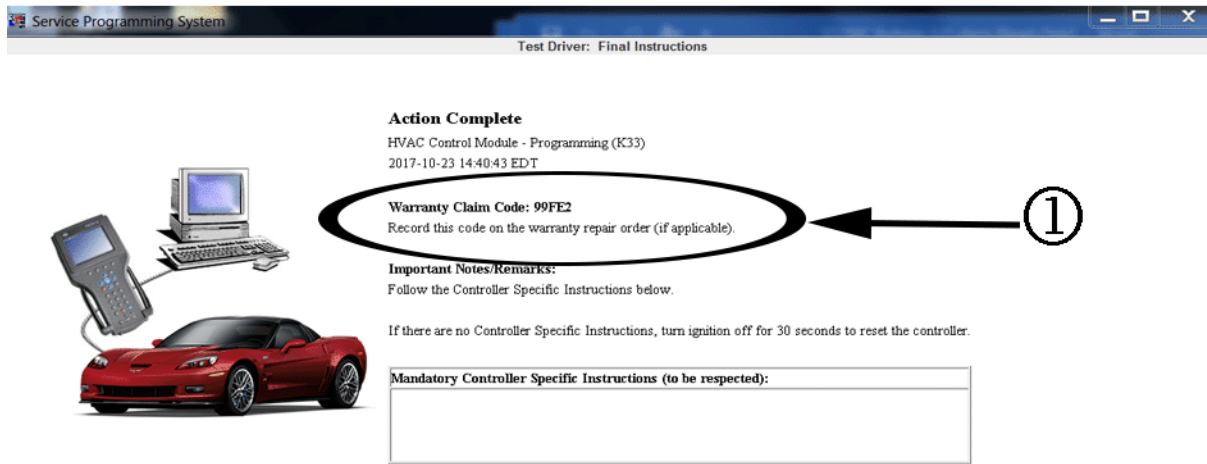
4896640

Important: Technicians **MUST** record the SPS Warranty Claim Code (1) on the job card. To avoid warranty transaction rejection, this information must be entered when submitting the transaction.

1. Reprogram the HVAC System Control Module. Refer to *HVAC System Control Module Programming and Setup* in SI.
2. Record SPS Warranty Claim Code on job card for warranty transaction submission.
3. Make a copy of the owner manual supplement on the last page of this bulletin and insert it into the vehicle's owner manual.
