Recall Bulletin

SUBJECT: Under Hood Fire

MODELS: 1997-2004 Buick Regal
2000-2004 Chevrolet Impala
1998-1999 Chevrolet Lumina
1998-2004 Chevrolet Monte Carlo
1998-1999 Oldsmobile Intrigue
1997-2004 Pontiac Grand Prix
Equipped with 3.8L V6 Engine (RPO L26, L32, L36 or L67)

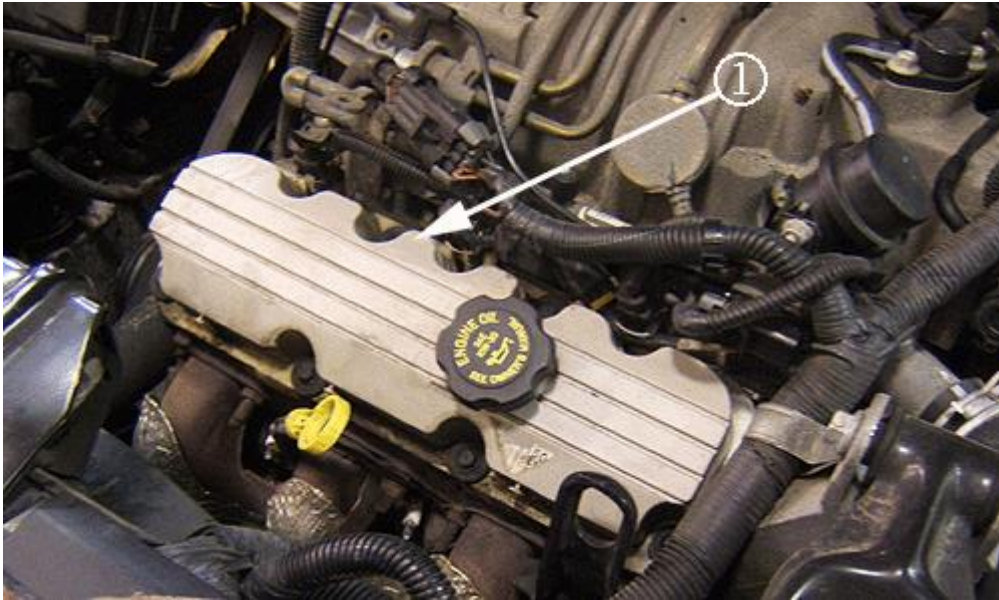
2074284

Danger: Do not use a brake cleaner, or equivalent to remove the oil residue from the exhaust manifold; doing so may cause an engine fire.

Note: Before the removal of the left or front engine valve cover, use an engine degreaser or equivalent in order to remove the oil residue from the exhaust manifold and the oil and dirt residue from the intake manifold, cylinder head, and engine block. It may be necessary to use a brush or scraper.

5. Remove and DISCARD the left or front engine valve cover (1) and gasket.

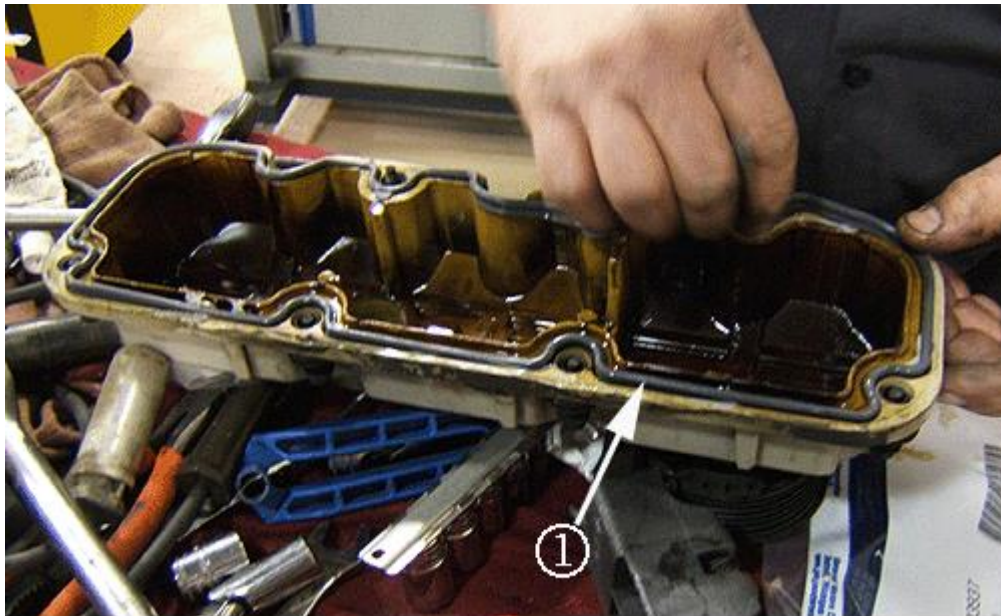
2076766

Warning: Ensure the new valve cover gasket is fully seated into the new valve cover groove. Use due care when installing the valve cover and gasket to the engine ensuring not to bump the valve cover or drag it over top of the rocker arms causing the gasket to come out of the groove. Inspect the mating surfaces of the valve cover and cylinder head to ensure the valve cover gasket is installed properly. Failure to do so may result in an oil leak and/or an engine fire.

6. Install a new left or front valve cover gasket (1) into the new valve cover and make sure that the valve cover gasket is seated properly in the valve cover groove. The old valve cover is shown for illustrative purposes only.
 - 6.1. Install the six valve cover bolts and the six grommets into the valve cover.
 - 6.2. Apply medium strength thread lock compound (blue) to the six valve cover bolt threads.
 - 6.3. Install the NEW valve cover and gasket (1) to the cylinder head.
 - 6.4. Tighten the valve cover bolts to 10 Nm (89 lb in).
 - 6.5. Verify that the valve cover gasket is properly installed (see the warning above).

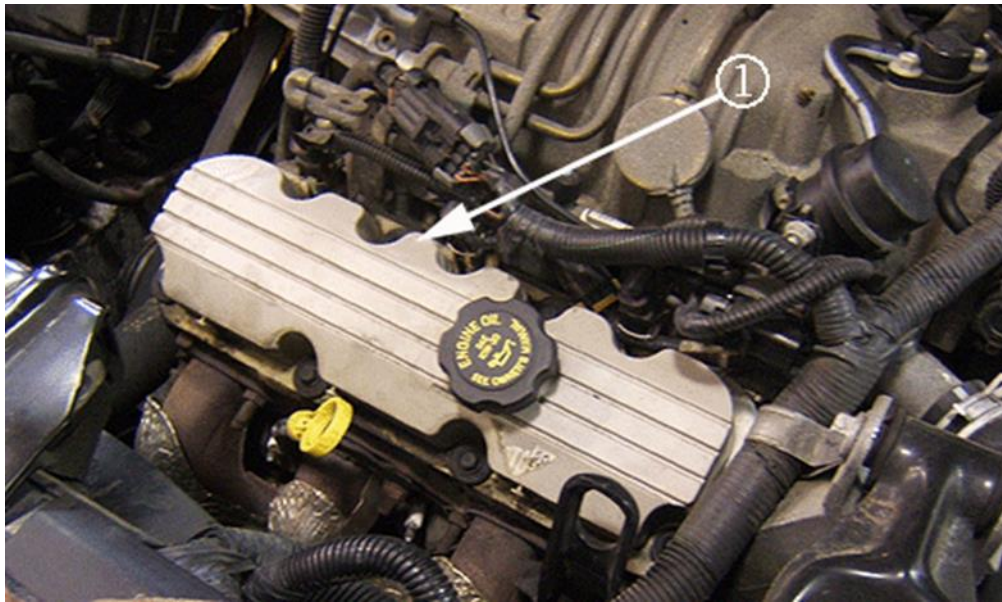
2074284

Danger: Do not use a brake cleaner, or equivalent to remove the oil residue from the exhaust manifold; doing so may cause an engine fire.

Note: Before the removal of the left or front engine valve cover, use an engine degreaser or equivalent in order to remove the oil residue from the exhaust manifold and the oil and dirt residue from the intake manifold, cylinder head, and engine block. It may be necessary to use a brush or scraper.

4. Remove and DISCARD the left or front engine valve rocker arm cover (1) and gasket.
 - 4.1. Remove the valve cover bolts.

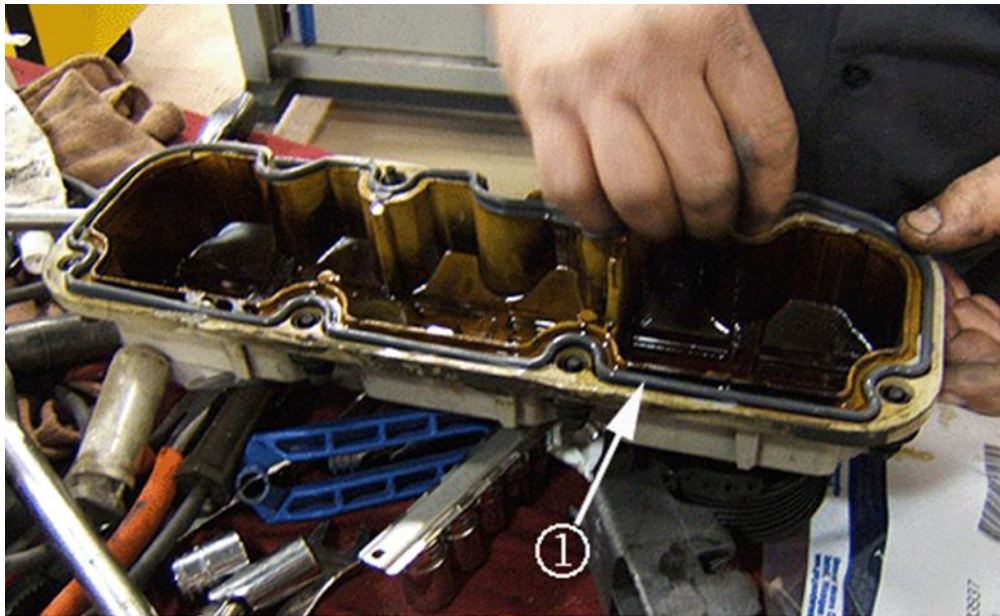
2076766

Warning: Ensure the new valve cover gasket is fully seated into the new valve cover groove. Use due care when installing the valve cover and gasket to the engine ensuring not to bump the valve cover or drag it over top of the rocker arms causing the gasket to come out of the groove. Inspect the mating surfaces of the valve cover and cylinder head to ensure the valve cover gasket is installed properly. Failure to do so may result in an oil leak and/or an engine fire.

5. Install a new left or front valve cover gasket (1) into the new valve cover and make sure that the valve cover gasket is seated properly in the valve cover groove. The old valve cover is shown for illustrative purposes only.
 - 5.1. Install the six valve cover bolts and the six grommets into the valve cover.
 - 5.2. Apply medium strength thread lock compound (blue) to the six valve cover bolt threads.
 - 5.3. Install the NEW valve cover and gasket (1) to the cylinder head.
 - 5.4. Tighten the valve cover bolts to 10 Nm (89 lb in).
 - 5.5. Verify that the valve cover gasket is properly installed (see the warning above).
6. Install the 1-3-5 spark plug wires to the ignition coils.
