IMPORTANT SAFETY RECALL

June 2015

General Motors has decided that a defect which relates to motor vehicle safety exists in certain 2011-2012 model year Chevrolet Malibu vehicles. As a result, GM is conducting a safety recall. We apologize for this inconvenience. However, we are concerned about your safety and continued satisfaction with our products.

Enclosure
GM Recall #15031

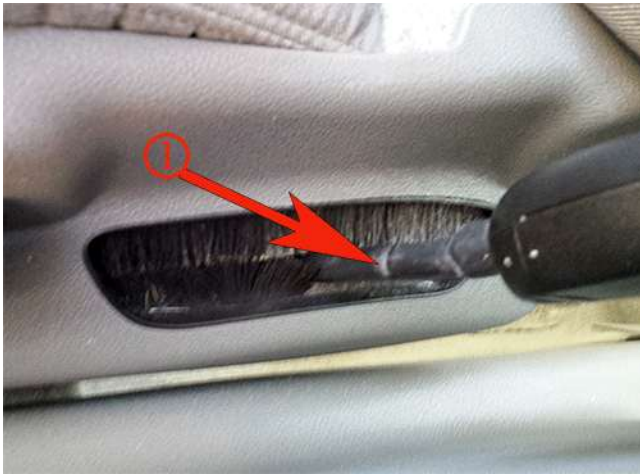
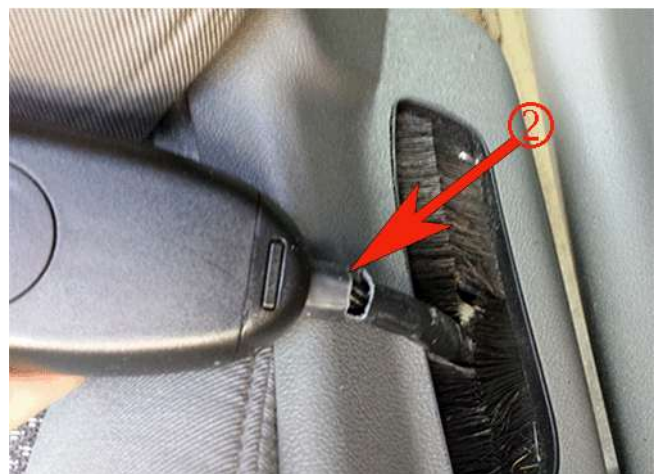
Inspection Overview

This inspection must be performed on both the driver and passenger side safety belt cable sleeve. If these front sleeves are cut or cracked either on the cable (see arrow 1 above) or where the cable meets the buckle (see arrow 2 above), the safety belt assembly should be replaced. If the sleeve shows only scuffs or wear marks (no cuts or cracks), replacement is not necessary.

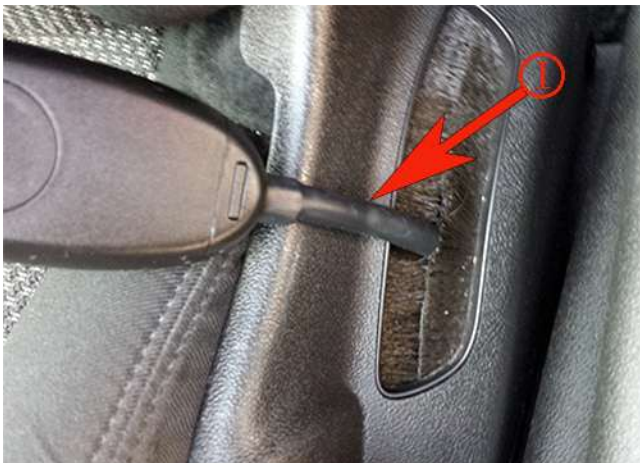
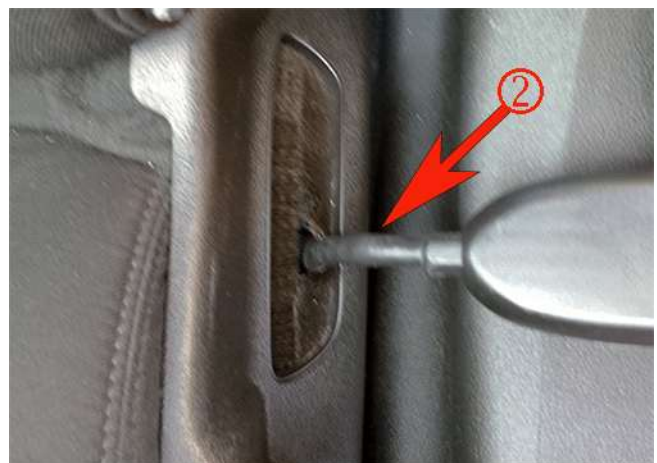
- Inspect the sleeve for any cuts or cracks. Bend the cable toward the inside (see arrow 1 above) and outside (see arrow 2 above) of the vehicle and carefully inspect for any cuts or cracks in the sleeve. This inspection must be performed on both the driver and passenger safety belt cable sleeves.

- If either the driver or passenger sleeves show any cuts or cracks, please stop driving your vehicle and immediately contact your GM dealer. Your dealer will arrange for your vehicle to be towed to the dealership at no charge and provide you with a free loaner vehicle while the damaged safety belt assembly is replaced. **Note that this replacement is a temporary repair and your vehicle will still need to be serviced when parts are available.**
