This Service Information bulletin supersedes SI 52 09 15 dated October 2015.

Delivery Stop - F10 ISOFIX Bracket

F10 (5 Series Sedan)

Produced from July 20, 2015 to September 14, 2015

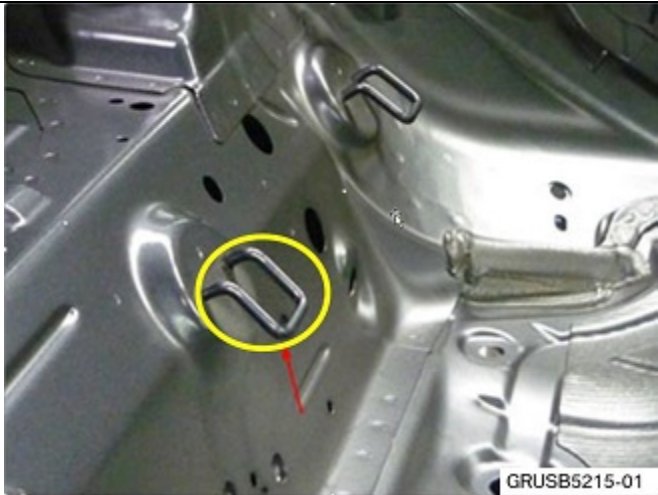
Right bracket (anchor) for left rear seating position may be deformed.

1. Check the gap on the right side bracket of the left side rear seat.

The bracket to be checked is shown.

Right bracket (anchor) for left rear seating position must be bent into correct position.

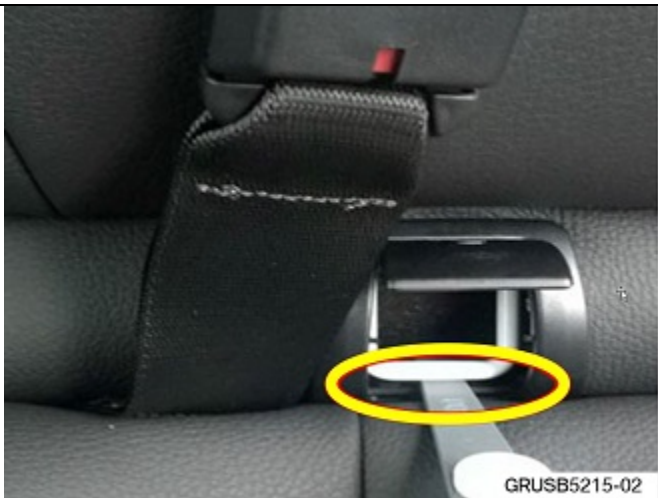
2. Check the gap between the seat bottom and ISO bracket using an appropriate measuring tool.

Note: The seat bottom to bracket gap must be 4 mm to 6 mm.
