| RE: <b>Recall Campaign Launch Notification – 2019050008 Takata PG4 and PG5 DRIVER and PASSENGER AIRBAGs</b><br>Certain MY08-09 C63 AMG C-Class (W204) | DATE: May 24, 2019 |

**Recall Campaign Launch Notification****May 24, 2019****Campaign No. :****NHTSA ID: 16V081****Campaign Desc. :****Takata Recall – PG 4 & 5****2019050008****16V363/17V017  
18V043****19P9194003****Driver and Passenger Airbag**

SUBJECT: **Model 204 (C63 AMG only)**  
**Model Years 2008 – 2009**  
**Replace Driver-Side and Front Passenger-side Airbag and install Knee Bolster**

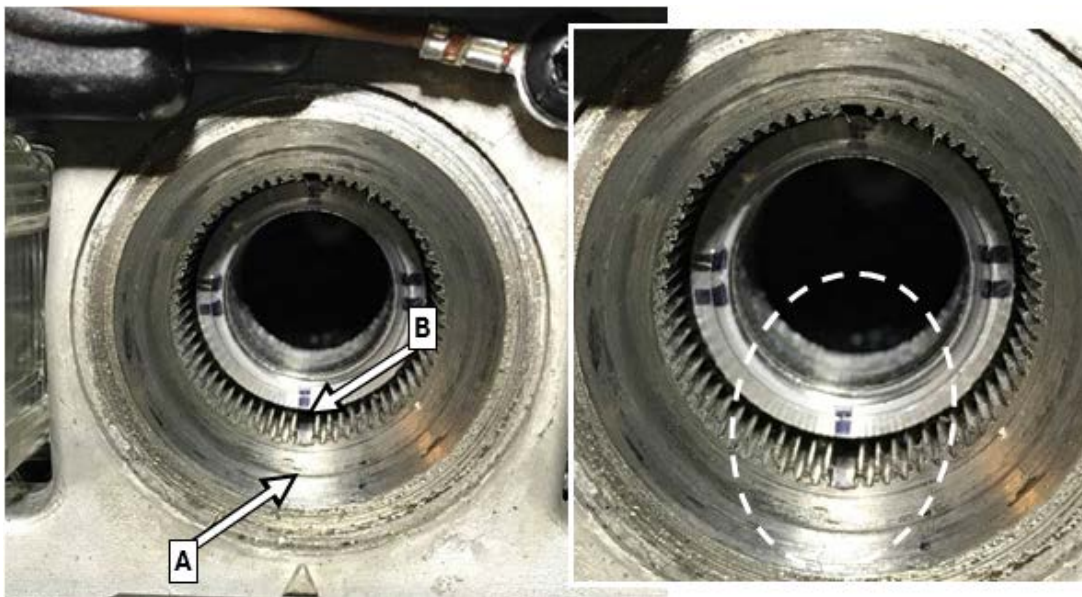
Figure 2

**i** The serrations (A, Figure 2) on the steering wheel must be aligned with the marking (B, Figure 2) on the steering shaft.
