Product Safety Recall

15815 Front Passenger Air Bag Inflator Module

Reference Number: N150815

Release Date: February 2018

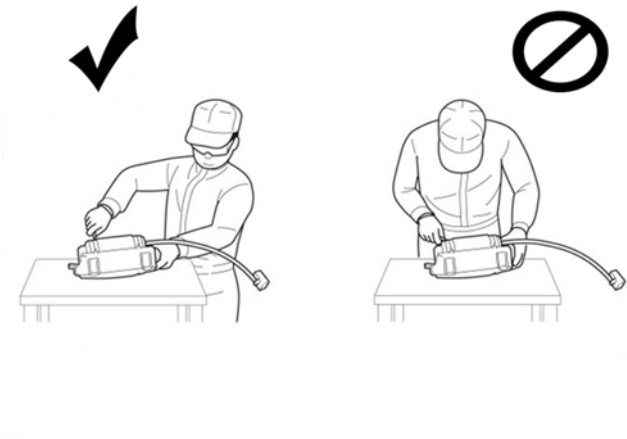
4486635

Caution: Avoid standing directly over the inflator.

Note: Place clean sheets of paper on the bench inflator side up.

1. Carefully place the air bag on the bench inflator side up.
2. Wrap a flat-blade screwdriver with tape.
